Release Note

Publication number E5902-92002
May 2000

Updating Firmware

Firmware gives your emulation probes and the trace port analyzers a “personality” for a particular processor or processor family. You need to update your E5900A #800 and E5903A #800 to use with the Toshiba TX39/H2 processors. The trace port analyzer can only be updated from the Toshiba TX19/39 family.

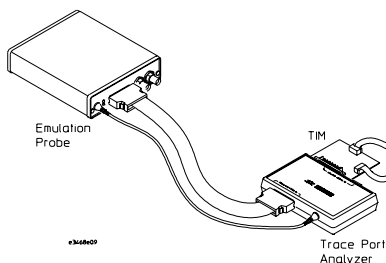
Performing the TIM and the trace port analyzer PV tests with the emulation probe

- 1 Plug the 20-pin cable into the target connector and the loop-back connector on the TIM.

- Details of the failure can be obtained through using a -v option ("verbose" level) of 2 or more.
- Check that the 20pin cable is loop-backed.
- If the problem persists, contact Agilent for assistance.
