Installation Note

Agilent Technologies E8257D PSG Signal Generators Add Option 1E1 (Attenuator)

Add Option 1E1 (Attenuator)

This upgrade kit adds Option 1E1 (Attenuator) to the E8257D (Analog) PSG Signal Generators.

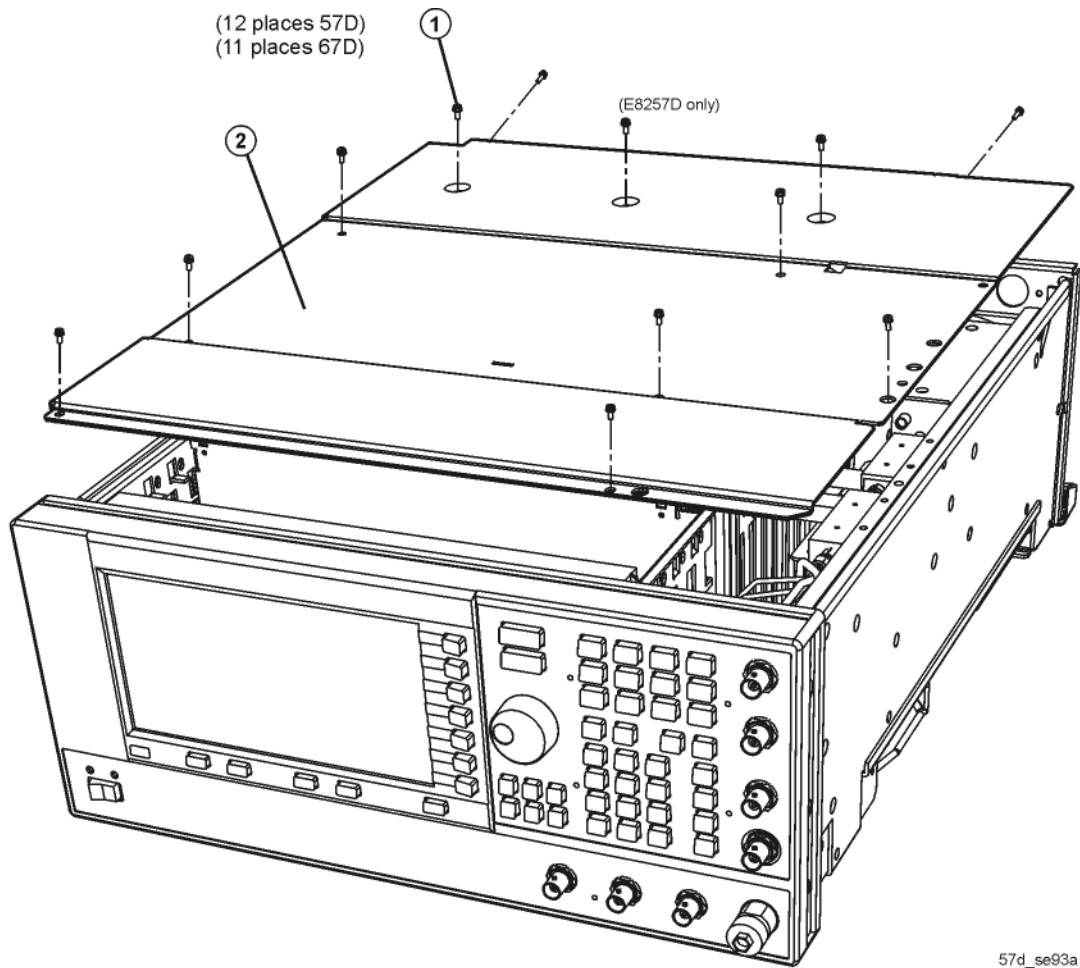
Figure 2

Refer to [Figure 2](#).

1. Using a T-10 driver, remove the twelve screws (1) from the inner-top cover (2).
2. Remove the inner-top cover.

Inner Top Cover Removal

Refer to [Figure 1](#) and [Figure 2](#).

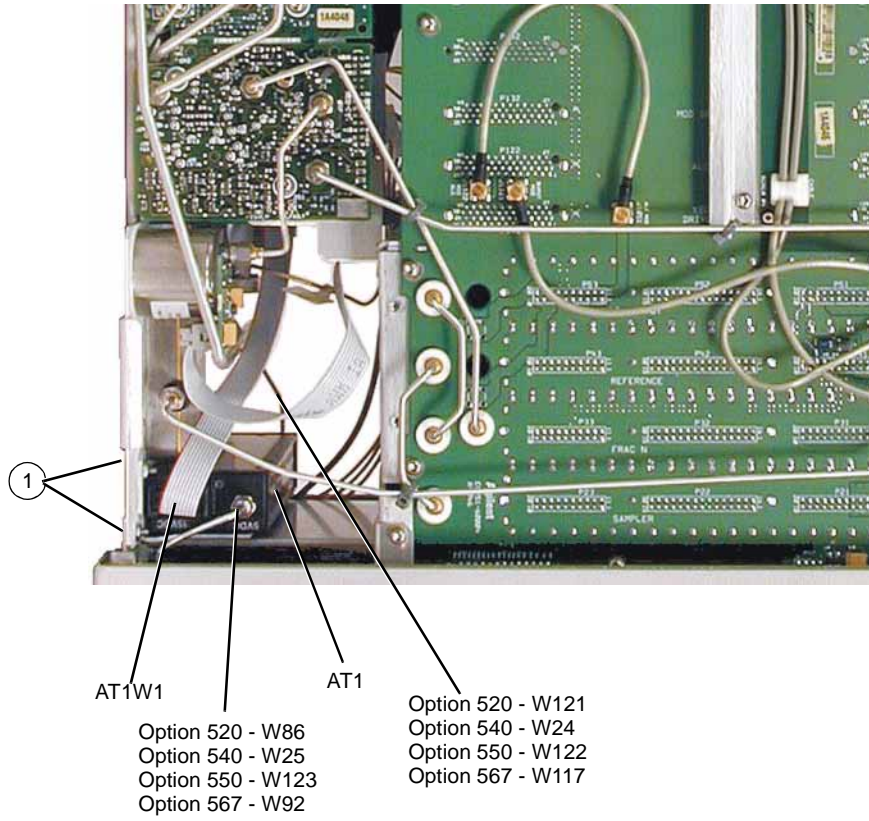
Figure 3

3. Refer to [Figure 3](#). Position the attenuator so it can be attached to the RF deck.
4. Using the T-10 driver, insert the two screws (1) through the side deck into the metal bracket that is attached to the attenuator. Torque these screws to 9 in-lbs.

Option 1E1 (Front Panel RF Output)

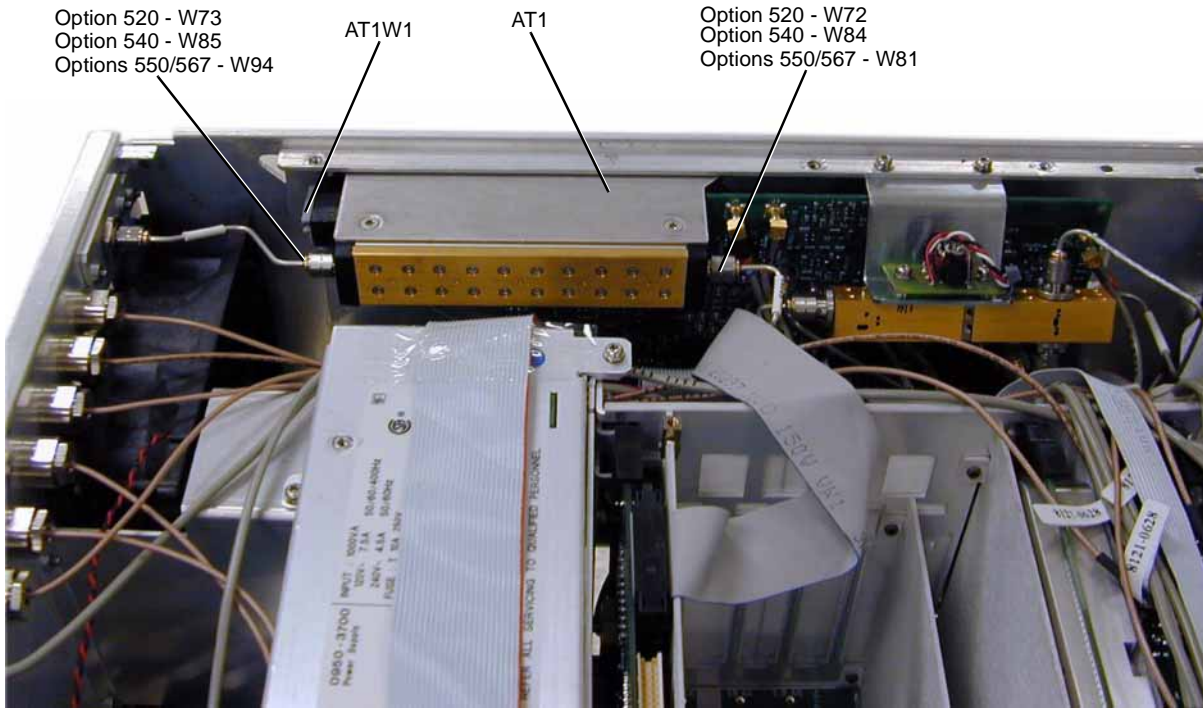
3. Refer to [Figure 4](#). Position the attenuator so it can be attached to the RF deck.
4. Using the T-10 driver, insert the two screws through the side deck into the metal bracket that is attached to the attenuator. Torque these screws to 9 in-lbs.

Figure 4 **Option 1E1 (Rear Panel RF Output)**
