S E R V I C E N O T E

8753C Network Analyzer**Serial Numbers:** 3214J01230 / 3214J01619**Reversed capacitor causes fuse A8F10 to blow****Parts Required:**

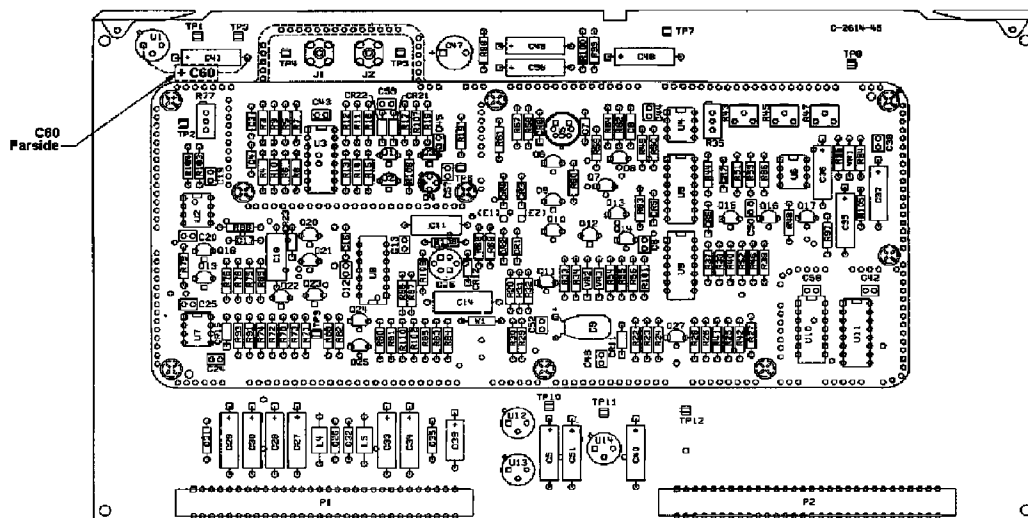
Several units have been found to have the capacitor A13C60 mounted with its polarity reversed. Over time the capacitors become leaky and cause the fuse A8F10 to blow.

When suspect units are received, the capacitor A13C60 should be checked to insure that the capacitor has been inserted correctly. If A13C60 has been inserted incorrectly replace with NEW capacitor.
