Installation Note

Agilent Technologies E8257D PSG Signal Generators Add Option 1E1 (Attenuator)

Add Option 1E1 (Attenuator)

This upgrade kit adds Option 1E1 (Attenuator) to the E8257D (Analog) PSG Signal Generators.

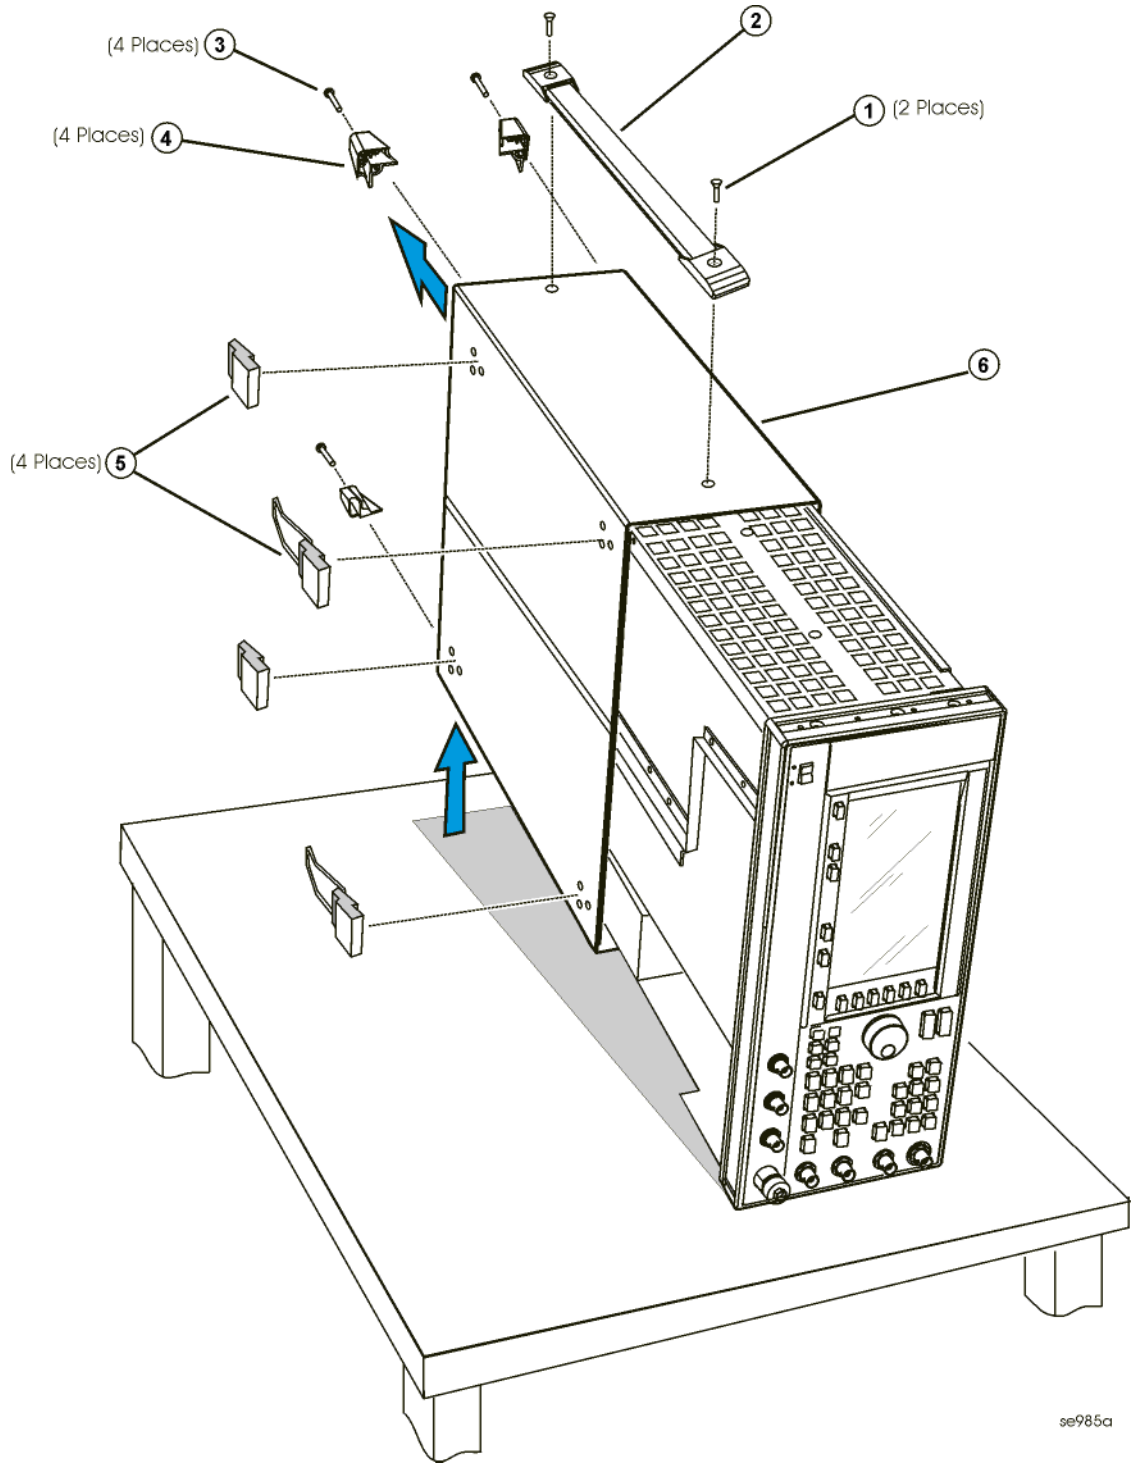
Figure 1 **Outer Cover Removal**

1. Disconnect the power cord.
2. Using a T-20 driver, loosen the two screws (1) and remove the strap handle (2).
3. Using a T-15 driver, remove the center screws (3) on the four rear-panel feet (4).
4. Remove the four bottom feet (5) from the cover by lifting the tab and sliding the foot toward the tab.
5. Place the signal generator on its side.
6. Tilt the signal generator forward and slide the outer cover (6) back to remove it from the frame.

Refer to [Figure 1](#).

Refer to [Figure 1](#) and [Figure 1-1](#).

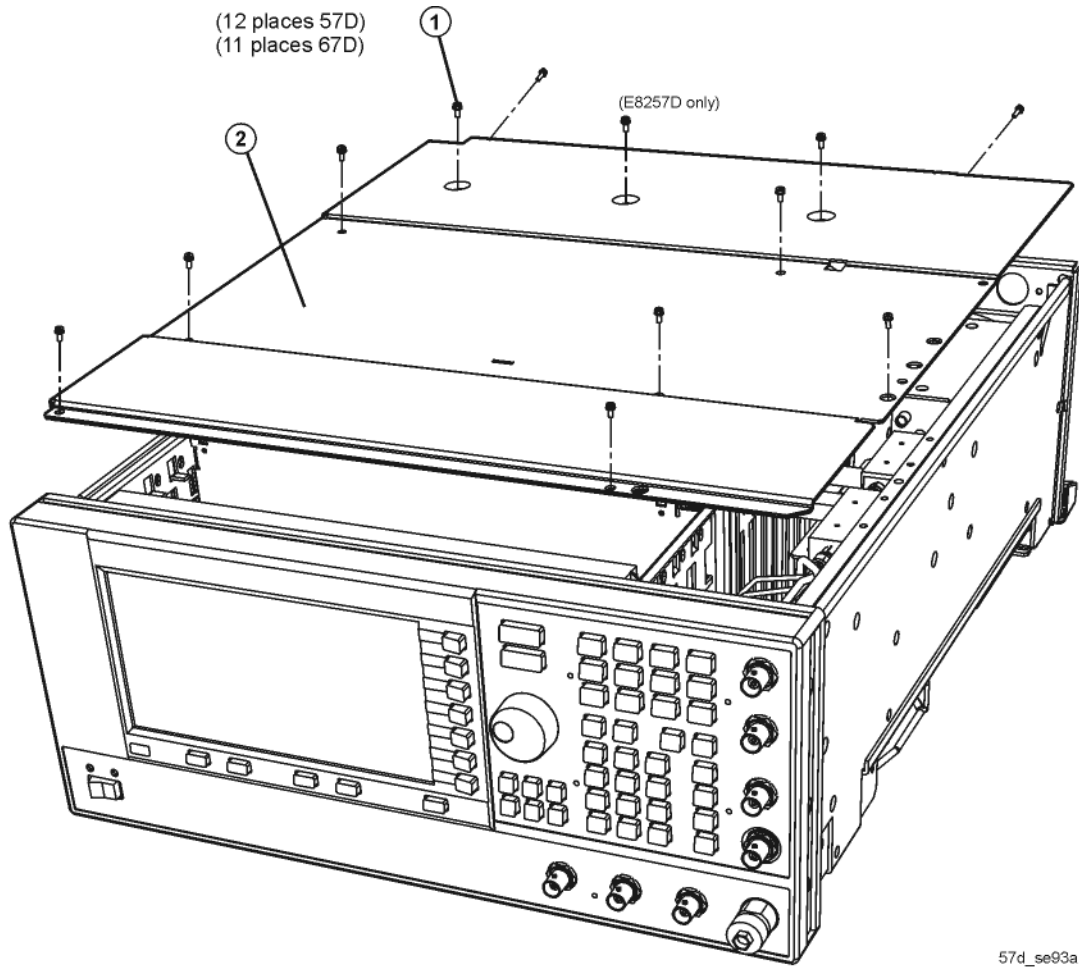
Figure 1-1

1. Using a T-10 driver, remove the twelve screws (1) from the inner-top cover (2).
2. Remove the inner-top cover.

Inner Top Cover Removal

Refer to [Figure 1-1](#).

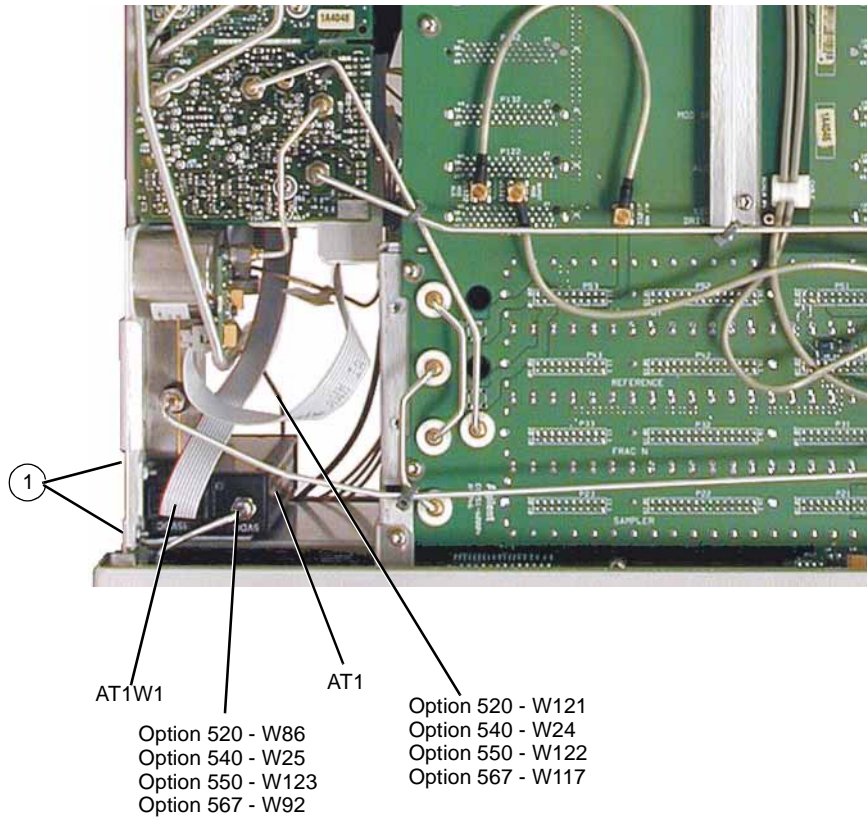
Figure 2

3. Refer to [Figure 2](#). Position the attenuator so it can be attached to the RF deck.
4. Using the T-10 driver, insert the two screws (1) through the side deck into the metal bracket that is attached to the attenuator. Torque these screws to 9 in-lbs.

Option 1E1 (Front Panel RF Output)

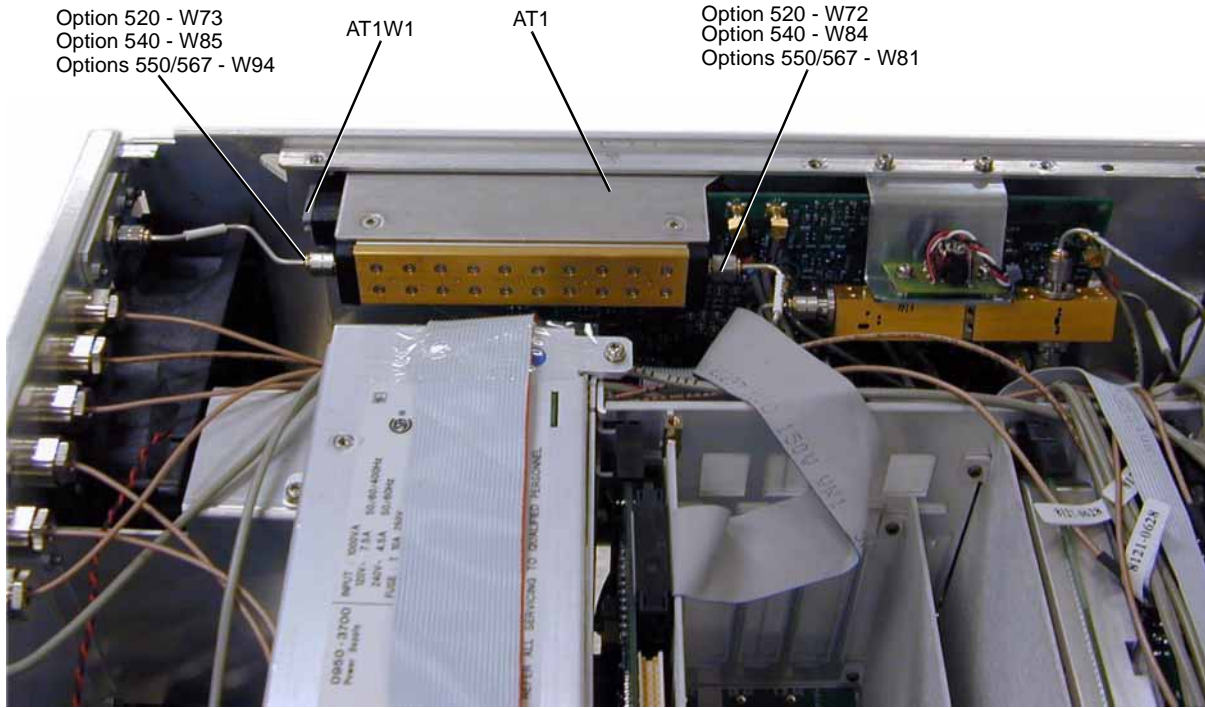
3. Refer to [Figure 3](#). Position the attenuator so it can be attached to the RF deck.
4. Using the T-10 driver, insert the two screws through the side deck into the metal bracket that is attached to the attenuator. Torque these screws to 9 in-lbs.

Figure 3 Option 1E1 (Rear Panel RF Output)
