Title & Document Type: 37204A/B HP-IB Extender Operating and Service Manual

Manual Part Number: 37204-90000

37204A/B
HP-IB EXTENDER

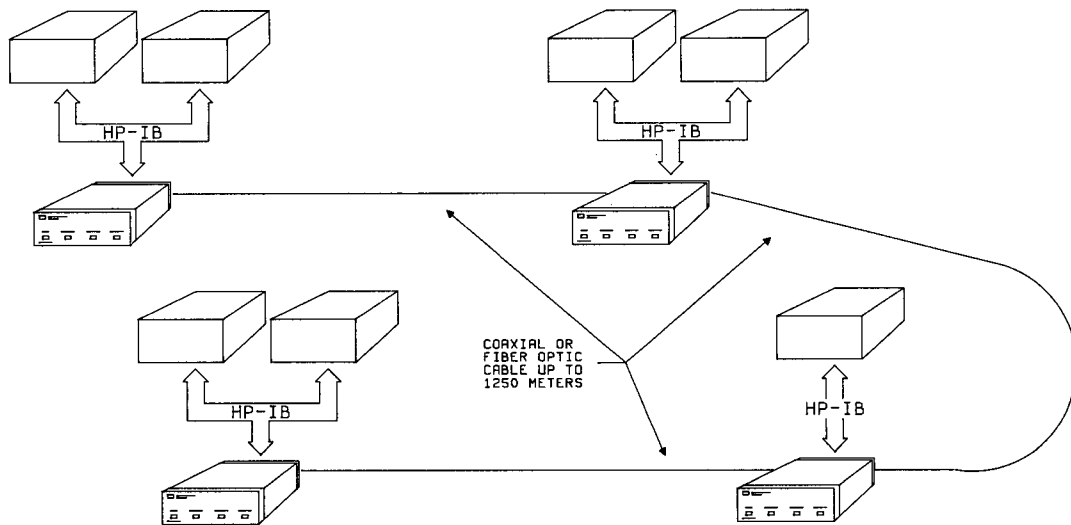
Figure 2-3 37204A/B Extender Configurations

SINGLE POINT CONFIGURATION

MULTI-DROP CONFIGURATION

If you require a very long cable link, you can insert Extenders (with no HP-IB devices attached) at suitable intermediate positions to ensure that the maximum length between nodes is not exceeded. Figure 2-3 illustrates typical HP-IB Extender chains. A single co-axial cable or, optionally, dual fiber optic cables provide the serial link between adjacent Extenders.
