Agilent Technologies
E8482A/B Six/Three 1x4
RF Multiplexer Module
Service Manual

Manual Part Number: E8482-90010
Printed in U.S.A. E0601

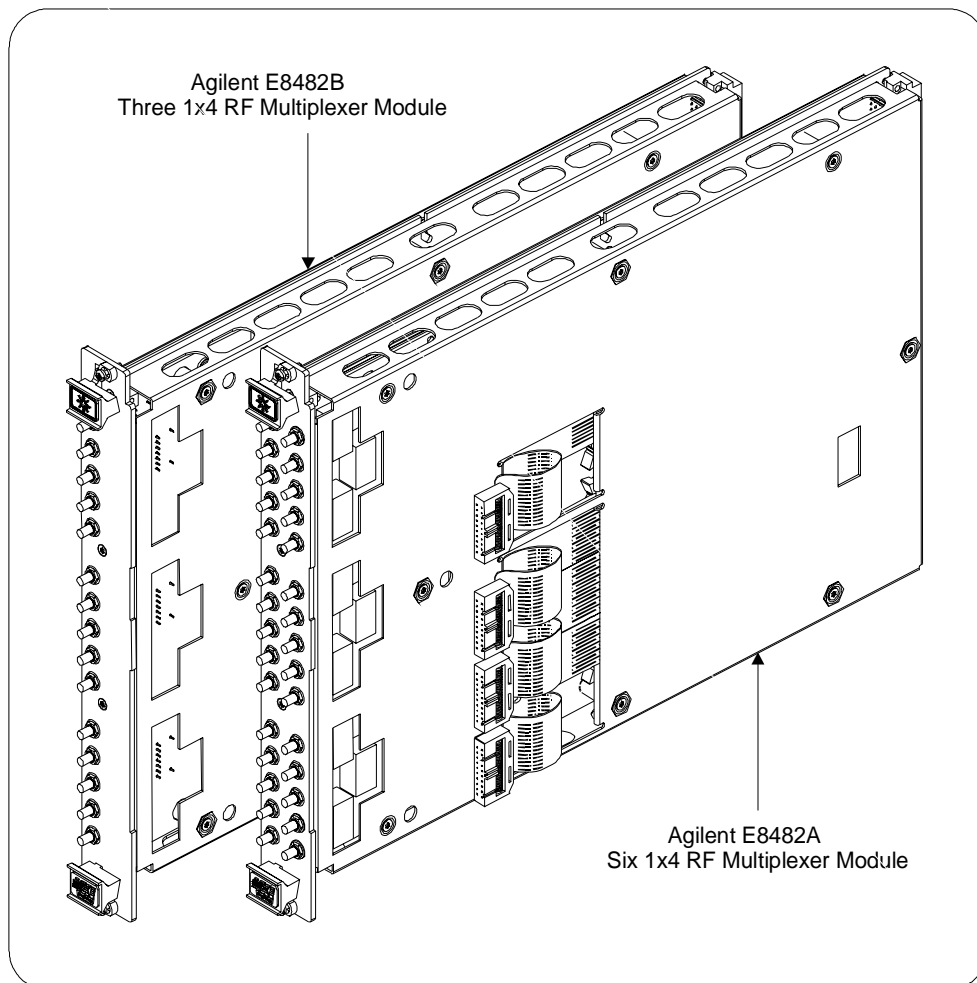
Figure 1-1. Agilent E8482A/B RF Multiplexer Modules

This manual contains information required to test, troubleshoot, and repair the Agilent E8482A/B Six/Three 1x4 RF Multiplexer module (see Figure 1-1). For more information on the RF Multiplexer modules operation, see *Agilent E8482A/B Six/Three 1x4 RF Multiplexer Module User's Manual*.

1. Inspect the shipping container for damage. If the shipping container or cushioning material is damaged, contact Agilent Technologies (see page 10).
2. Check the shipping contents and verify they are complete. Normally, the module you ordered (E8482A or E8482B as shown in Figure 1-1) and a User's Manual should be included. If the contents are incomplete or with mechanical damage/defect, contact Agilent Technologies (see page 10).

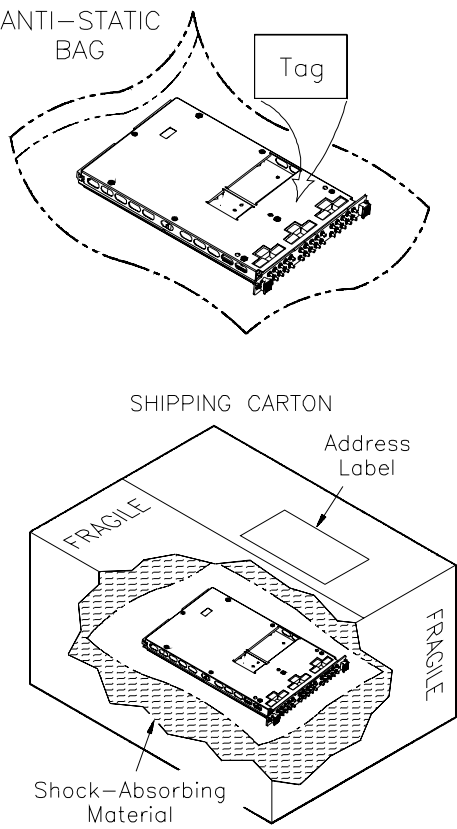
1. Prepare the Module

- Remove user wiring from terminal module.
- Attach tag to module/pod that identifies:
 - Owner
 - Model Number/Serial Number
 - Service Required
- Place tagged device in approved anti-static bag.

Figure 1-2. Packaging/Shipping Guidelines

If the instrument is to be shipped to Agilent for service or repair, follow the procedures in Figure 1-2.

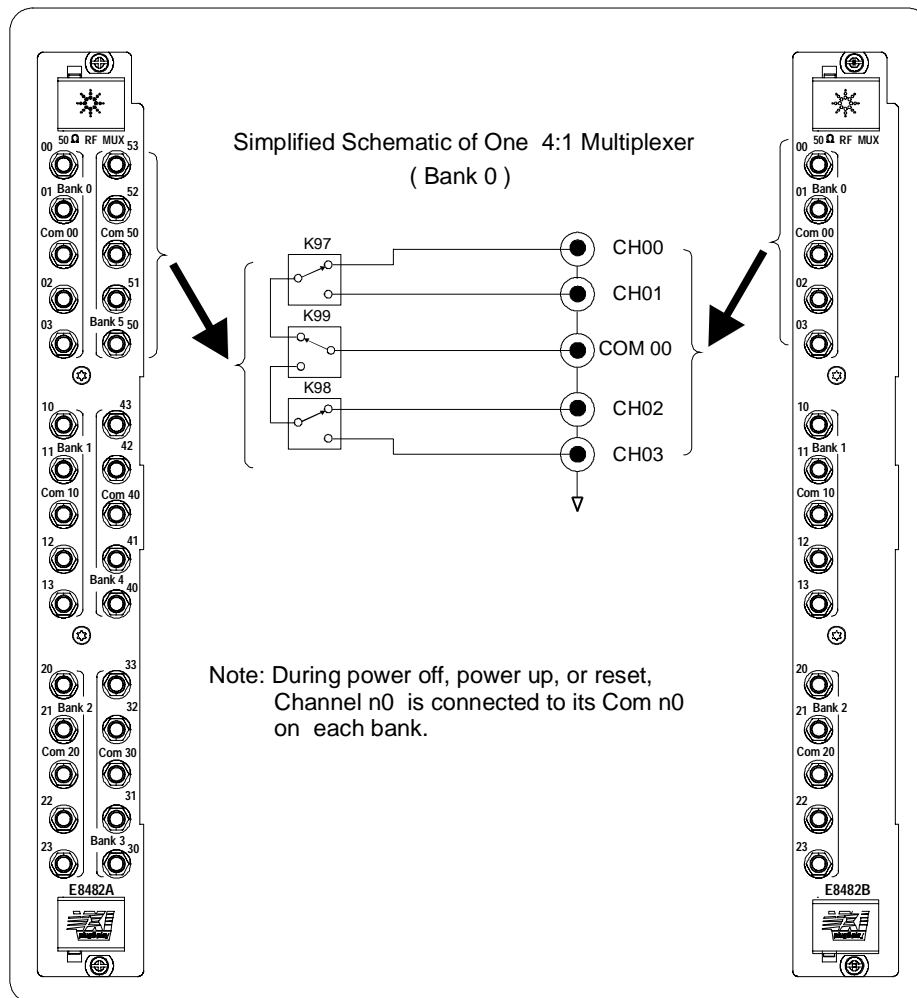
Figure 1-3. Simplified Schematic of the RF Multiplexers

As shown in Figure 1-3, the E8482A consists of six banks of channels (banks 0 - 5) to form six 1x4 RF multiplexers, while the E8482B consists of three banks of channels (banks 0 - 2) to form three 1x4 RF multiplexers. The switching sections of each bank are identical.

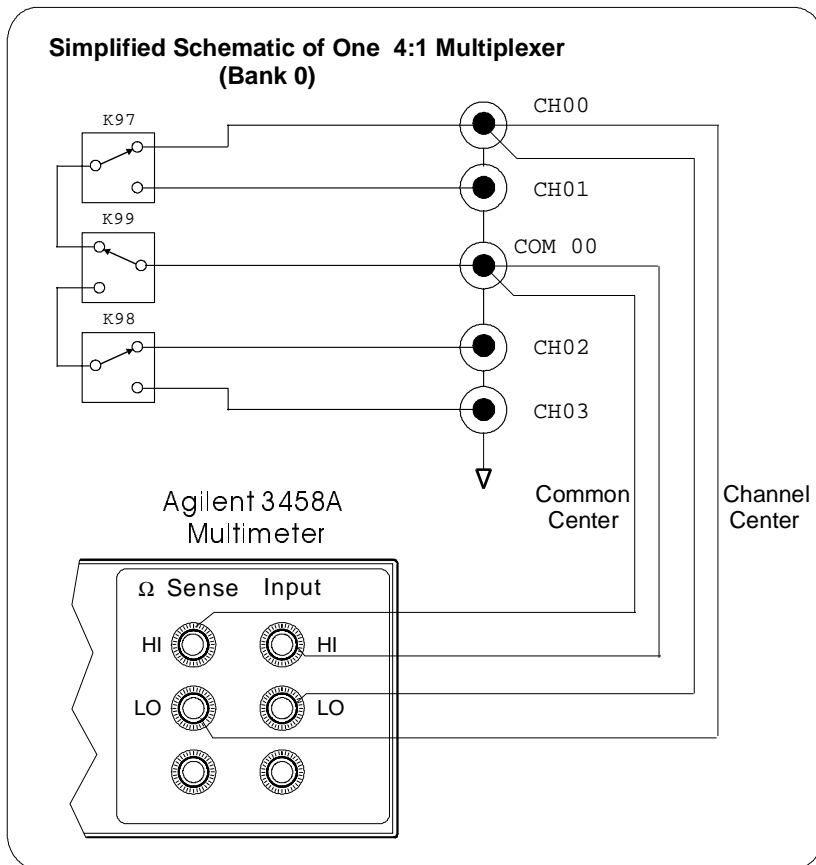
Figure 2-1. Closed-Channel Resistance Test Connections

1. Verify that the E8482A/B module is properly installed in the mainframe and the mainframe has passed its power-on sequence test.
2. Verify that the computer is properly connected to the mainframe via GPIB interface.
3. Measure closed-channel resistance for channel 00 (in Bank 0)
 - Connect the DMM (Agilent 3458A) between the center conductor of the COM 00 connector and the center conductor of the channel 00 connector (see Figure 2-1). Refer to Figure 1-3 for the channel connector locations on the module's front panel.
 - Power on the DMM (Agilent 3458A), and set the DMM to 4-wire Ohms, autorange.
 - Send CLOS (@ ss00) to the RF multiplexer module to close channel 00.
 - Observe the DMM display and record the reading in Table 2-3.

4. Repeat step 3 for channels 01, 02 and 03 (in Bank 0) with the following changes:
 - Move the DMM LO line to the center conductor of the channel under test.
 - Use CLOS (@sscc), where *ss* = card number and *cc* = channel number under test (01-03 for Bank 0).

5. Repeat Steps 3 & 4 for channels in Banks 1, 2, 3, 4, and 5 (Banks 1 and 2 for E8482B) with the following changes:
 - Move the DMM HI line to the COM connector of the Bank under test and the DMM LO line to the channel under test within the tested bank.
 - Use CLOS (@sscc), where *ss* = card number and *cc* = channel number (10-13 for Bank 1, 20-23 for Bank 2, 30-33 for Bank 3, 40-43 for Bank 4 and 50-53 for Bank 5).

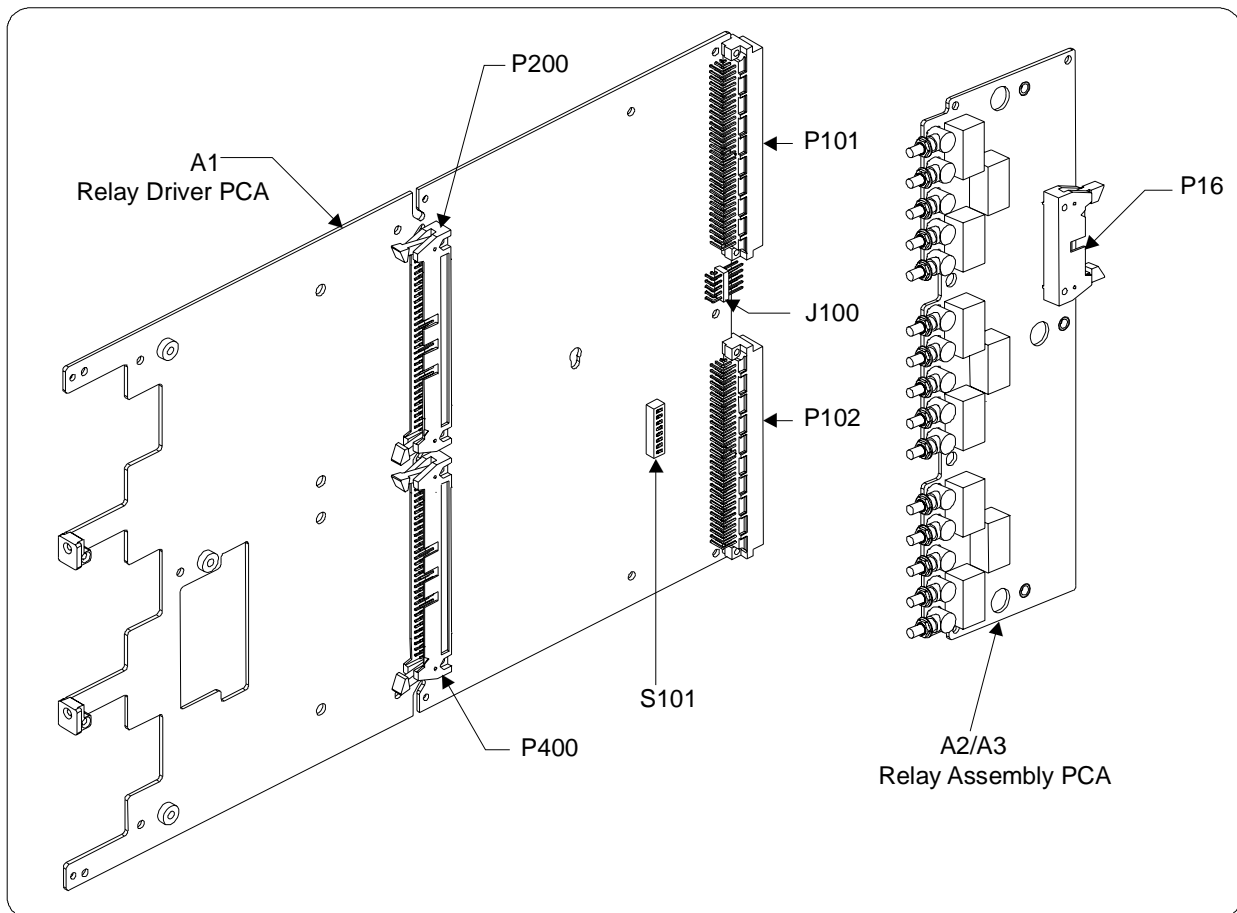
Figure 3-1. Printed Circuit Assemblies of the E8482A/B

The replaceable parts for the Agilent E8482A/B modules are the PCA boards (see Figure 3-1). To order a replaceable PCA board, specify the Agilent part number listed in Table 3-1 and the quantity required. Send your order to Agilent Technologies. See "Contact Agilent Technologies" in *Chapter 1* for details.

You can use the tests and checks in Table 3-3 to identify the problem on the user-replaceable assembly. See Figure 3-1 for the locations of the checked components on the E8482A/B PCAs. The typical checks for the RF multiplexer modules include:

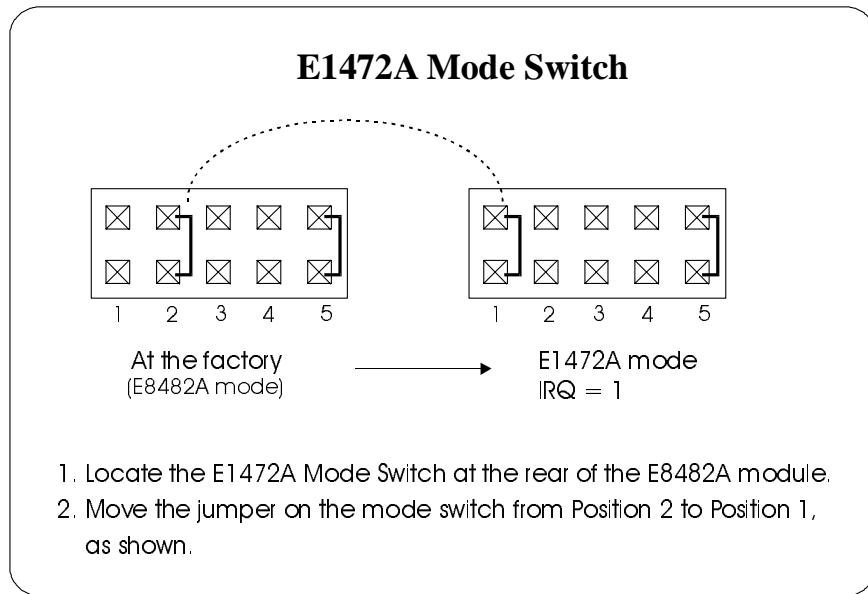
Figure 3-2. E1472A Mode Switch Settings

Verify that the E1472A Mode Switch (J100) is set correctly (see Figure 3-2). For more details, see *Agilent E8482A/B Six/Three 1x4 RF Multiplexer Module User's Manual*.

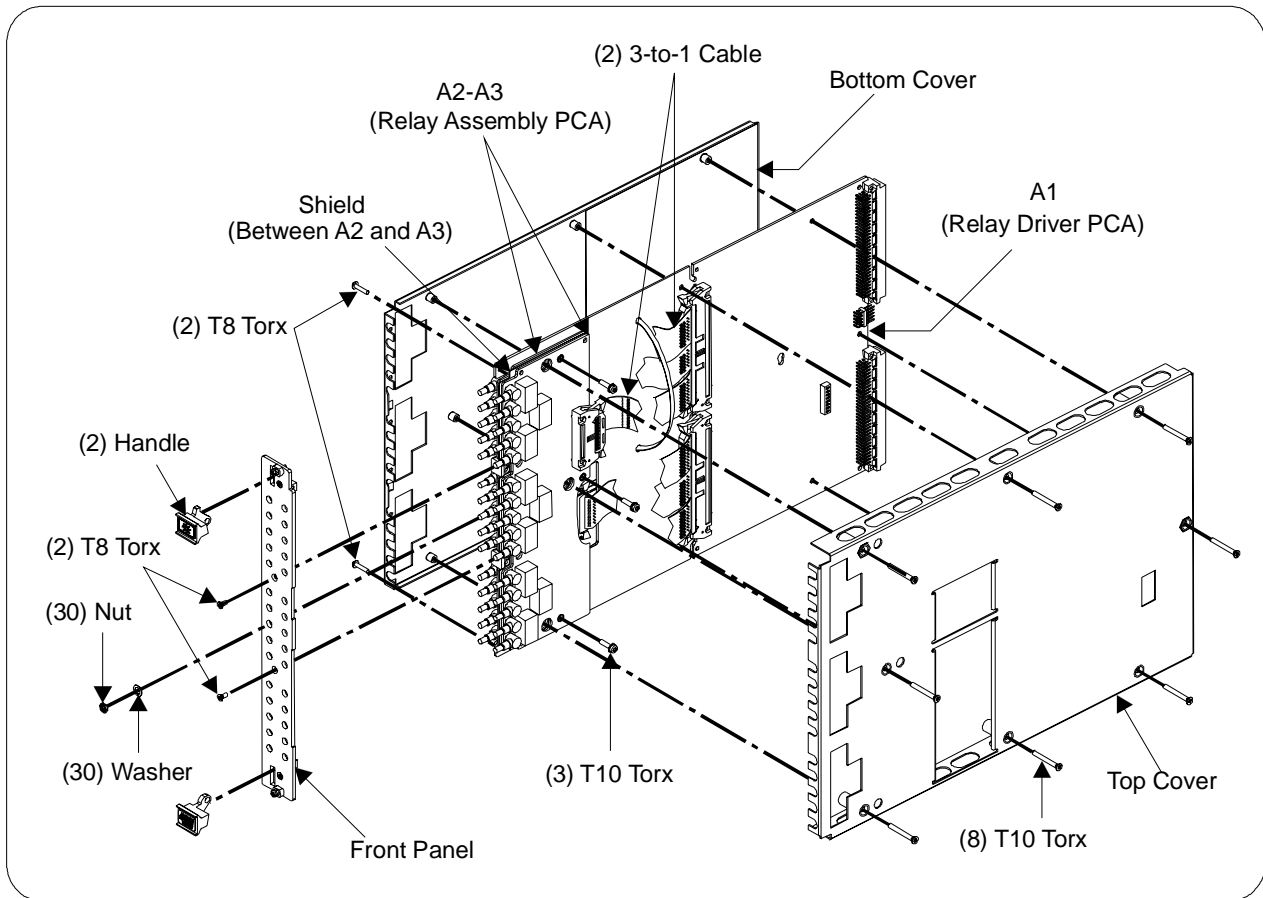
3. To remove the front panel and front panel handles:

- Remove the two T8 Torx screws from the handles as shown.
- Remove the two T8 Torx screw holding the front panel to the A1 PCA as shown.
- Lift the front panel off the A1 PCA.

Figure 3-3. Agilent E8482A Disassembly

As shown in Figure 3-3, the E8482A RF Multiplexer module contains three PCA boards (A1, A2, and A3). The E8482B module contains two PCA boards (A1 and A2) as shown in Figure 3-4. Both the E8482A and the E8482B have one relay driver PCA (A1, P/N E8482-60002) where the VXI interface, relay decoders and relay drivers are located. The relay assembly PCA (A2/A3, P/N E8482-60001) where the multiplexer relays, tree relays, and their associated RF connectors are located provides three banks of channels. Therefore, the E8482A RF Multiplexer (six banks of channels) has two relay assembly PCAs, while the E8482B module (three banks of channels) has one relay assembly PCA only.

Use the following procedures to disassemble the Agilent E8482A Six 1x4 RF Multiplexer module (see Figure 3-3).

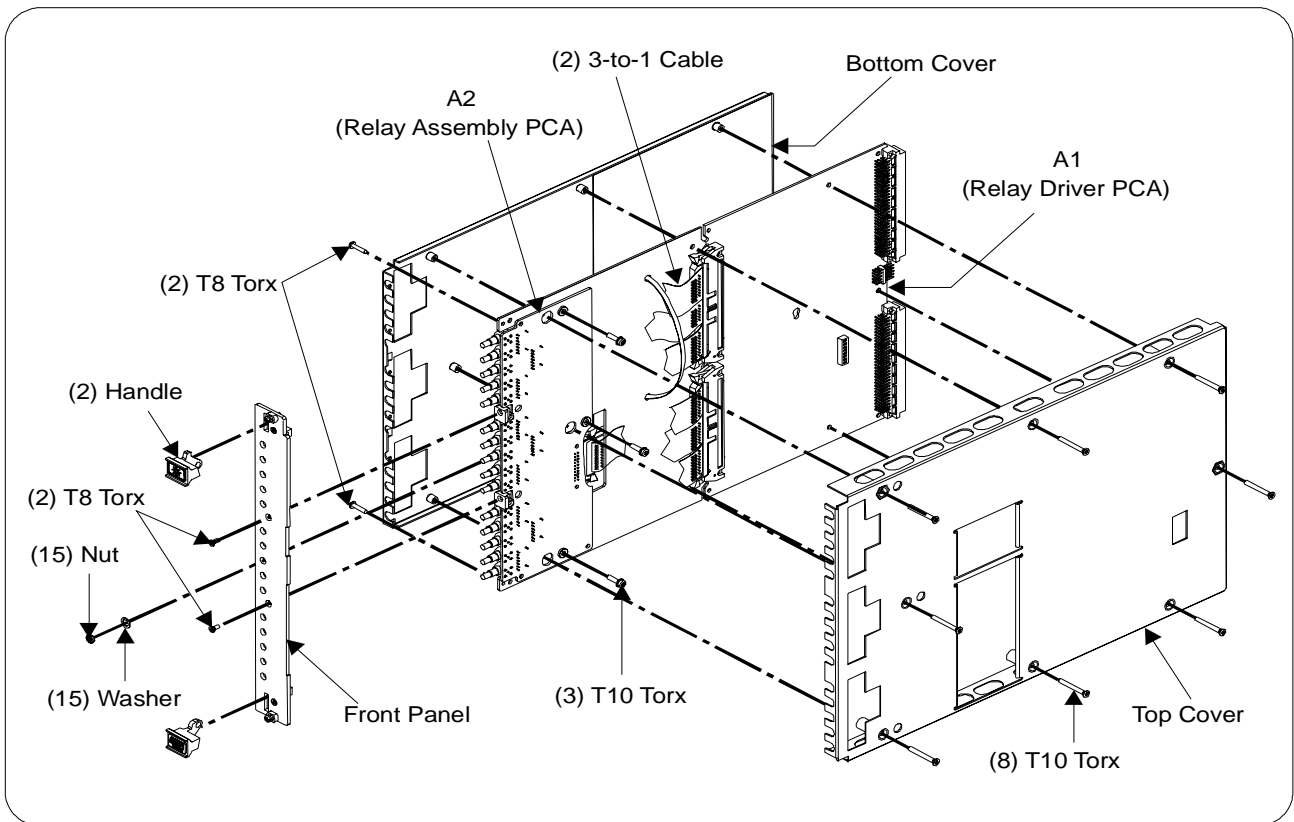
3. To remove the front panel and front panel handles:

- Remove the two T8 Torx screws from the handles as shown.
- Remove the two T8 Torx screw holding the front panel to the A1 PCA as shown.
- Lift the front panel off the A1 PCA.

Figure 3-4. Agilent E8482B Module Disassembly

Use the following procedures to disassemble the Agilent E8482B Three 1x4 RF Multiplexer module (see Figure 3-4).

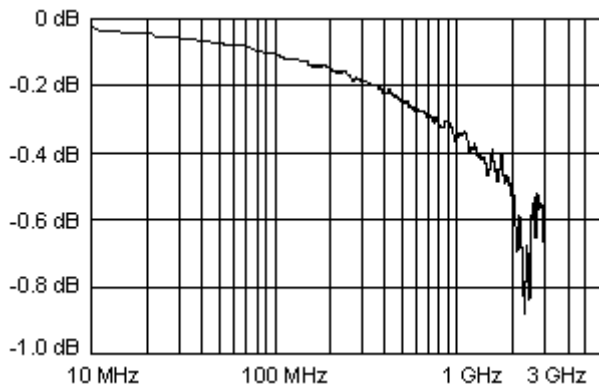
Typical Insertion Loss

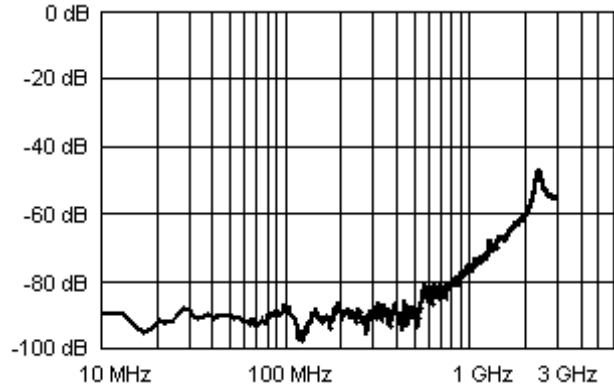
Typical Crosstalk (Channel-to-channel)

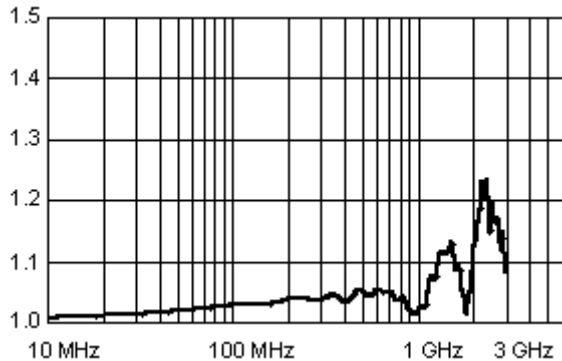
Typical VSWR
