## TECHNICAL MANUAL

### MAINTENANCE INSTRUCTIONS WITH ILLUSTRATED PARTS BREAKDOWN DEPOT

# RADIO FREQUENCY AMPLIFIER, AM-7224/URC, P/N 10087-0000

HARRIS CORPORATION, RF COMMUNICATIONS GROUP  
FO4606-82-D-0079  
FO9603-94-D-1349

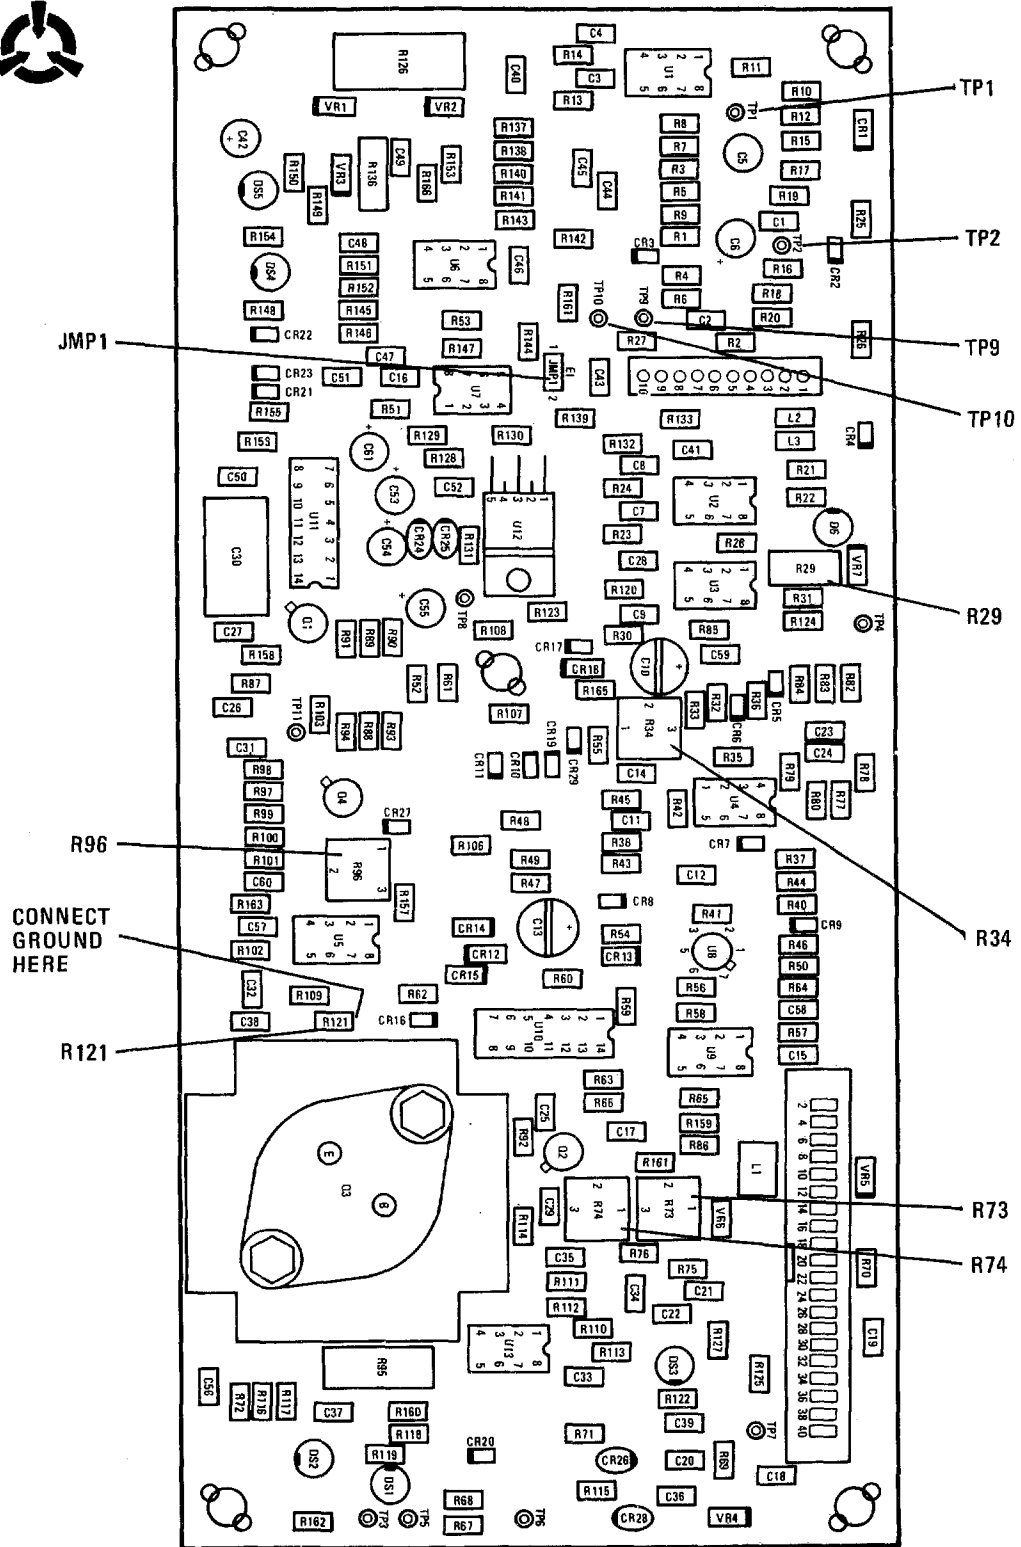
355-039A

Figure 6-3. Power Control PWB Assy

- (d) Connect a digital multimeter between test point TP1 and ground on the A5 Power Control PWB Assy (see figure 6-3). Ensure that R34 is fully CCW and R74 is fully CW.

- (c) Lower the LPA front panel to its horizontal position to gain access to the Power Control PWB Assy.
  - (d) Connect a digital multimeter between test points TP1 and TP2 on the A5 Power Control PWB Assy (see figure 6-3).

e. POWER CONTROL PWB ASSY, A5 (figure 6-3)

(d) Connect a ground to the J1-5 side of R121 on the Power Control PWB Assy (see figure 6-3). This will place the Power Control PWB Assy into the coupler tune mode.

- (1) Lower the LPA front panel to its horizontal position to gain access to the Power Control PWB Assy.
  - (2) Remove JMP1 (PN65474-001) on the Power Control PWB Assy (see figure 6-3).
  - (3) With the LPA in warmup (for a cold LPA) or standby (for a hot LPA), connect a digital multimeter between test points TP9 and TP10 on the Power Control PWB Assy.
  - (4) If the voltage on the multimeter is  $0 \pm 2$  mV, no adjustment is necessary. If not, adjust R2 (R2 is accessible through the rear grille of the LPA--see figure 6-4) until the voltage is within the limits.
  - (5) Re-install JMP1 on the Power Control PWB Assy.
- i. INTERCONNECT PWB ASSY, A9  
No adjustments.
  - j. LOW PASS FILTER ASSY, A10  
No adjustments.
