IBM 3420/3803

Magnetic Tape Subsystem

Reference Guide

THIRD EDITION (January 1980)

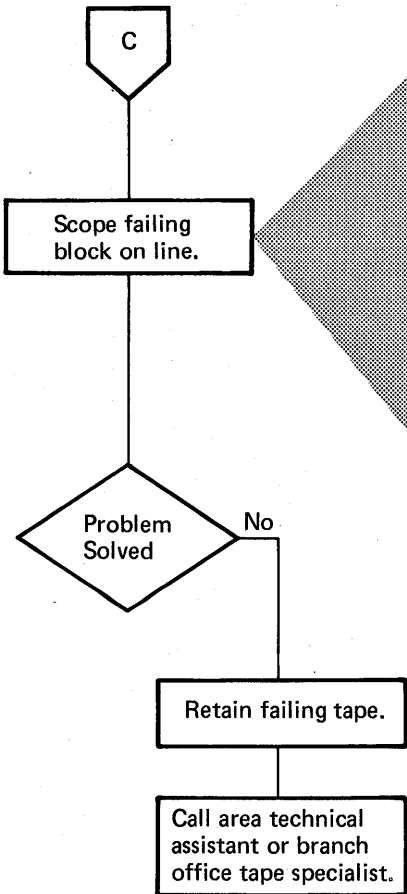
Permanent Read Error Analysis Chart
Sheet 6

1. Locate the failing block with the control unit offline.
2. Set up a program loop to read forward-backspace or read backward-forward space whichever is applicable.
3. By altering the channel command word (CCW) byte count, the command-out response to service-in will set the stop trigger in the tape control at any byte chosen. Sync external on the stop trigger to examine any portion of the block in detail.

Note: Detailed observation of a PE block is difficult due to normal distortion of the PE signal and the high amount of skew the PE detection circuits can tolerate. Examine several tracks at comparable points, looking for noticeable differences in levels and waveforms. A record containing excessive phase shift is usually indicated by multi-track error (MTE) or read write register (R/W Reg) vertical redundancy checks (VRC). Check the tape unit that wrote the tape for a possible defective write driver. Refer to MLM 00-012 for more information.

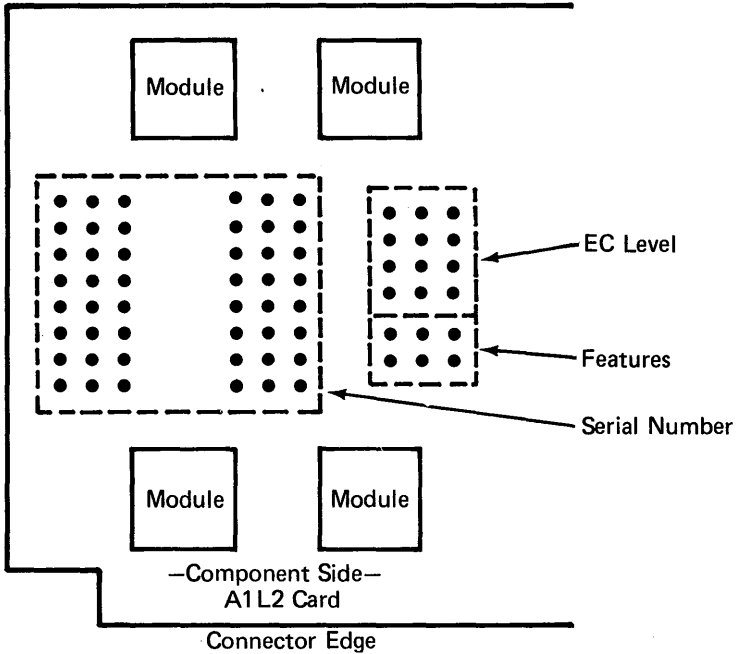
CARD JUMPERS - MODELS 3, 5, 7

Reference Logic A6106
