IBM 3745 Communication Controller
All Models

Problem Determination Guide

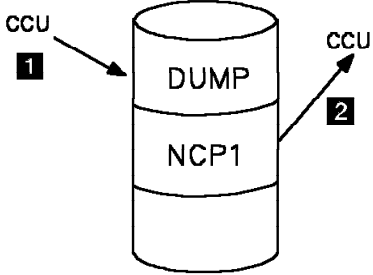
<p>After NCP1 abend</p>
---	--

<p>Event A</p> <p>It is assumed that AUTO DUMP/LOAD=YES and ACTIVE LOAD MODULE=NCP1 are displayed on the MOSS DII screen.</p> <p>If the NCP1 fails or a hardcheck occurs:</p> <ul style="list-style-type: none">• 1 The controller dumps NCP1 (which failed) onto the hard disk.• 2 The controller reloads NCP1 from the hard disk, and you do not have to reload NCP using a diskette or an SDLC link.

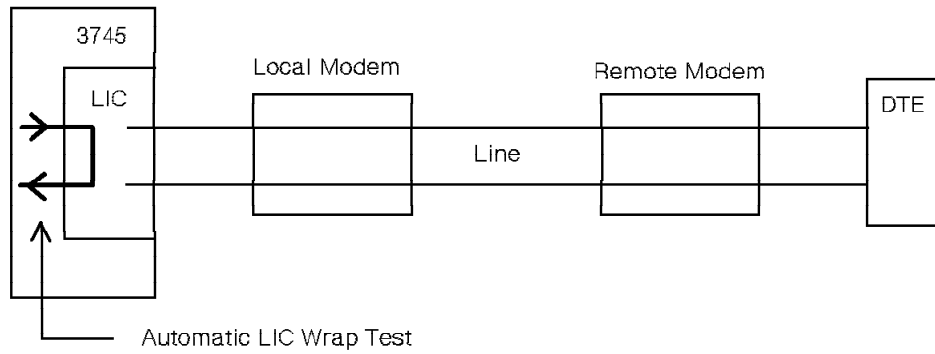
Figure 9-1. Automatic LIC Wrap Test (For LIC Types 1 to 4)

Problems on All Lines (LIC1 to LIC4)

- 5** Enter the address of one of the lines of the suspected LIC,
This screen is displayed:
