NHL-8 Series Transceivers

6(a) Baseband Troubleshooting

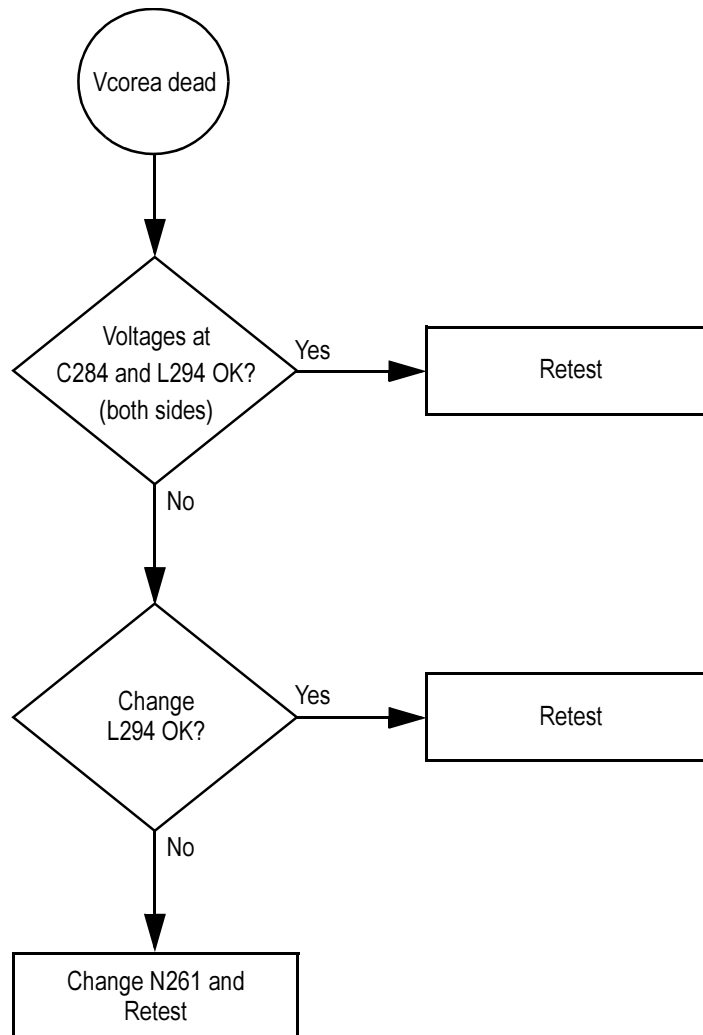
General power checking

Use service tool FLA-21. Battery voltage should be at least 3.6V. After phone disassembly, use module jig MJS-9Q.

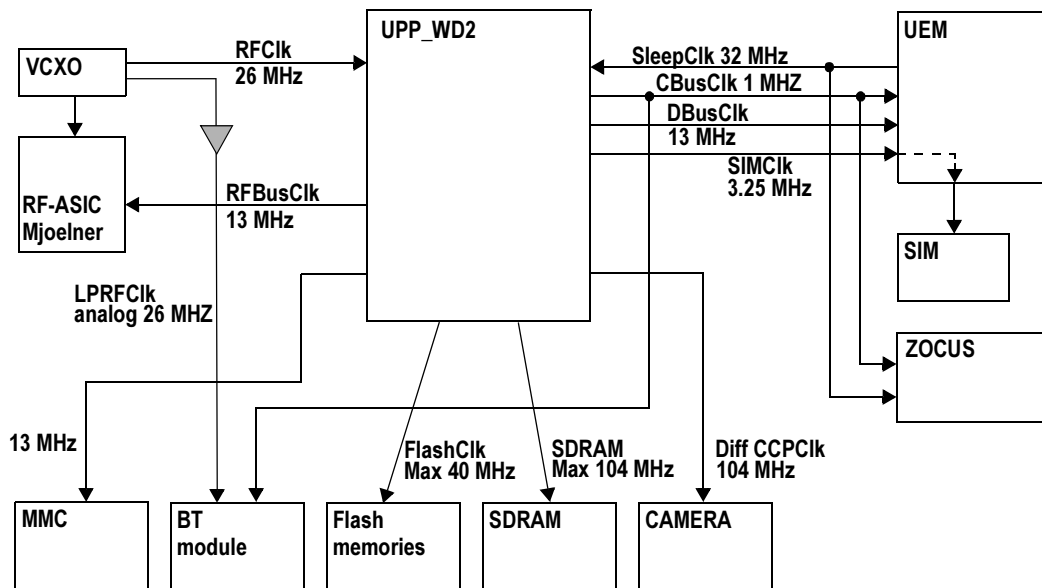
The main clock signal for the baseband is generated from the voltage controlled crystal oscillator VCXO. This 26 MHz triangle wave clock signal is supplied to OSC_IN pin of Mjoelner and out to UPPWD2. Inside UPPWD2 the clock frequency is divided to 13 MHz and then fed to RFCLK.

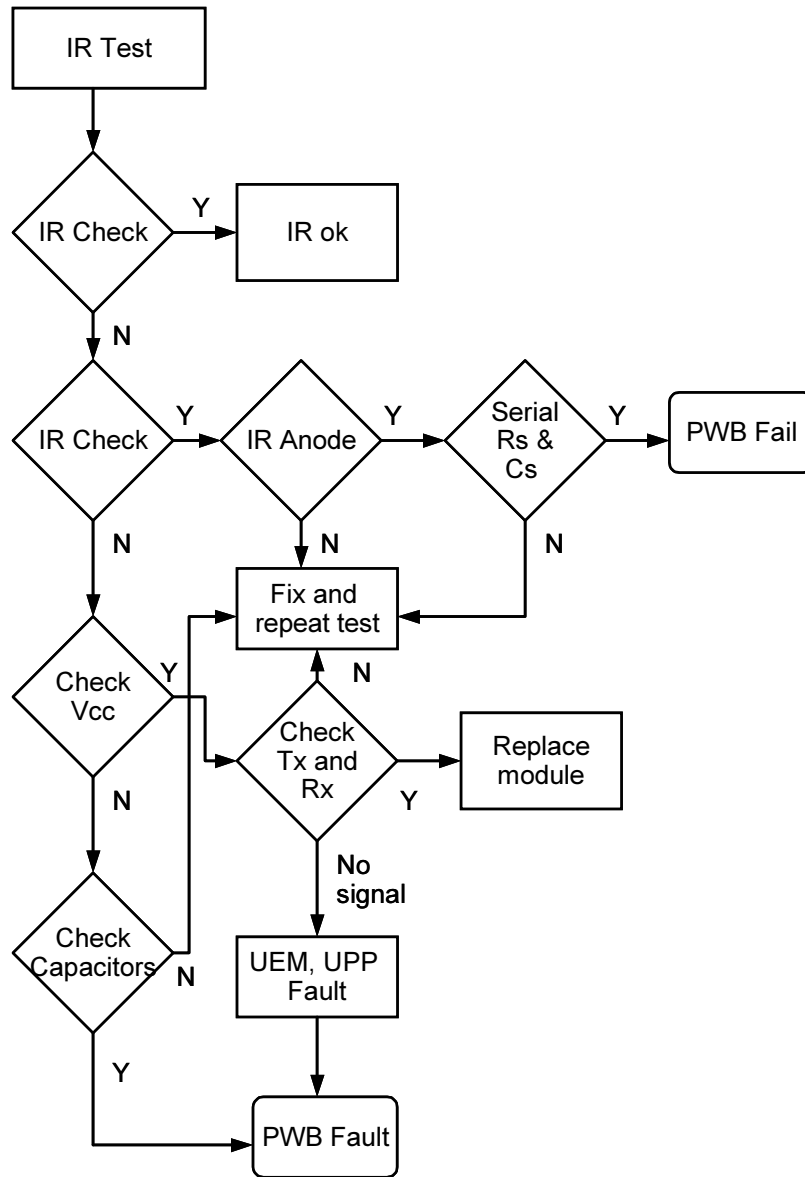
IR interface

At this point it is supposed that problem is in HW.

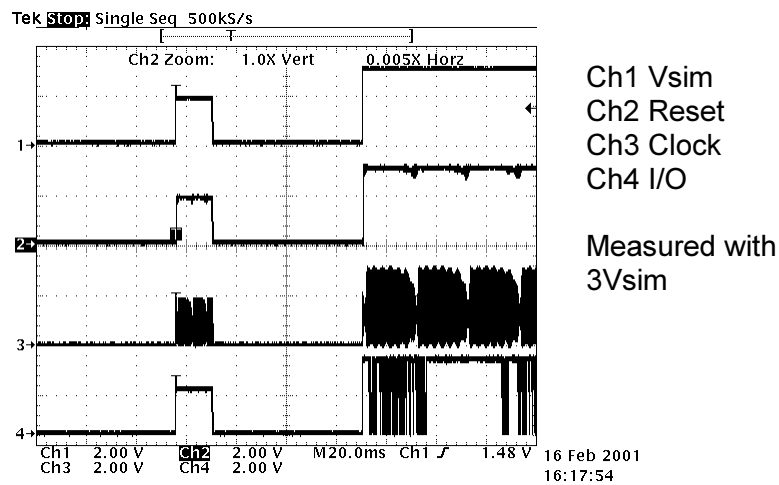
Figure 3: SIM Power Up.

The SIM power up/down sequence is generated in the UEM. This means that the UEM generates the RST signal to the SIM. Also the SIMCardDet signal is connected to UEM. The card detection is taken from the BSI signal, which detects the removal of the battery. Monitoring of the BSI signal is done by a comparator inside UEM. The threshold voltage is calculated from the battery size specifications.

The SIM interface is powered up when the SIMCardDet signal indicates "card in". This signal is derived from the BSI signal. SW tries first to power up the SIM with 1.8 V. If this doesn't succeed power up is repeated with VSIM switched to 3 V.

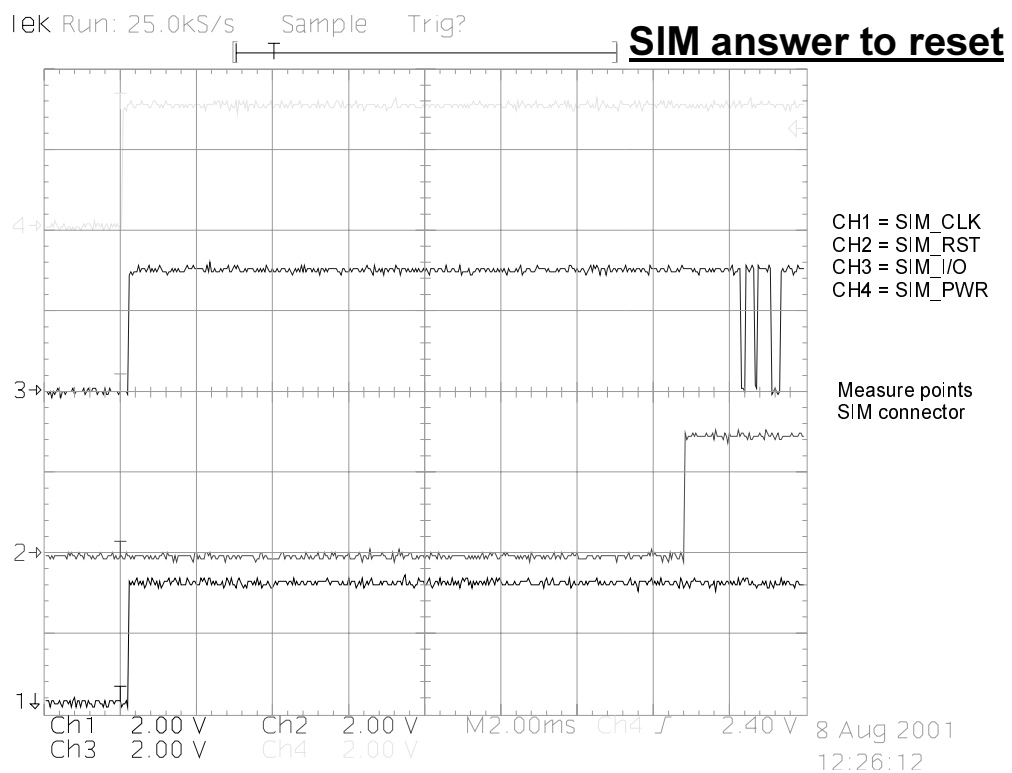
Figure 4: SIM answer to reset.

The data communication between the card and the phone is asynchronous half duplex. The clock supplied to the card is in GSM system 1.083 MHz or 3.25 MHz. The data baudrate is SIM card clock frequency divided by 372 (by default), 64, 32 or 16.

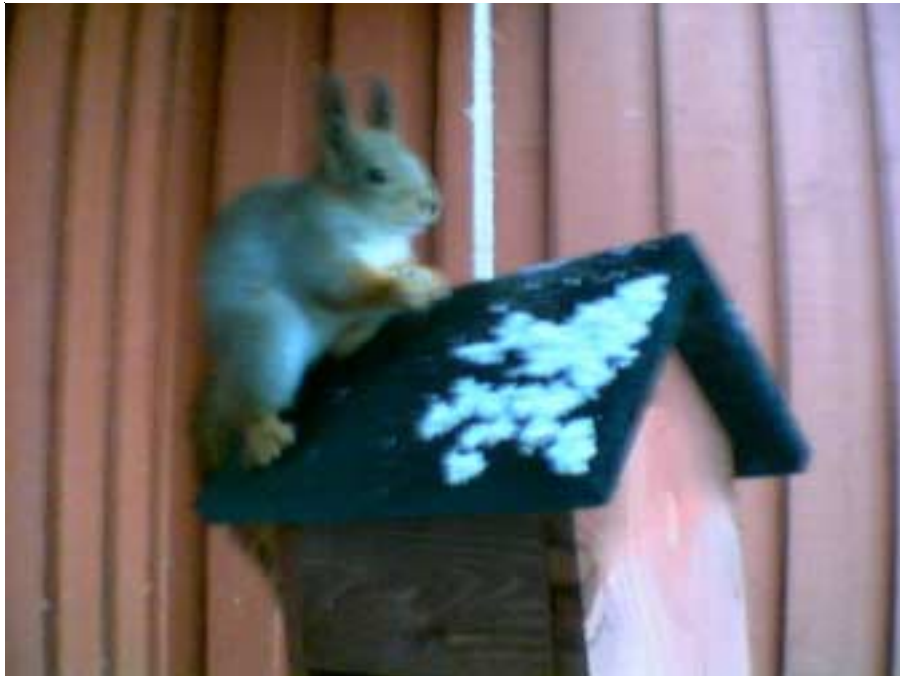
Geometrical distortion: camera lens will cause some amount of so called barrel distortion in images. In practice, this appears as bending of straight objects in edges of the image. See the following picture. Note geometrical barrel distortion in background for example (wall in the background).

Amount of light available: in dim conditions camera runs out of sensitivity. Exposure time is long (especially in night mode) and the risk of getting shaken images grows. Image noise level grows. The maximum exposure time in night mode is approximately 1/4 seconds, so images need to be taken with extreme care when the amount of light reflected from the target is low.

Figure 7: shaking hands caused blurring of this image. Note geometrical barrel distortion in background

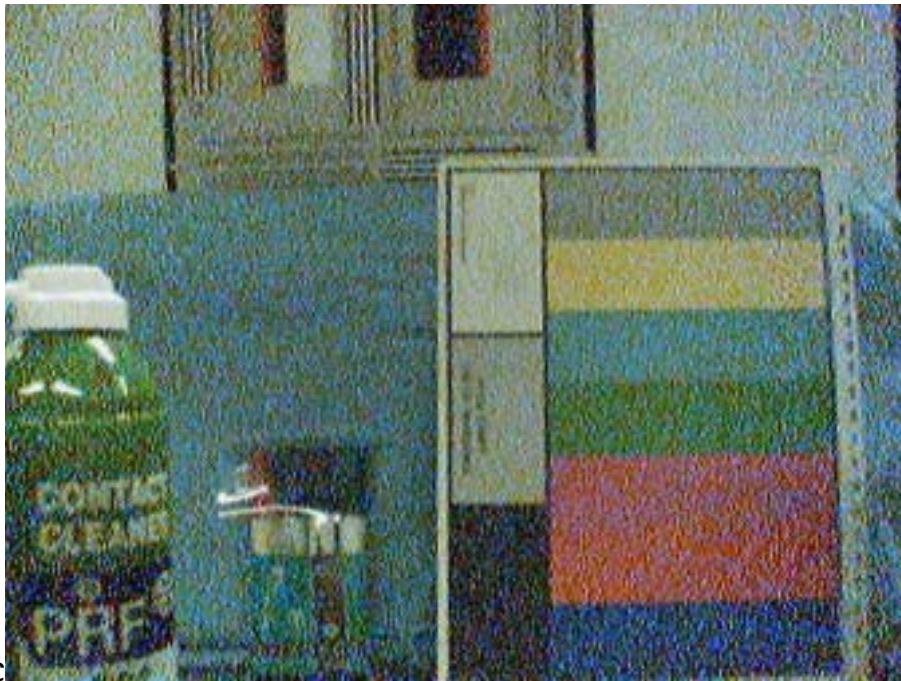
Temperature: high temperatures inside the mobile phone will cause more noise to appear in images, e.g. in +70 degrees of celsius the noise level may be very high, and it further grows if the conditions are dim. This is also normal to camera operation. (See Figure 9, "Noisy image taken in +70 deg C," on page 43)

Figure 9: Noisy image taken in +70 deg

Noise: Variation of response between pixels with same level of input illumination. See e.g. Figure 9, "Noisy image taken in +70 deg C," on page 43 for example of noisy image.

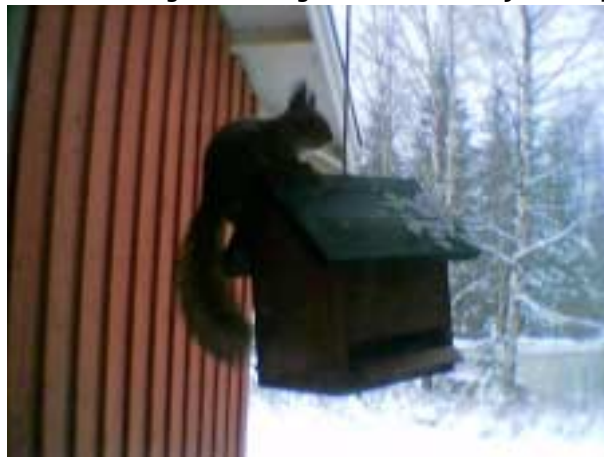
Basic rules of photography, especially shooting against light: electronic image sensors typically have much lower dynamic range than films. In practice this means that when taking a picture inside e.g. having a window behind object, will produce poor results.

Figure 10: Image which has been taken "against the light". The actual object (a squirrel) can not be seen well.

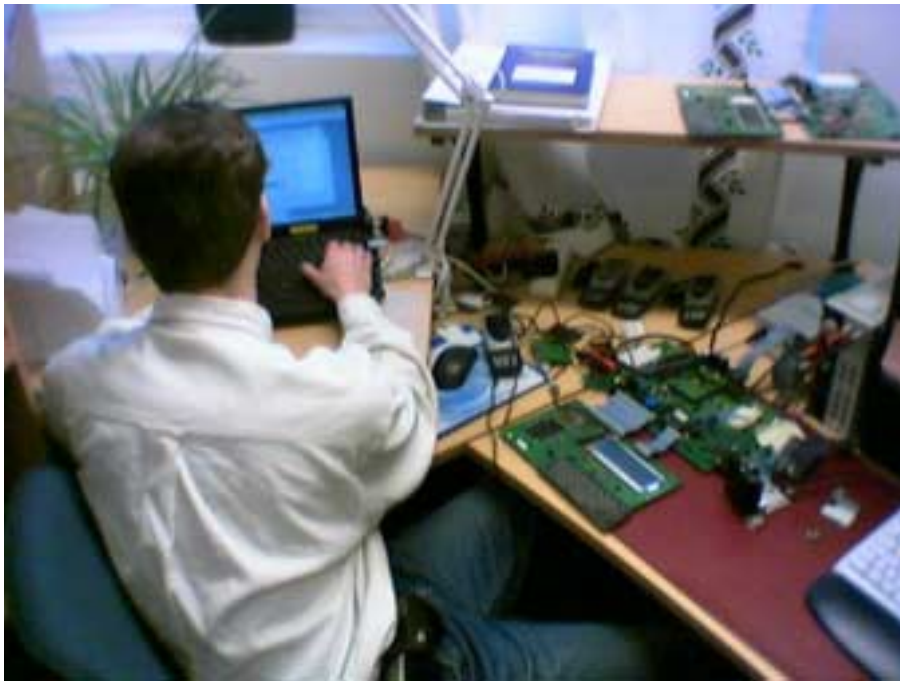
Figure 13: A good quality picture taken indoors

If no visible defects (items 2-4) can be found, a couple of test images should be taken and checked. Generally, a well illuminated typical indoor office scene, such as the one in Figure 13, "A good quality picture taken indoors," on page 45, can be used as a target. The main considerations are:

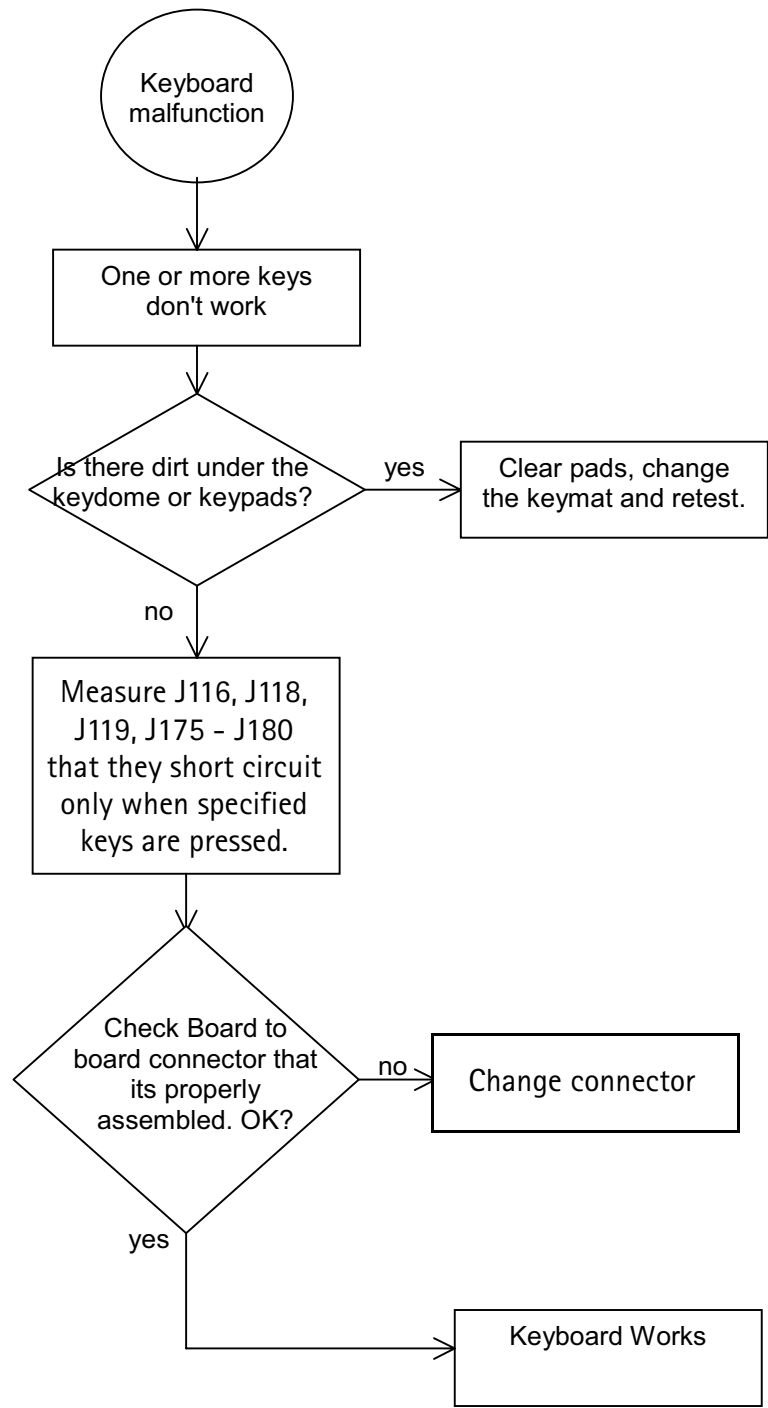
Keyboard

If keyboard doesn't work, follow the troubleshooting flow chart below:

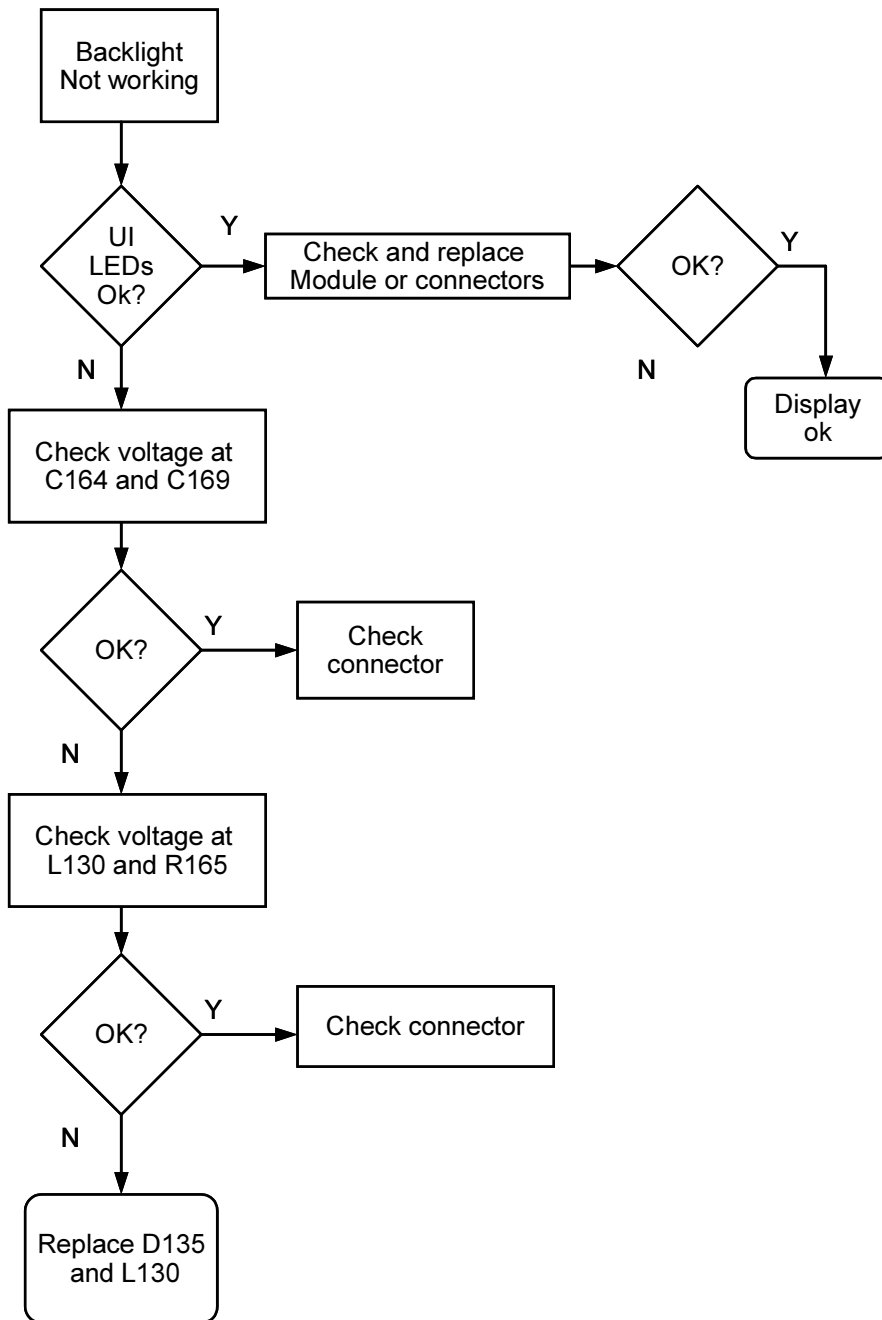
Figure 14:

Backlight does not turn on
