PAMS Technical Documentation

NSK-3 Series Transceivers

Troubleshooting Instructions

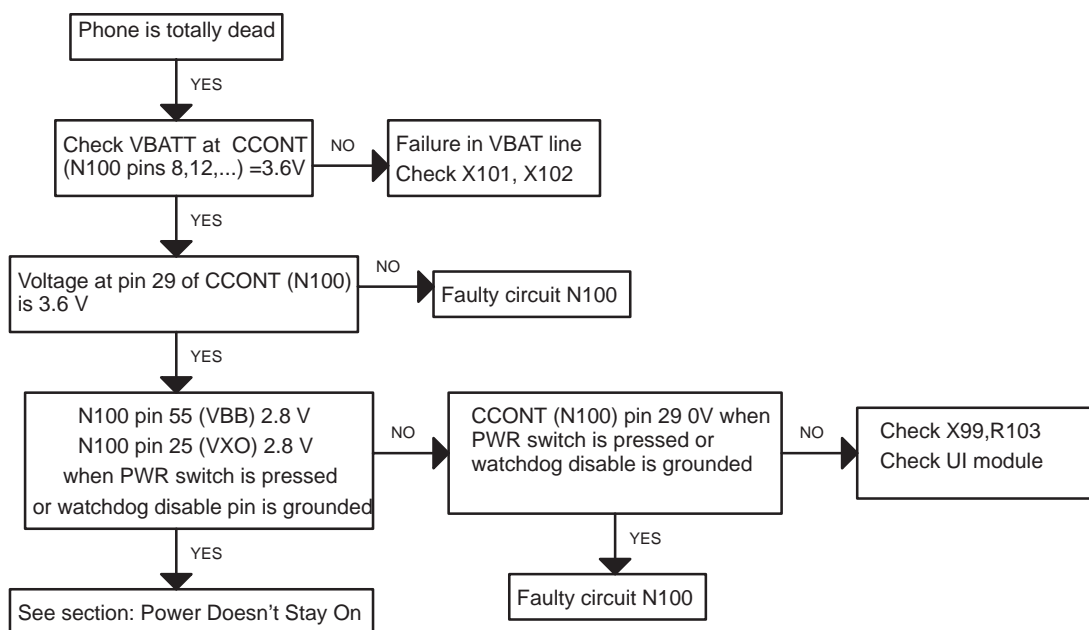
Phone is totally dead

This means that phone doesn't draw current at all when the power switch is pressed or when the watchdog disable is grounded (J113, J114 connected together).

Used battery voltage must be higher than 3.0 V. Otherwise the hardware of CCONT (N100) prevents totally to switch power on.

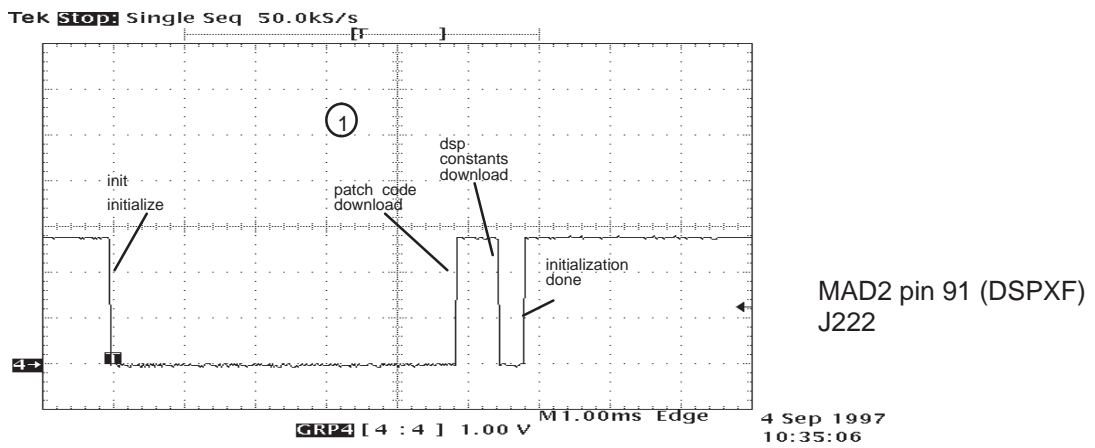
The DSP software is constructed so that operation states of DSP (MAD2) can be seen in external flag (DSPXF) output pin (D200 pin 91).

After power up, DSP signals all completed functions by changing the state of the XF pin (see figures 39 and 40).
