Programmes After Market Services

NPL-1 Series Cellular Phones

6 - Troubleshooting

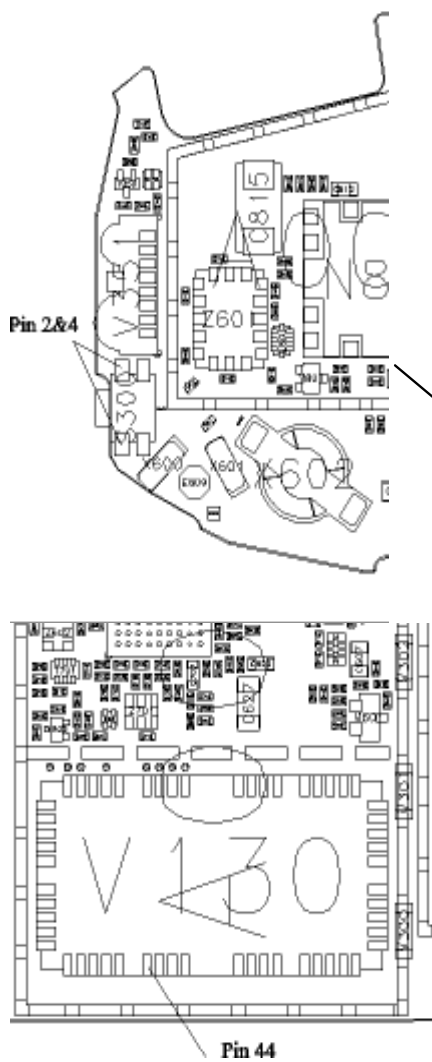
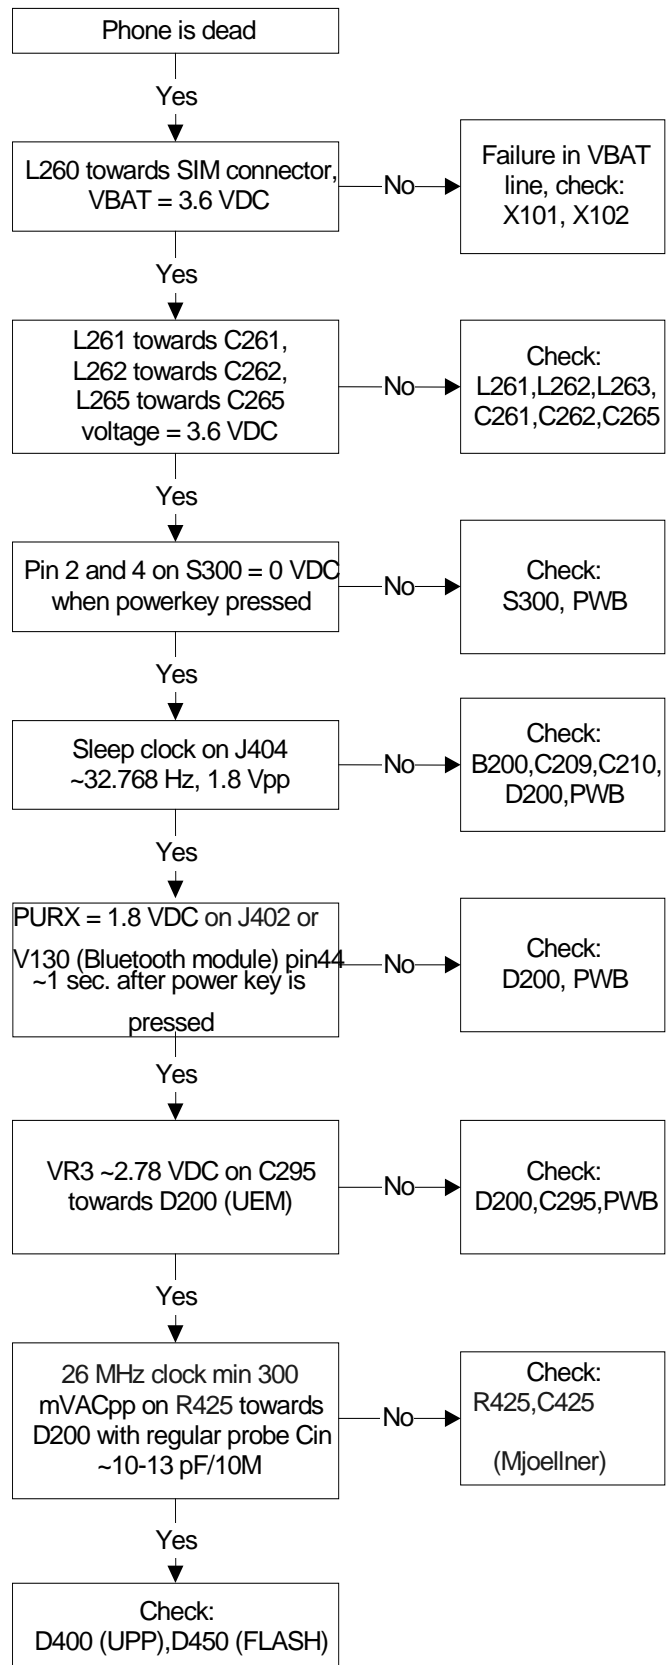
This means that the phone does not use any current at all when supply is connected and/or powerkey is pressed.

It is assumed that the voltage supplied is 3.6 VDC. The UEM will prevent any functionality what so ever at battery/supply levels below 2.9 VDC.

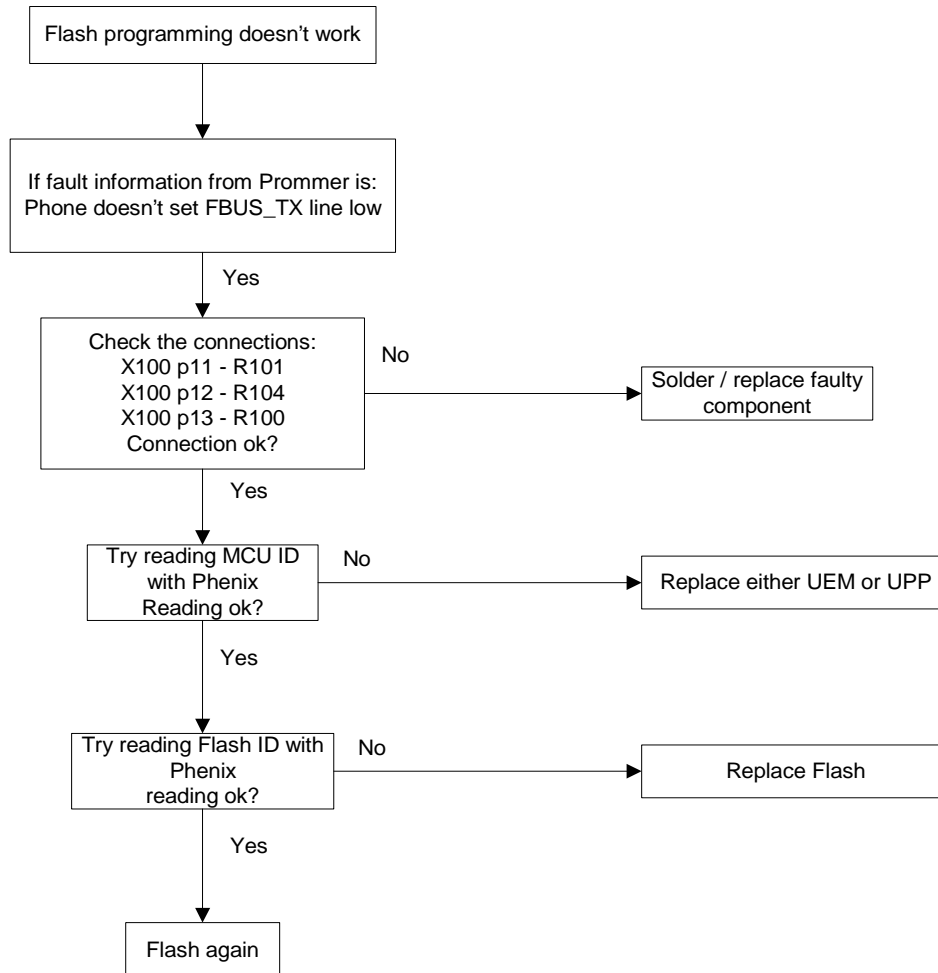
Flash programming

The preliminary fault-finding diagrams for flash programming are shown in the next page.

Because of the use of uBGA components it is not possible to verify if there is a short circuit in control- and address lines of MCU (UPP) and memory (flash).

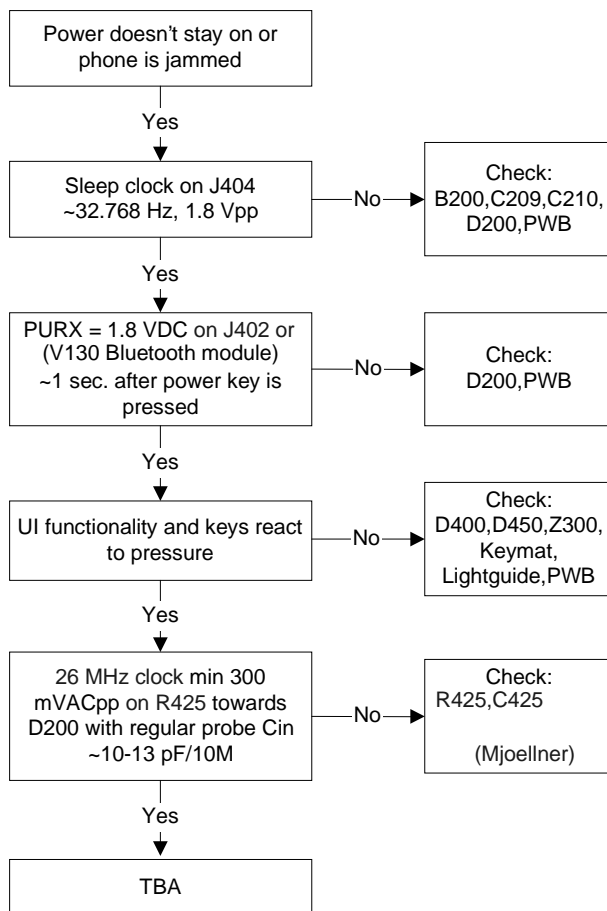
Power doesn't stay on, or phone is jammed

If this kind of failure is presenting itself immediately after FLALI, it is most likely caused by ASICs missing contact with PWB.

If for some reason the MCU does not service the watchdog register within the UEM, the operations watchdog will run out after approximately 32 seconds. Unfortunately, the service routine can not be measured.

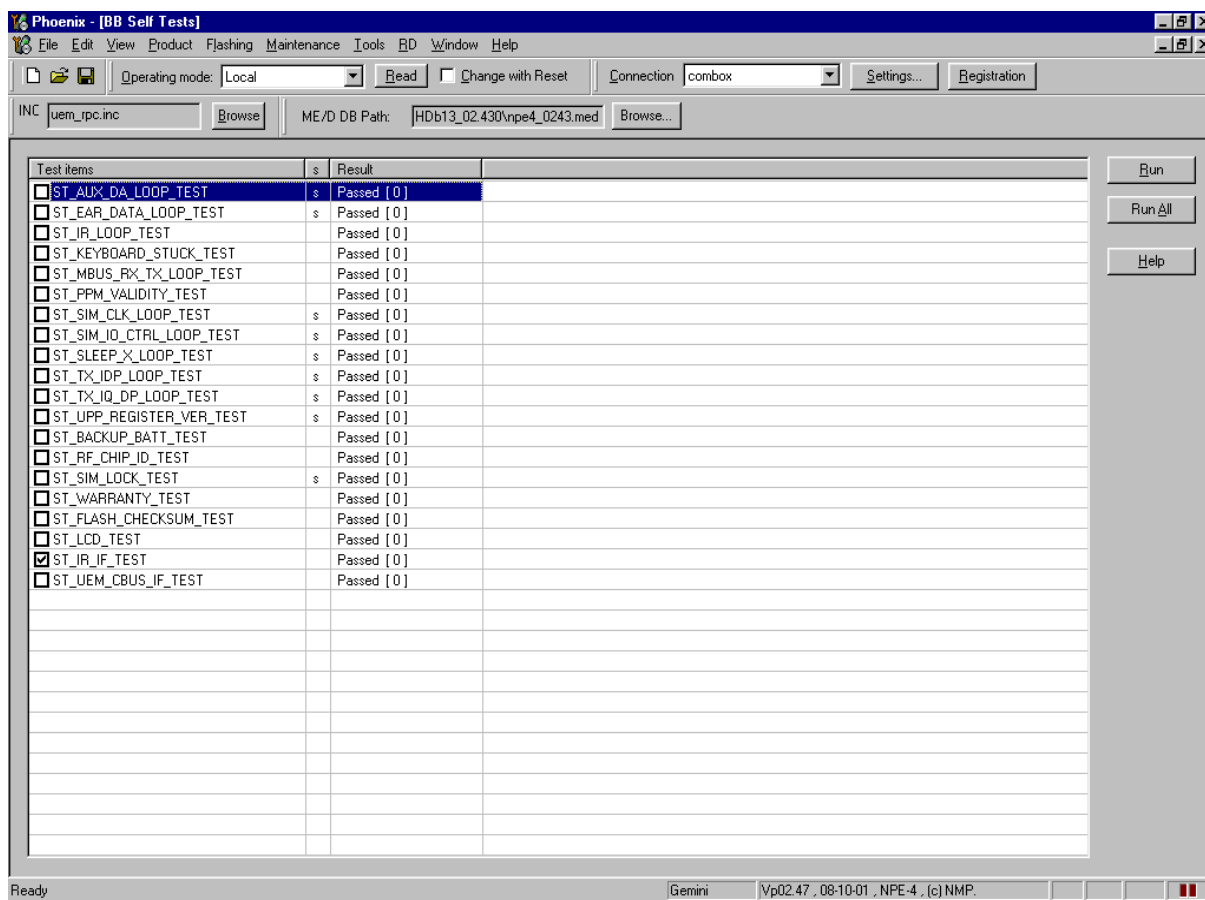
From Phoenix it is possible to run all the selftest and the additional "Runtime test". The test cases can be seen below.

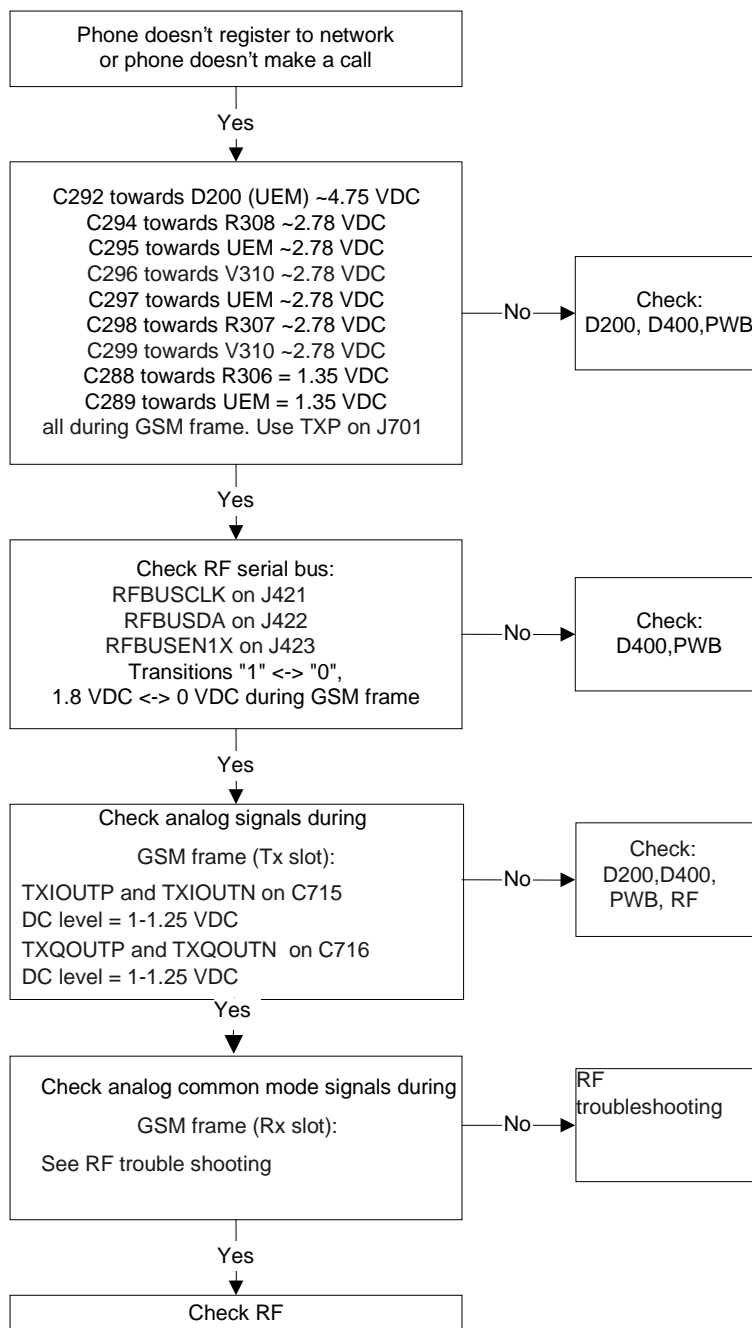
The phone doesn't register to the network or phone doesn't make a call

If the phone doesn't register to the network, the fault can be in either BB or RF. Due to the highly module design of the BB area, very few signals can be measured.

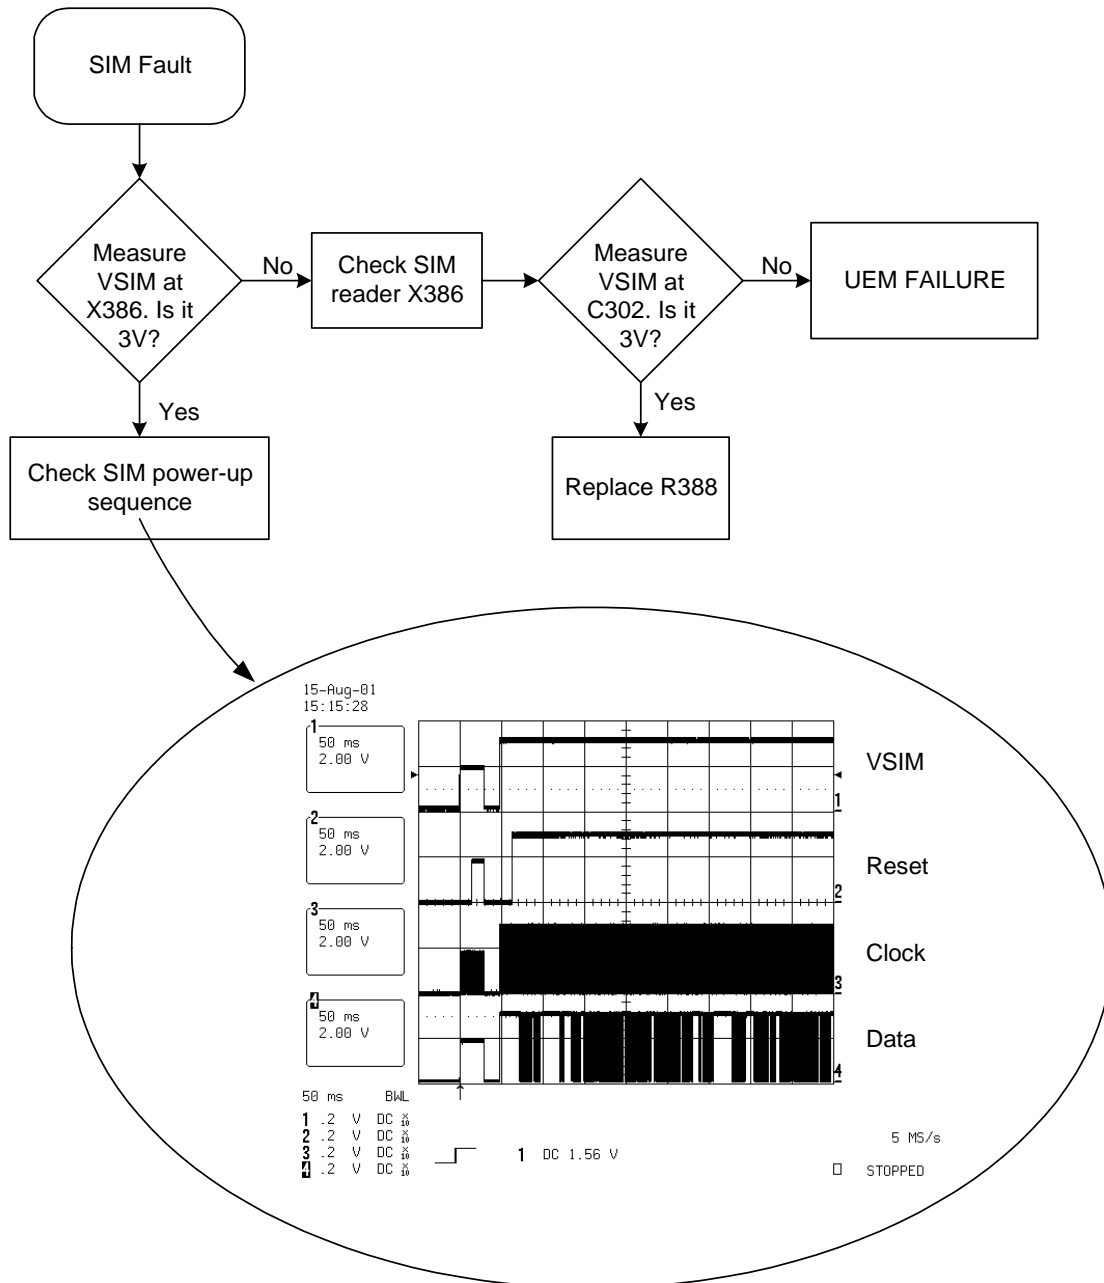
SIM Failure

The hardware of the SIM interface from UEM (D200) to the SIM connector (X386) can be tested without a SIM card. When the power is switched on the phone first check for a 1,8V SIM card and then a 3V SIM card. The phone will try this four times, whereafter it will display "Insert SIM card".

The error "SIM card rejected" means that the ATR message received from SIM card is corrupted, e.g. data signal levels are wrong. The first data is always ATR and it is sent from card to phone.

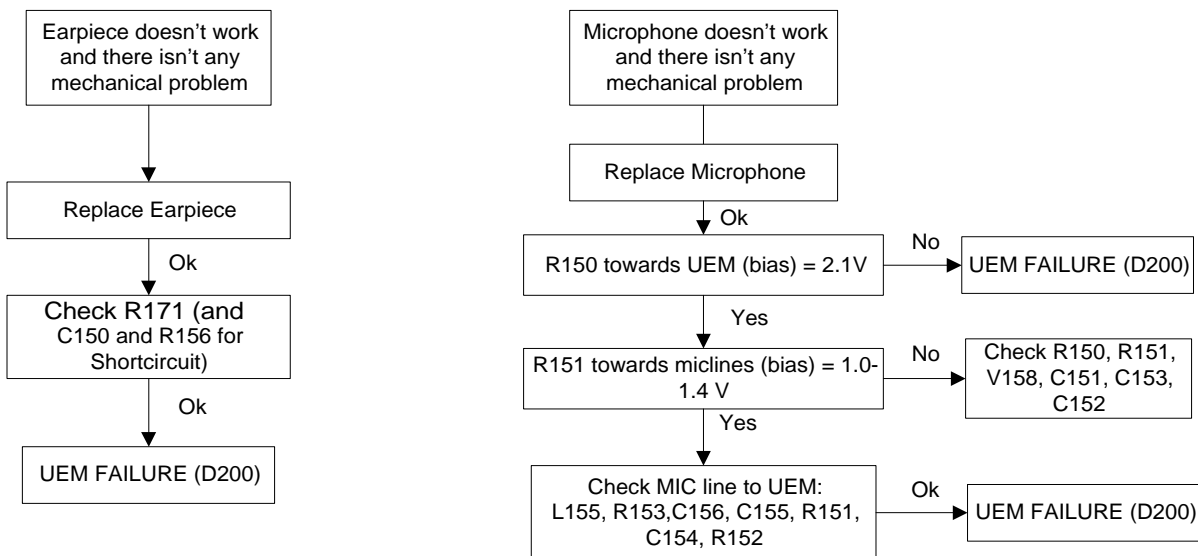
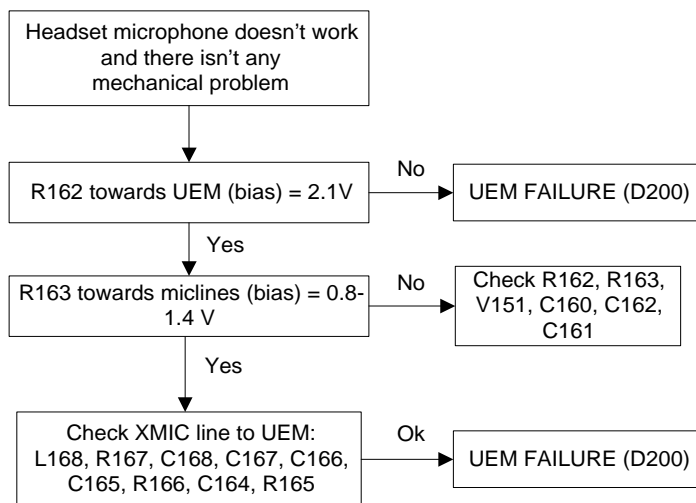
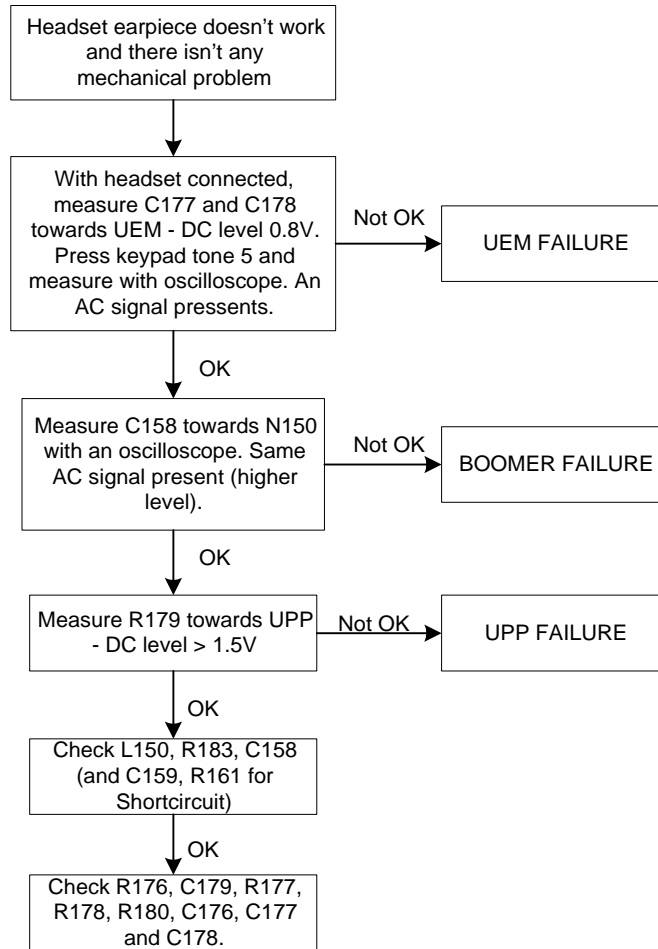
Audio faults

Note: L158 does not exist

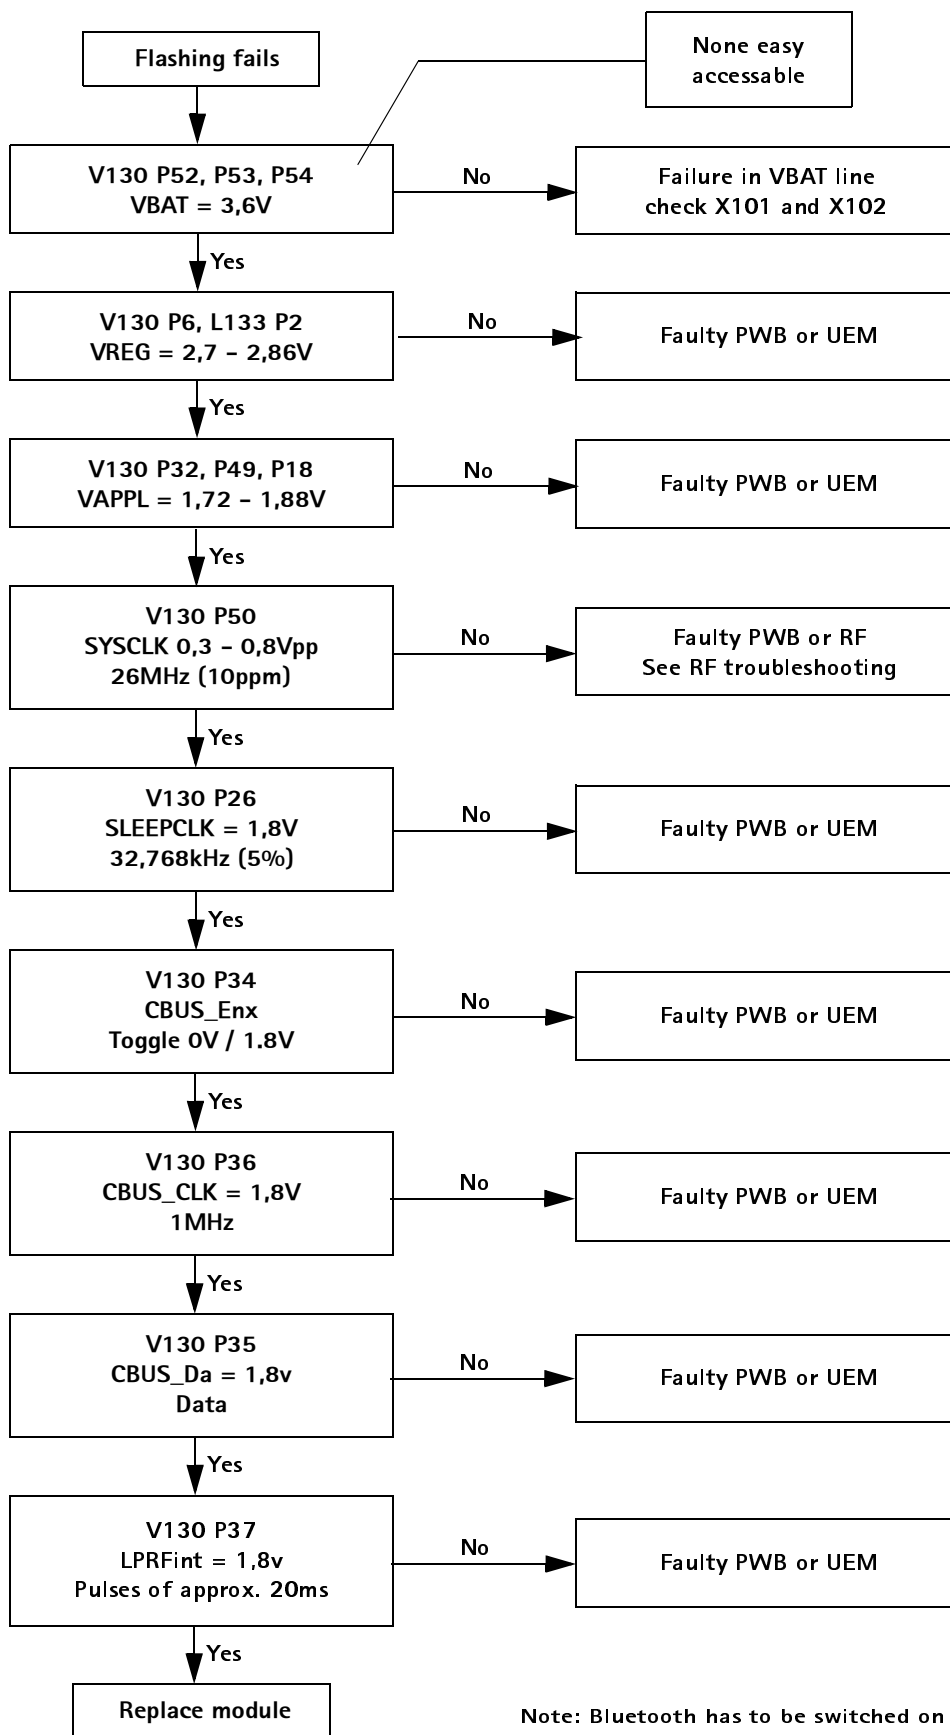
BlueTooth module faults

Note: Bluetooth has to be switched on (Phone UI)
