**CCS Technical Documentation
NHL-2NA Series Transceiver**

Troubleshooting Instructions

Baseband Troubleshooting

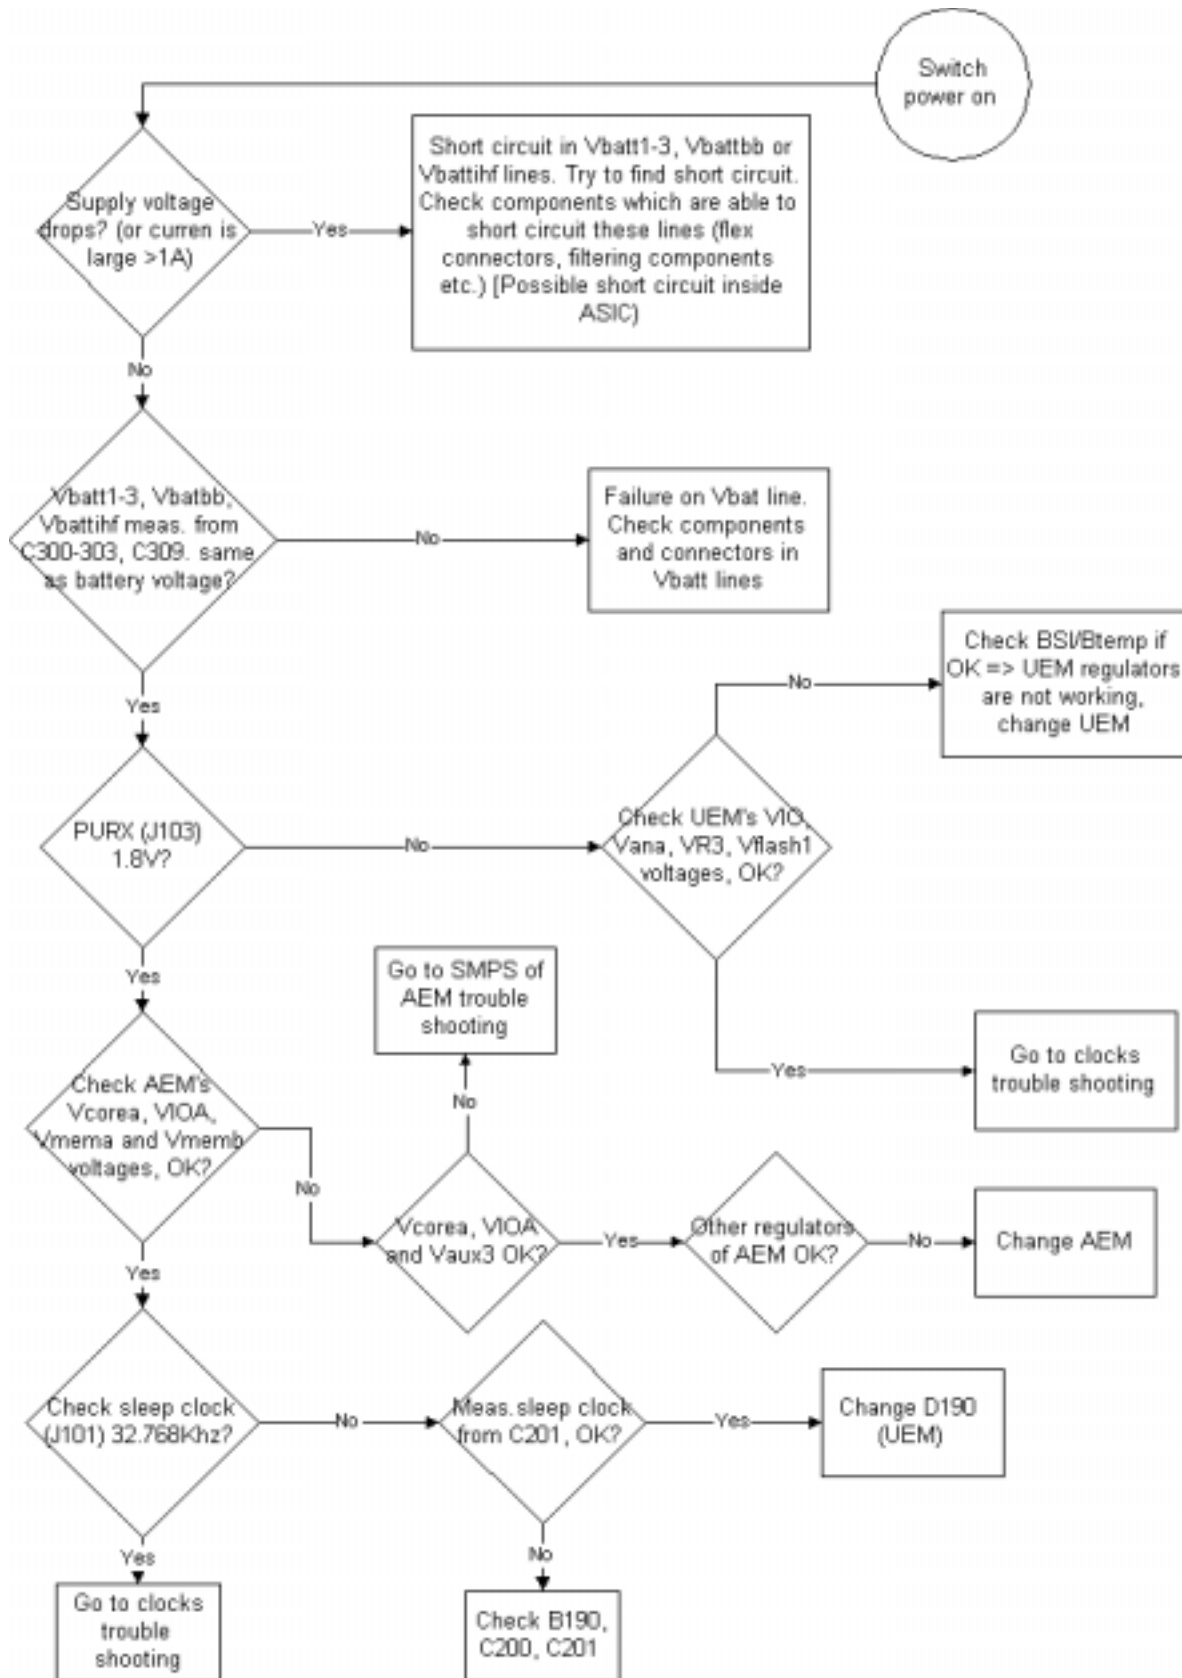
General power checking

Use service tool FLA-21. Battery voltage should be atleast 3.6V. After phone disassembly, use module jig MJS-9Q.

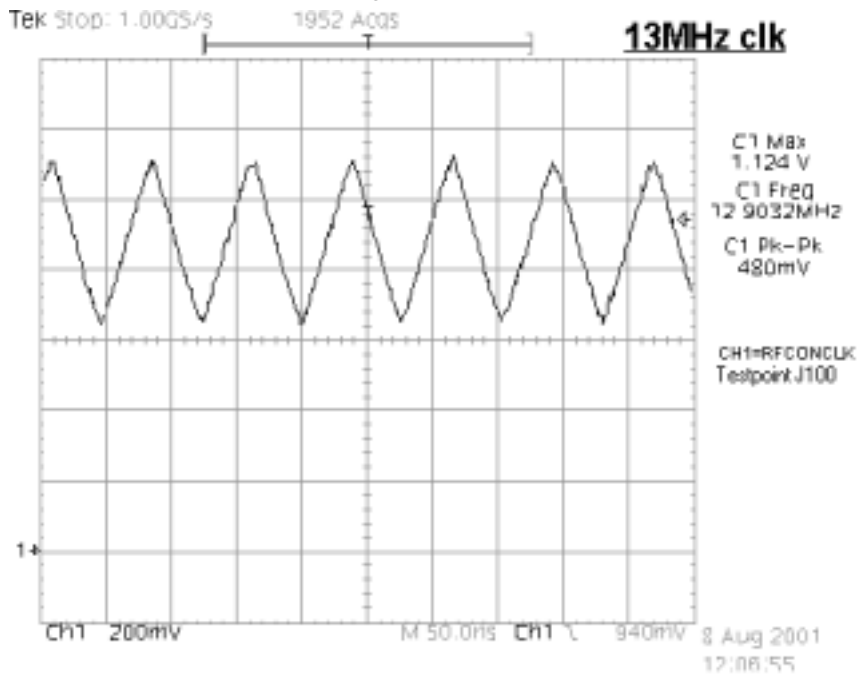
Figure 3: 13 MHz clock

- 2 Check 13Mhz Rfclk from testpoint J100. See figure below. Offset should be about 900mV. If the offset does not exist something is broken inside UPP_WD2 or DC-filtering capacitor in series on trace.

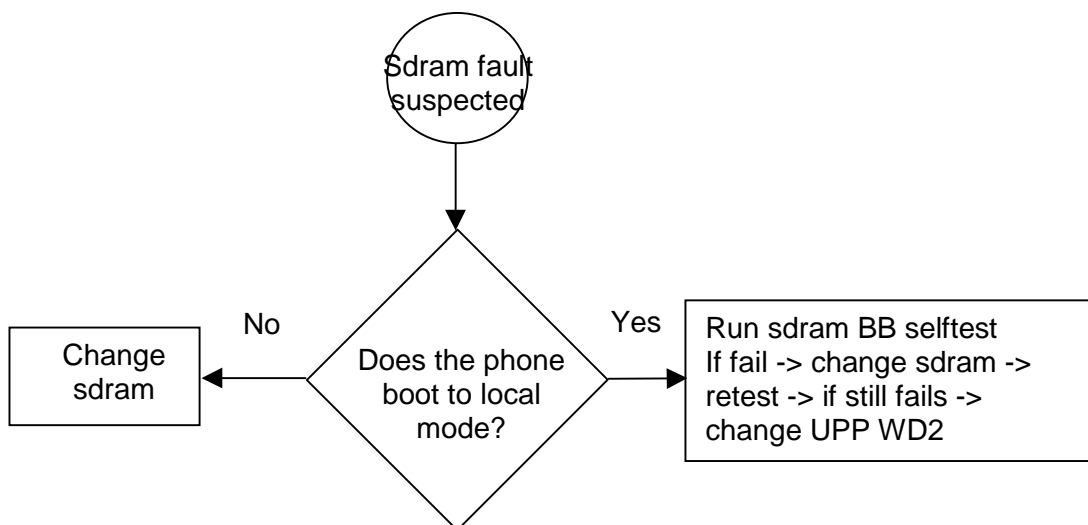
- SDRAM partially damaged
This can mean that the sdram component itself is partially damaged and all the memory locations cannot be successfully accessed or there is a soldering problem somewhere either under UPP or sdram.

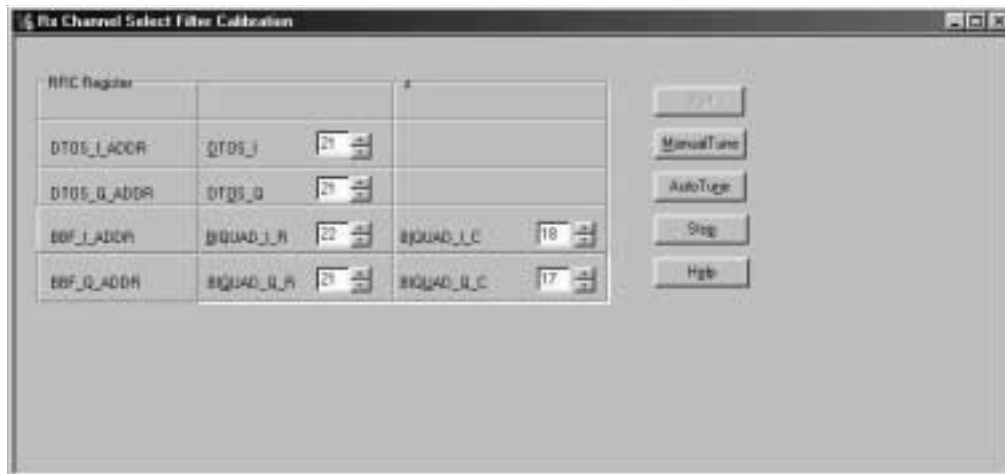
- Press "AutoTune" to start the tuning

- Tuning values should be 0...31
- Select "Stop"
- If values shown are within limits, choose "Yes" to save values to the phone save them to phone.

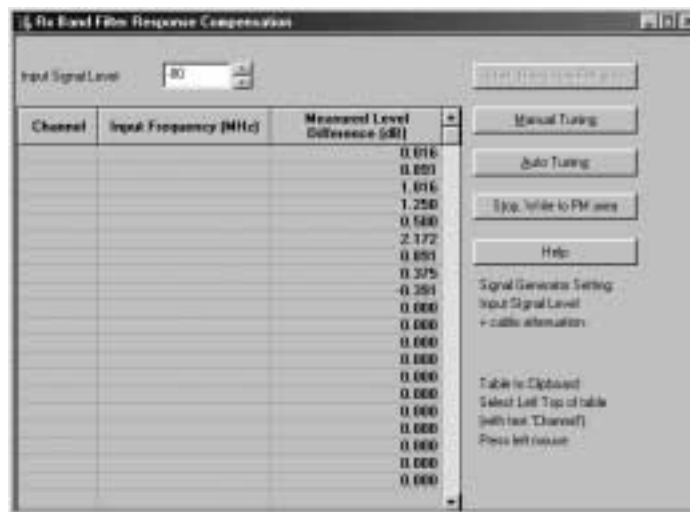
- Select "Manual tuning"

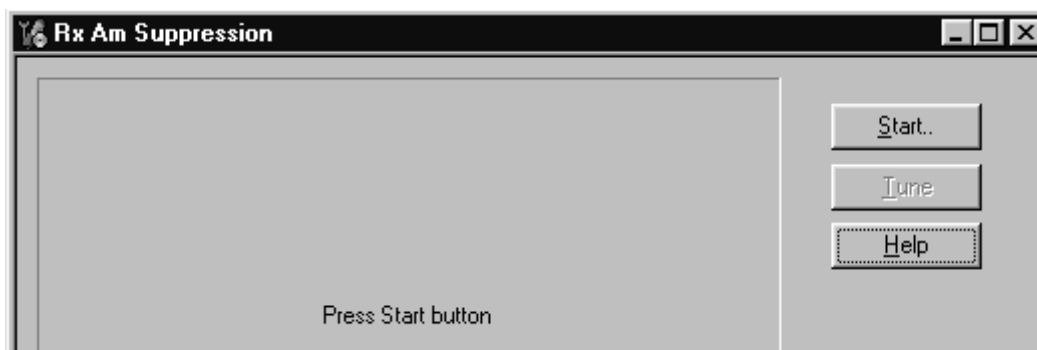
- Start => Default settings => OK,

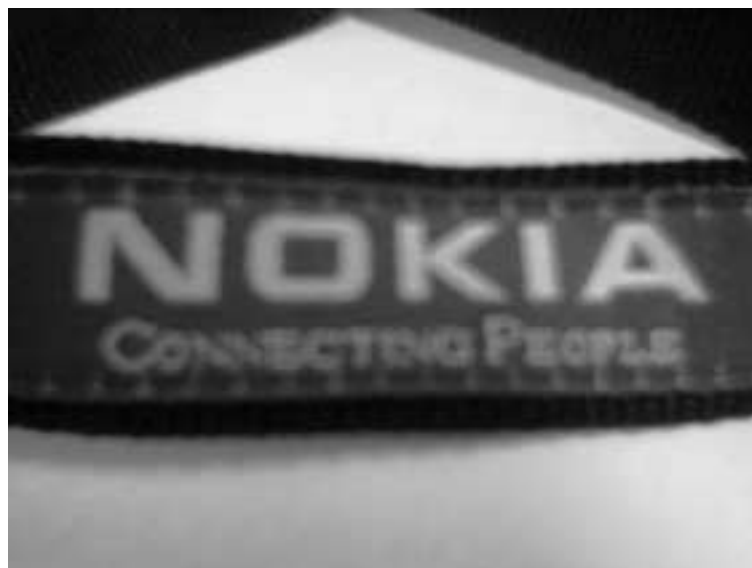
Distance to target: the lens in the module is specified to operate satisfactorily from 30cm to infinite distance of scene objects. In practice, the operation is such that close objects may be noticed to get more blurred when distance to them is shortened from 40cm. Lack of sharpness will be first visible in full resolution (VGA) images. If observing just the viewfinder, even very close objects may seem to appear sharp. *This is normal behavior, do not change the camera module.*

Figure 1: Image blurred due to too close distance to target (5 cm)

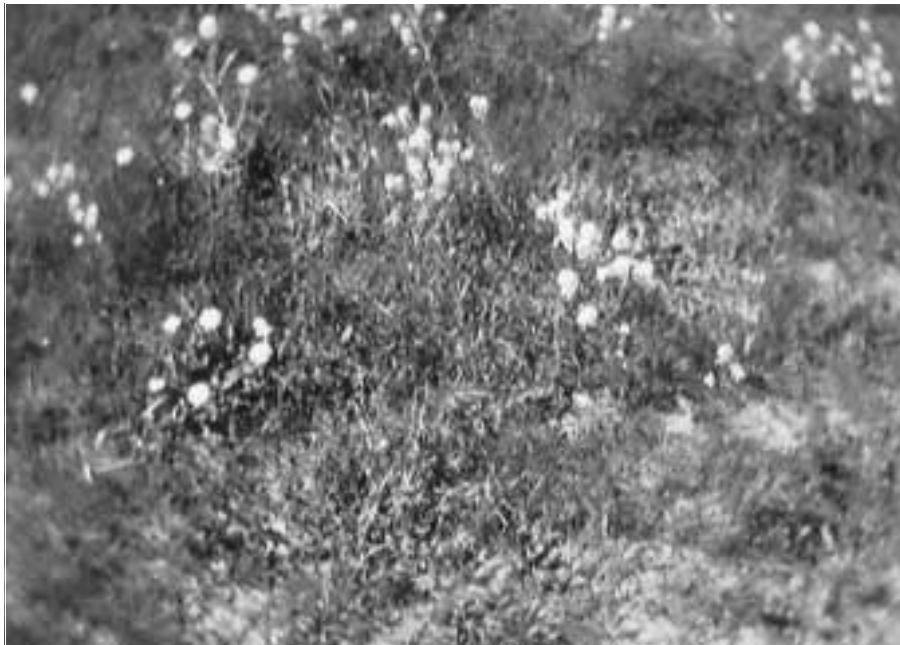
Figure 3: Especially this type of images are affected much by lack of sharpness in edges / corners

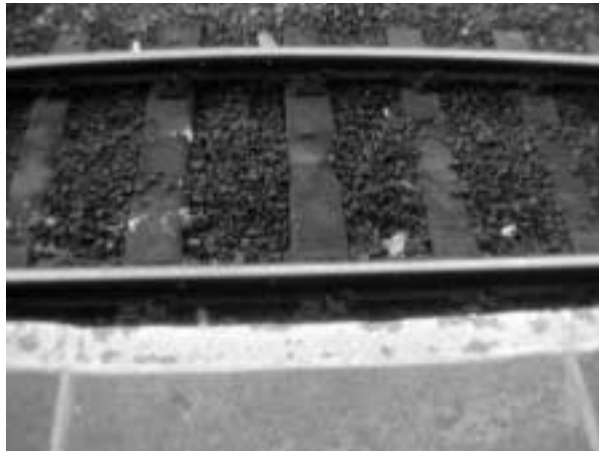
Geometrical distortion: camera lens will cause some amount of so called barrel distortion in images. In practice, this appears as bending of straight objects in edges of the image. See Geometrical distortion and Handshake has caused blurring of this image. Note geometrical barrel distortion in background for example. *This is normal behavior, do not change the camera module.*

Figure 4: Geometrical distortion

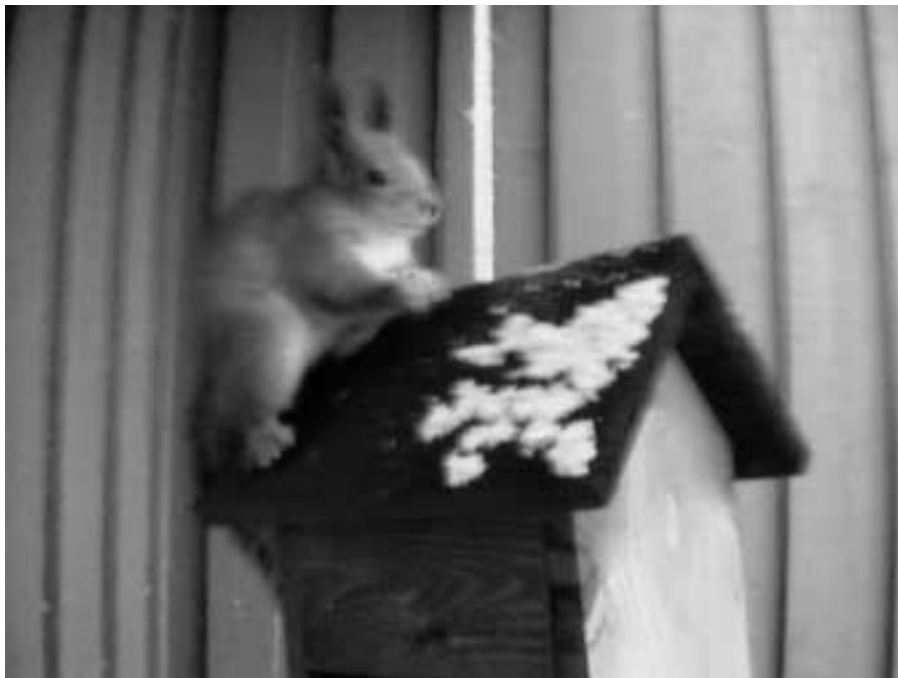
Amount of light available: in dim conditions camera runs out of sensitivity. Exposure time is long (especially in night mode) and the risk of getting shaken (= blurred) images grows. Image noise level grows. The maximum exposure time in night mode is $\frac{1}{4}$ seconds, so images need to be taken with extreme care and by supporting the phone when the amount of light reflected from the target is low. Sometimes blurring may even happen at daytime if image is taken very carelessly. See Handshake has caused blurring of this image. Note geometrical barrel distortion in background for example. *This is normal behavior, do not change the camera module.*

Figure 5: Handshake has caused blurring of this image. Note geometrical barrel distortion in background

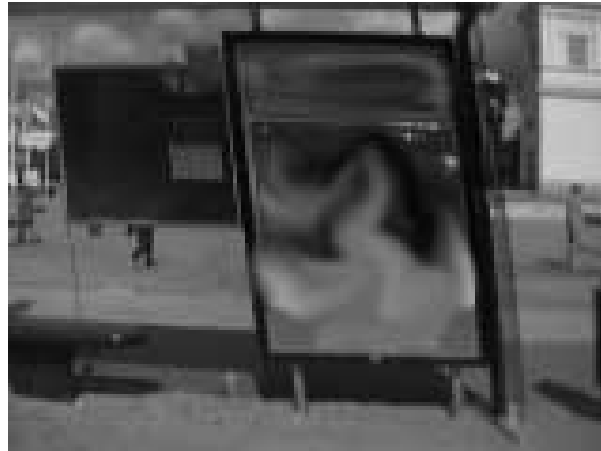
Movement in bright light: If pictures of moving objects are taken or if the device is used in a moving car, object 'skewing' or 'tilting' will occur. This phenomena is fundamental to most CMOS camera types and normal, and can not be helped. Movement of camera or object will usually cause blurring in inside or dim lighting conditions due to long exposure time. *This is normal behavior, do not change the camera module.*

Figure 6: Near objects in image get skewed when shooting from a moving car

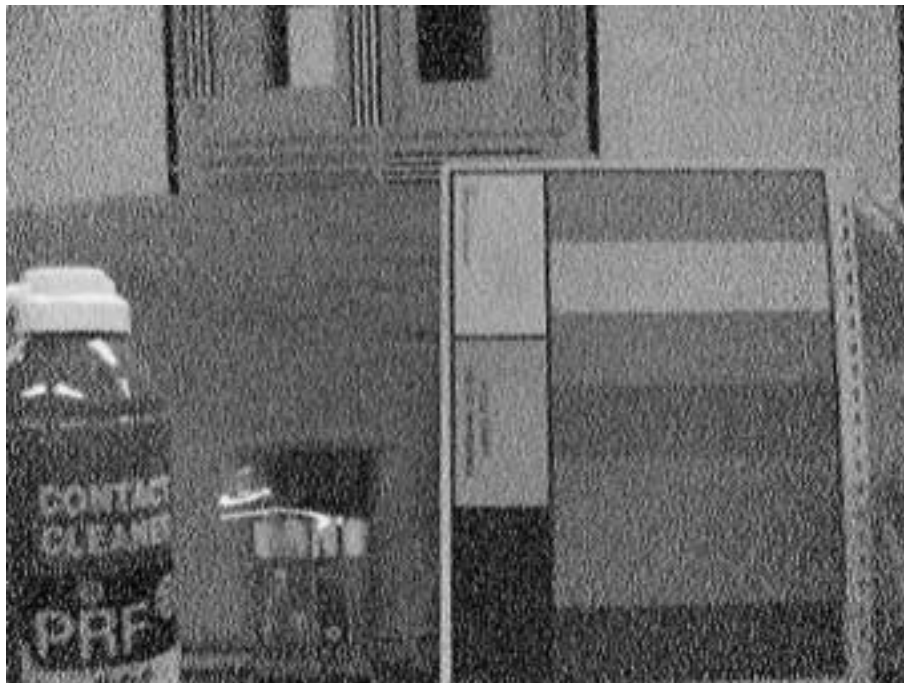
Temperature: high temperatures inside the mobile phone will cause more noise to appear in images, e.g. in +70 degrees of celsius the noise level may be very high, and it further grows if the conditions are dim. This is also normal to camera operation. *This is normal behavior, do not change the camera module.*

Figure 7: Noisy image taken in +70 degrees celsius

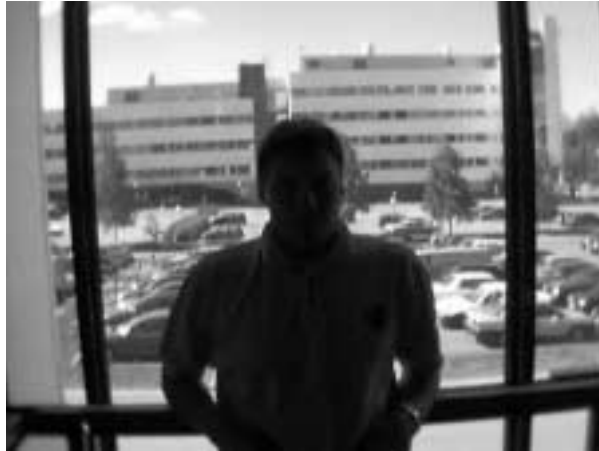
Basic rules of photography, especially shooting against light: electronic image sensors typically have much lower dynamic range than what films have. In practice this means that when taking a picture inside e.g. having a window behind object, will produce poor results. *This is normal behavior, do not change the camera module.*

Figure 8: Image which has been taken "against light". The actual object is dark.

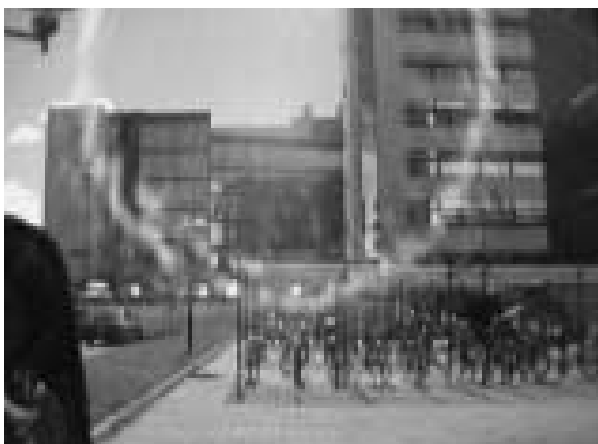
Bright light outside of image view: Especially sun can cause clearly visible 'halo' effects and poor contrast in images. This happens due to unwanted reflections inside camera optics. Generally this kind of reflections are common in all optical systems. *This is normal behavior, do not change the camera module.*

Figure 10: A lens reflection effect caused by sun shining above the scene

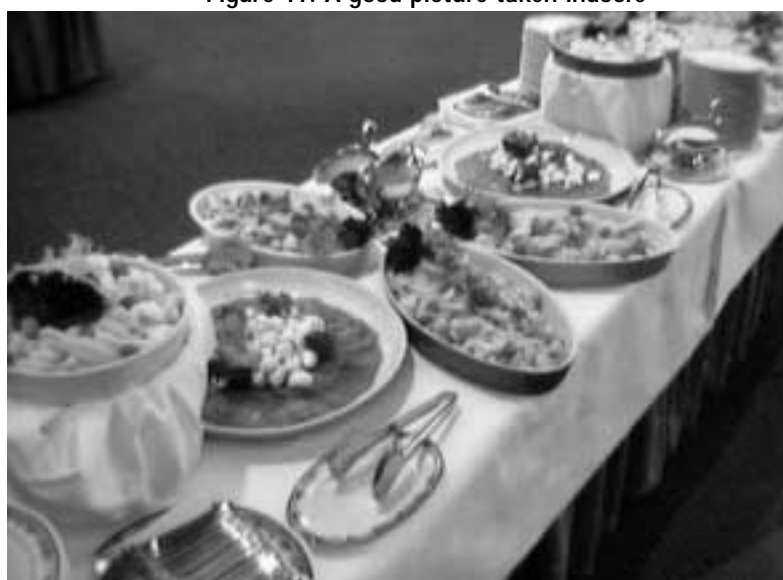
Figure 11: A good picture taken indoors

If no visible defects (items 1-4) can be found, a couple of test images should be taken and checked. Generally, a well illuminated typical indoor office scene, such as the one in A good picture taken indoors, can be used as a target. The main considerations are:

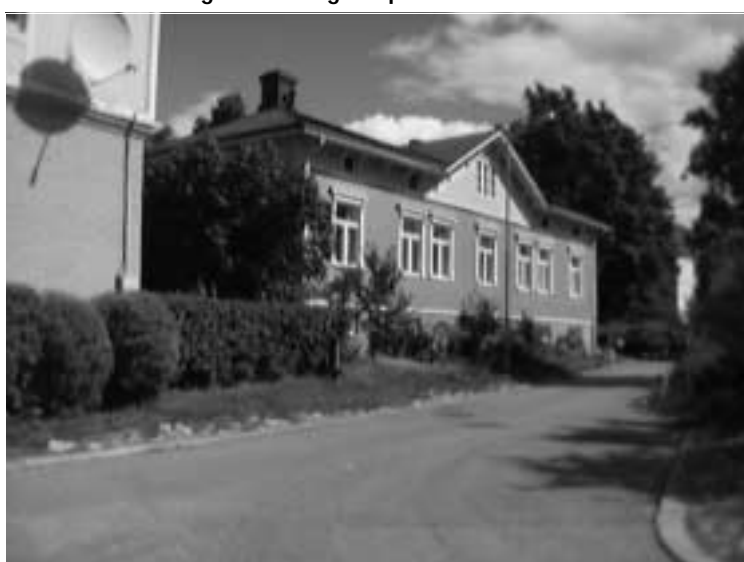
Figure 12: A good picture taken outdoors

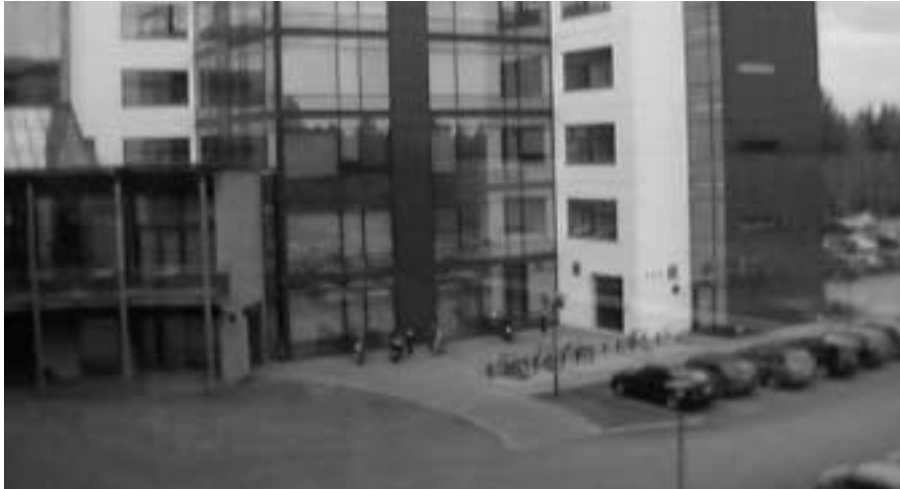
Figure 19: Natural scene, clear back window

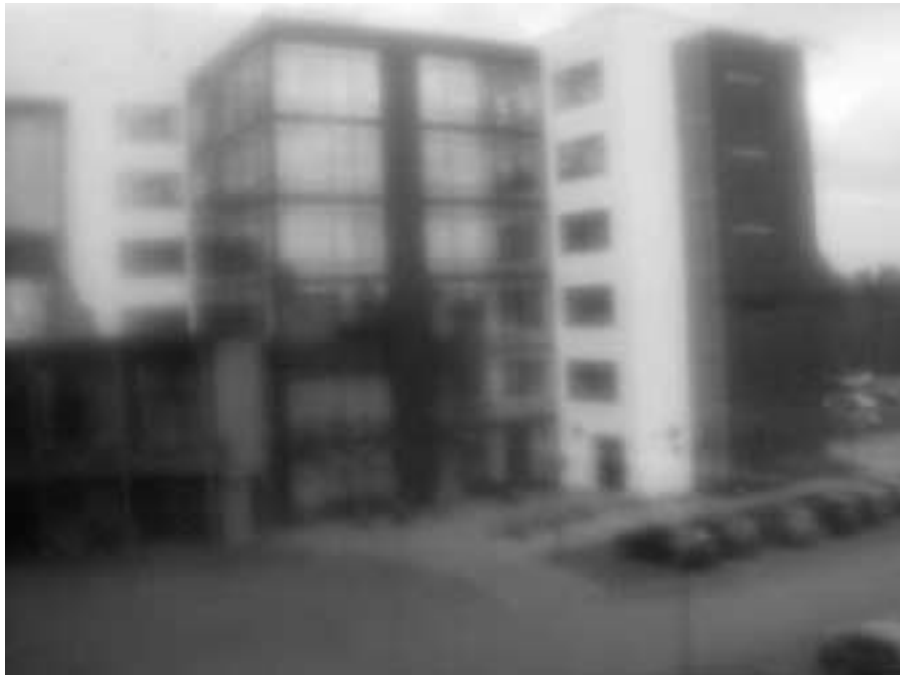
**Figure 20: Natural scene, badly soiled back window**
