CCS Technical Documentation RH-41 Series Transceivers

Troubleshooting Instructions

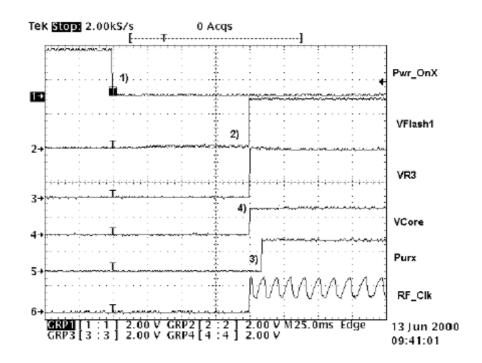
Figure 1: Power up sequence

Note: In the following figure, the RF_Clk frequency appears to be lower than 19.44 MHz because of a too low oscilloscope sampling frequency (2kS/s).

- 1 Power key pressed
 - After 20ms UEM enters RESET MODE if VBAT>Vmstr+
 - VFLASH1, Vana, Vcore, Vio and VR3 goes high.
 - VCTCXO enabled by VR3 -> RFClk 19.44 MHz running.
- 2 Purx released
 - Purx released by UEM, UEMINT goes high for 100 ms, SleepX goes high and UEM starts feeding SleepClk (32 KHz) to UPP.

Note: The sleepclock starts running in the crystal circuitry (B200) immediately when the battery voltage is supplied.

- 3 Software running
 - Default value for Vcore is 1.5 volts when the software is running.
 - Cbus (1.08MHz) clock starts running.

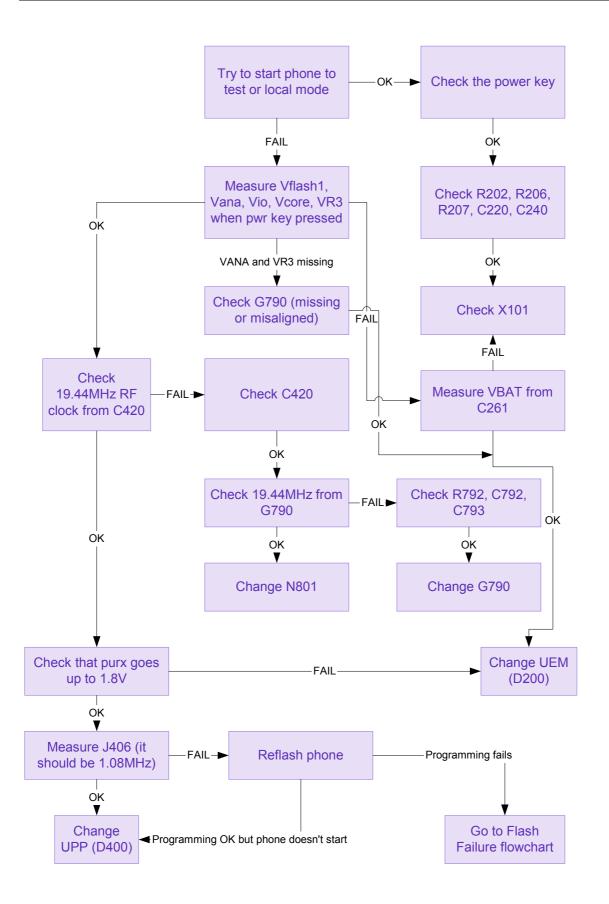
Figure 2: Fault tree, phone does not power up

Note: In case of power up faults, it is not possible to force the phone on by disabling the watchdog. Instead, measurements should be taken immediately when the power key is pressed or when the battery voltage is connected to the phone (local/test mode).

The easiest way to check if the software is running when the phone takes an abnormal amount of current is to measure the *cbusclk* and *Vcore*.

The Dbus clock (programmable 9.72MHz) is not automatically visible in the test and local modes.

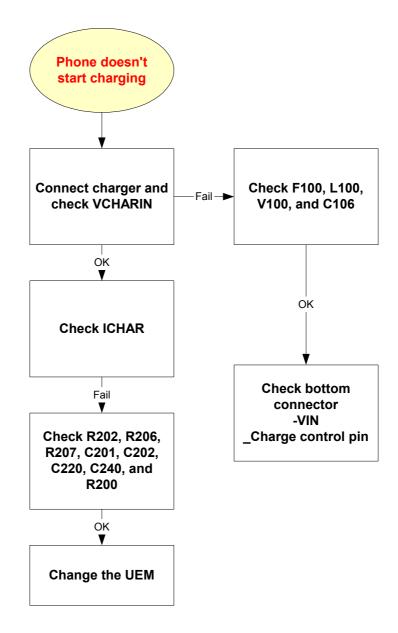
Figure 3: Fault tree, charging

Note: The charging voltage and current can be checked by connecting the phone to the service software and reading the ad- converter values of the vchar and ichar.

If charging fails when the LCH-9 is used, and works with ACP-7 and ACP-8, check that the charge control pin of the system connector is connected to the ground.

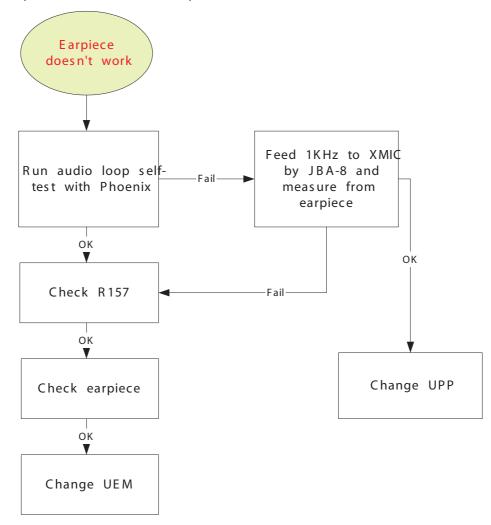
Figure 4: Fault tree, earpiece failure

- 1 Make a phone call against tester and check audios.
- 2 In case the earpiece/XMIC fails: Feed a 1 Khz signal to the XMIC line and measure the signal from the earpiece line. The Audio test box (JBA-8) is needed. The Audio loop (*Audio test/Ext In Hp Out*) must be switched on by the Phoenix service software. This loop will connect audios only through the UEM. In this case, the UPP is not used.

Earpiece or external microphone line does not work

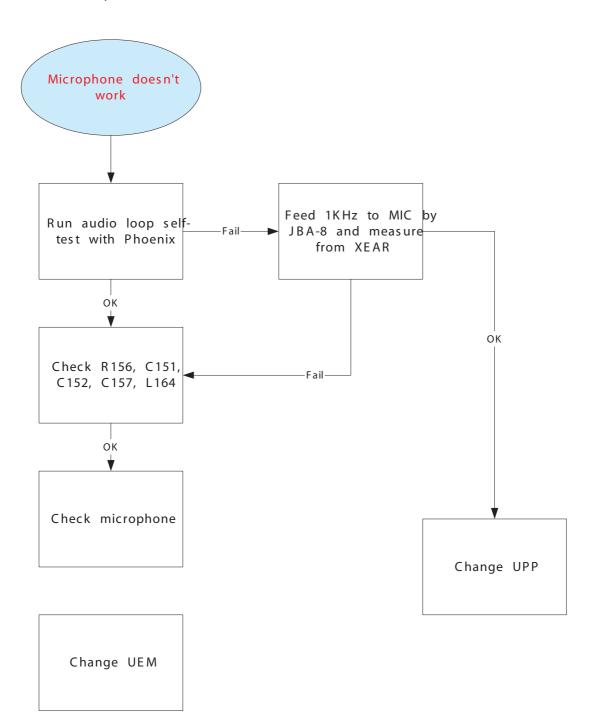
Figure 5: Fault tree, microphone failure

In case the internal microphone/XEAR fails: Feed the tone to the microphone and measure the signal from the XEAR line. The Audio test box (JBA-8) is needed. The Audio loop (*Audio test/Hp In Ext Out*) must be switched on by the Phoenix service software. This loop will connect audios only through the UEM. In this case, the UPP is not used.

Microphone or XEAR line does not work

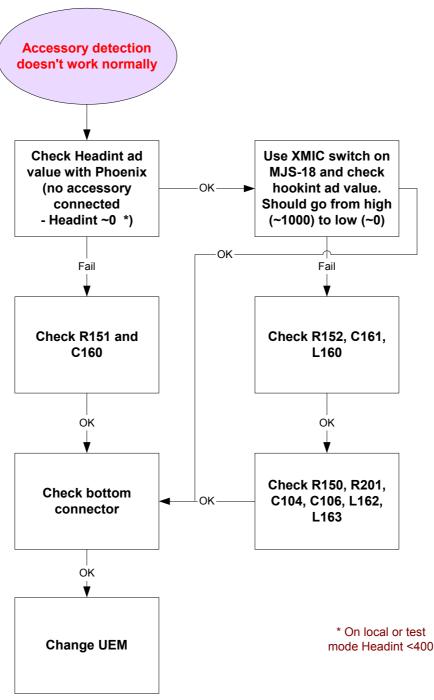
Figure 6: Fault tree, accessory detection

- 1 Start the phone in the normal mode when checking for accessory detection.
- 2 The Ad- converter value of the hookint-line can be checked with the Xmicswitch on an MJS-18 test jig. Changes normally from high to low when no accessory is connected.
- 3 When the headset (HDC-5) is connected, the hookint- value should be between 600 and 800.

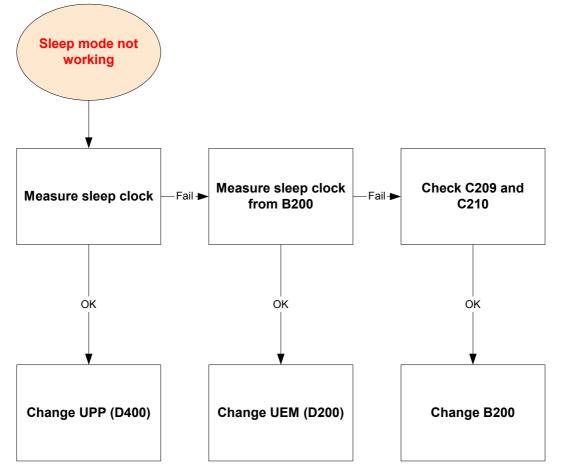
Figure 7: Fault tree, sleep clock

Missing/nonfunctional sleep clock causes

- Entering sleep mode fails (higher current consumption -> shorter standby time).
- Baseband self tests cannot be run.
- Phone clock (on display) does not function properly.

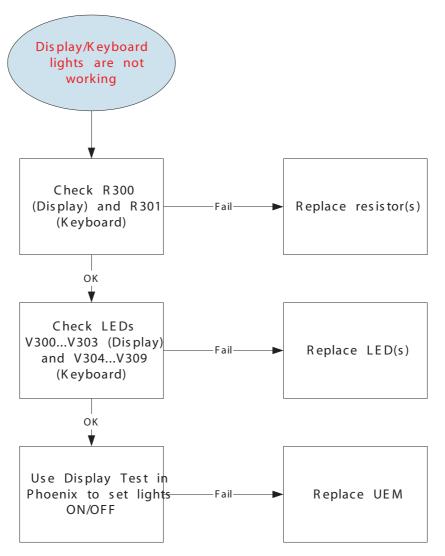
Figure 8: Fault tree, Display/Keyboard lights

Display/Keyboard lights do not work

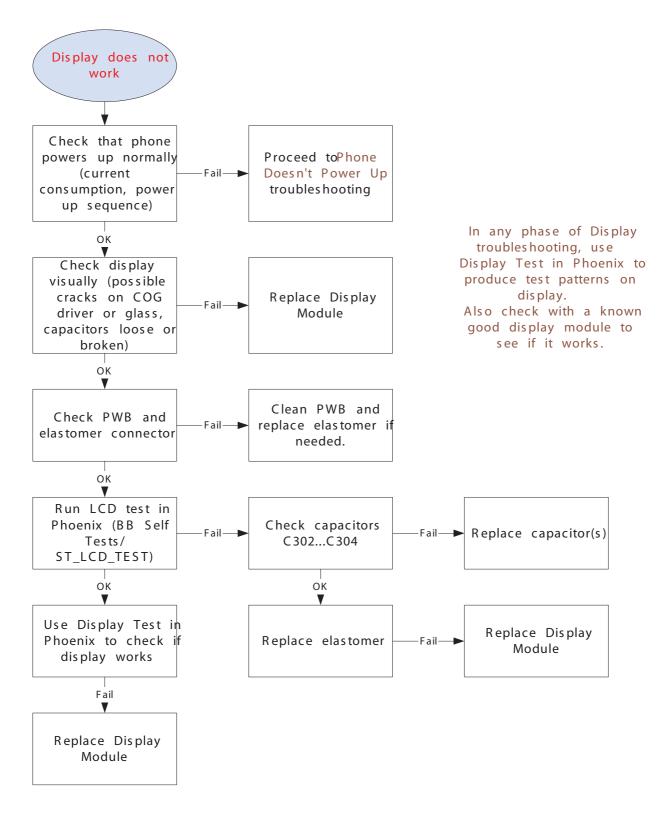
Display does not work

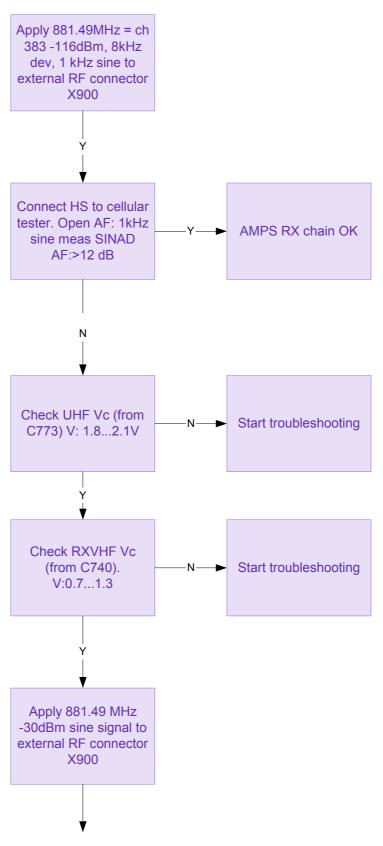
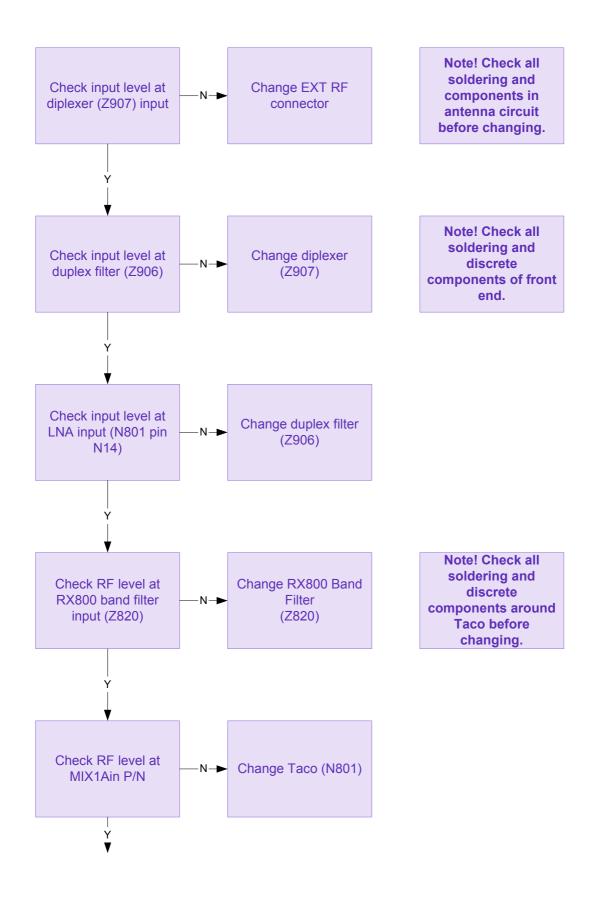
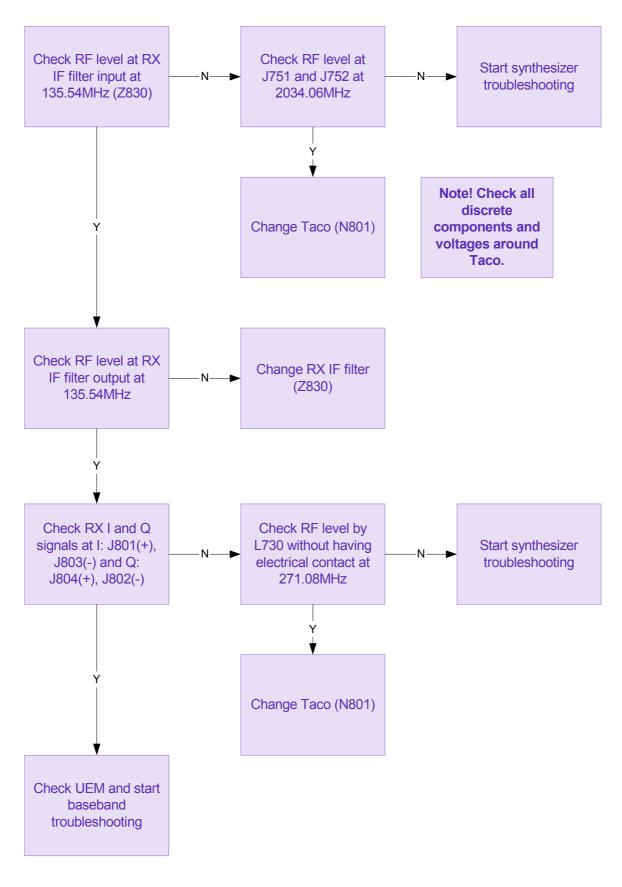
Figure 10: Fault tree. AMPS

(Antenna/ext RF) – Diplexer – Duplexer – Low Noise Amplifier (LNA) – RX band filter – First mixer – 135.54 MHz RX IF filter – IF-amplifier – second mixer – 14 kHz low-pass filter – adjustable IQ amplifier – Baseband.

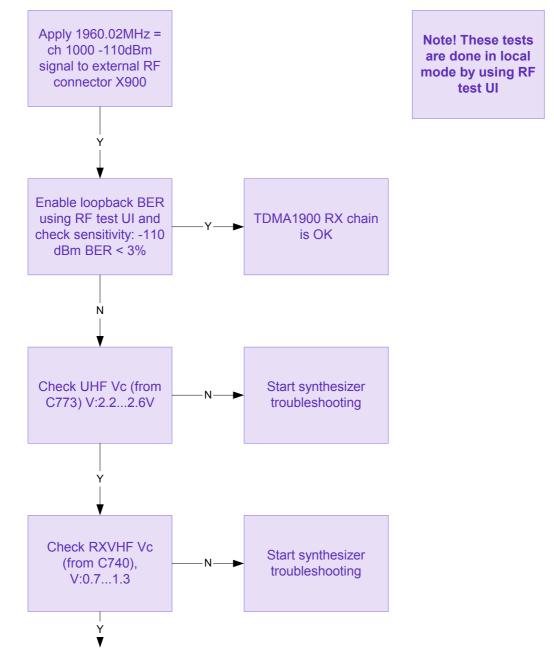
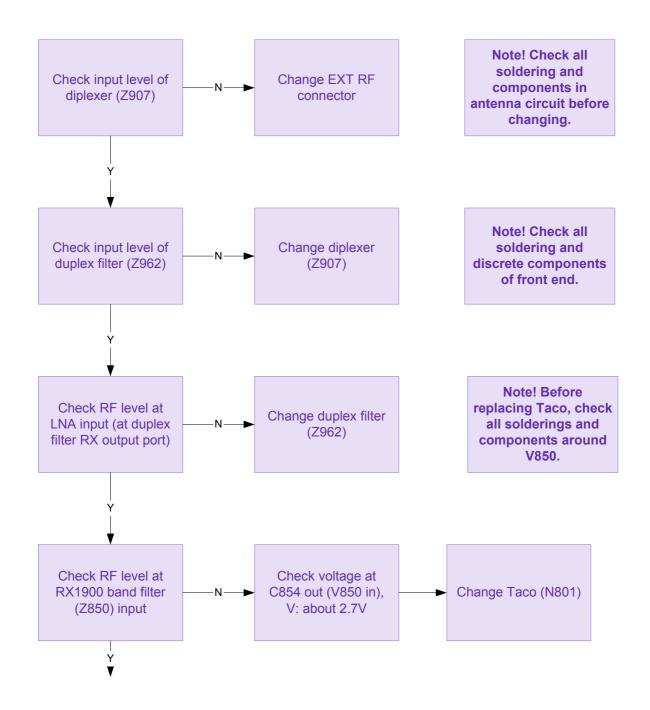
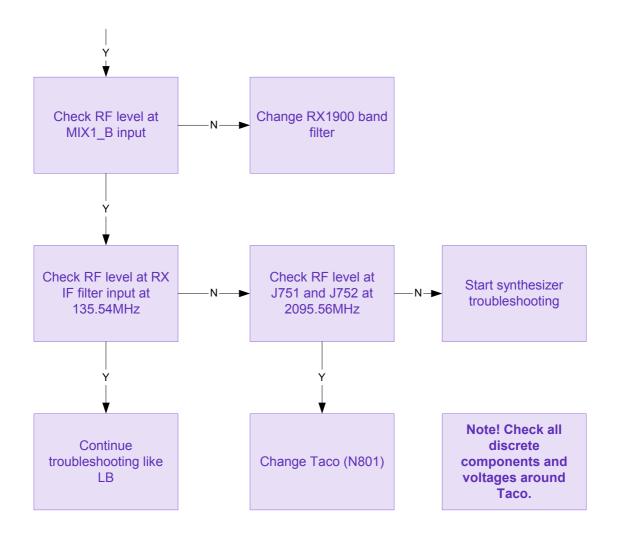
Figure 11: Fault tree: TDMA 1900 troubleshooting

Only EXT RF connector -> 1st IF needs separate troubleshooting at upper band. After down conversion (RF -> 135.54 MHz) both lower and upper band use same signal path.

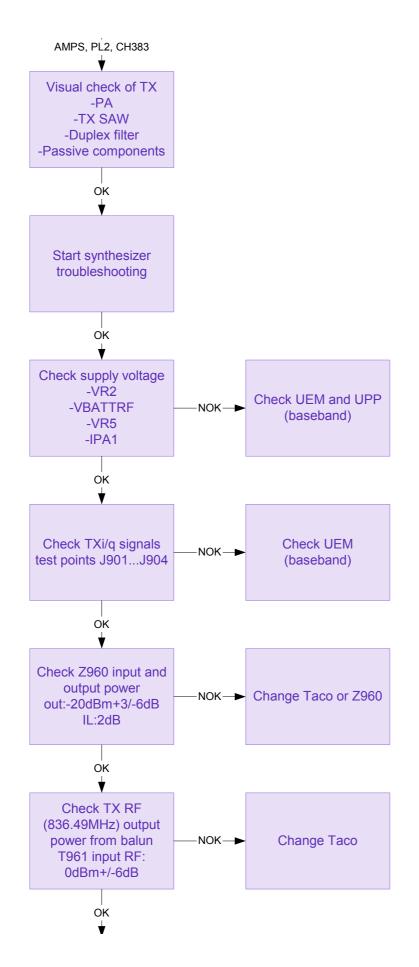
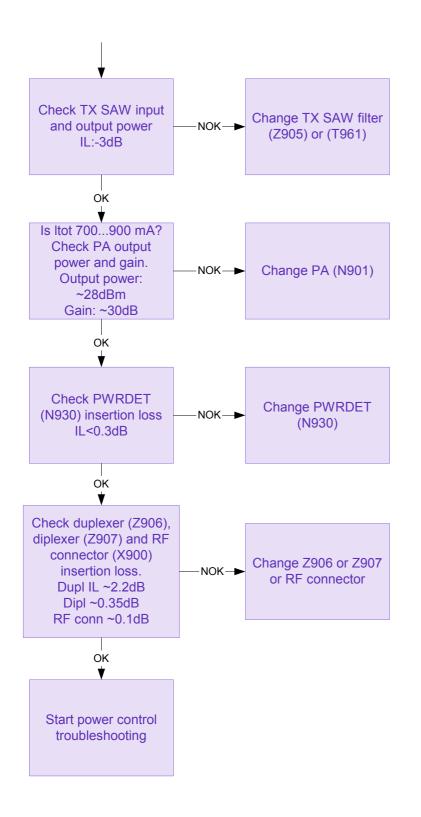
Figure 12: Fault tree. Transmitter troubleshooting

- 1 Start the Phoenix software and set the phone to the analog mode by using RF Test UI.
- 2 Set the channel to 383 and the power level to 2.
- 3 Connect the RF cable to the Ext RF connector.
- 4 Connect the cable to the Spectrum analyzer input.
- 5 Measure the RF level.

Note: Insertion loss of the cable and attenuations.

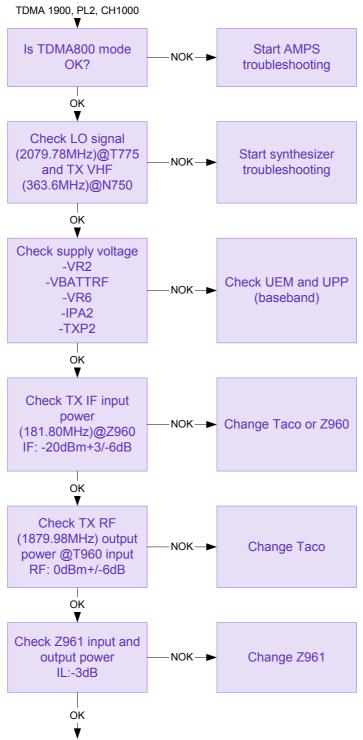
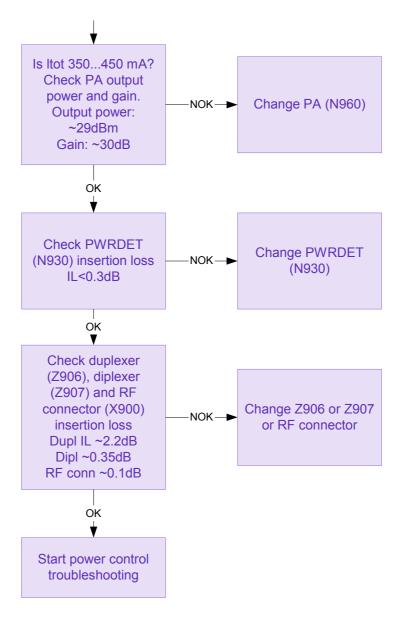
Figure 13: TDMA 1900 troubleshooting

TDMA 1900 mode and DAMPS mode have a common RF modulator and thus it is important that the DAMPS mode have no faults.

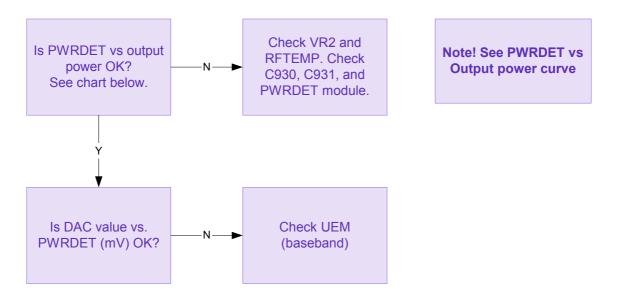
Basically, the power detection is done with the Power detector module and power control is done inside the Taco. Power detection is basically similar for both bands, except that both bands have their own coupler.

Figure 14: Fault tree: Power control loop				
The detected voltages are illustrated in the following table and diagram:

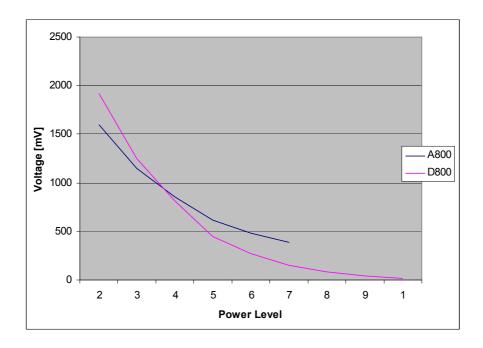
Figure 15: Detected voltage limits

Note: DAC values may vary about +- 20%

Note: TXPWRDET is the difference between TX on burst and off burst.

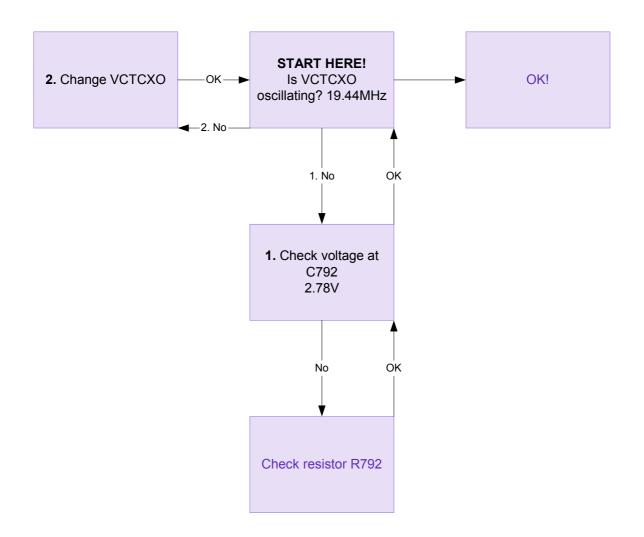
Figure 16: Fault tree: 19.44 MHz oscillator

The VCTCXO oscillator frequency (G790) is controlled by UEM. This output 19.44 MHz signal is connected to Taco. It is used as a reference signal in Taco and also fed out as buffered clock signal to UPP. All synthesizers use divided 19.44 MHz signal as a reference signal for Phase locked loop to provide correct LO frequency.

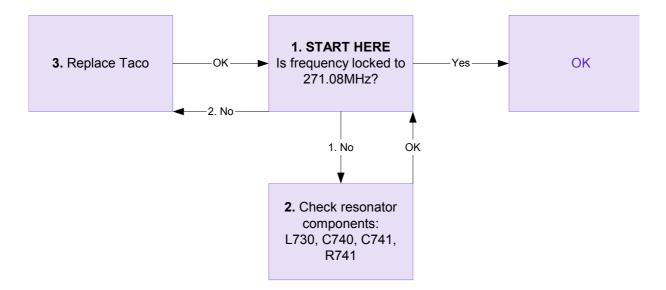
Figure 17: Fault tree: RX VHF

Fault-finding chart for RX VHF VCO

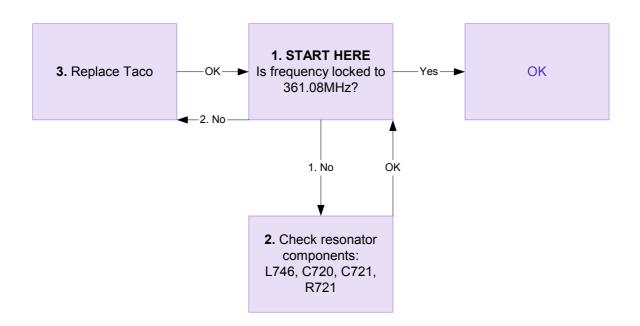
Figure 18: Fault tree: TX VHF

The TX VHF signal is used to generate transmitter Intermediate frequency. TX VHF VCO has one fixed frequency (361.08). Operating frequency is locked in Phase locked loop. TX VHF VCO output signal is divided by 2 and fed to the modulator.

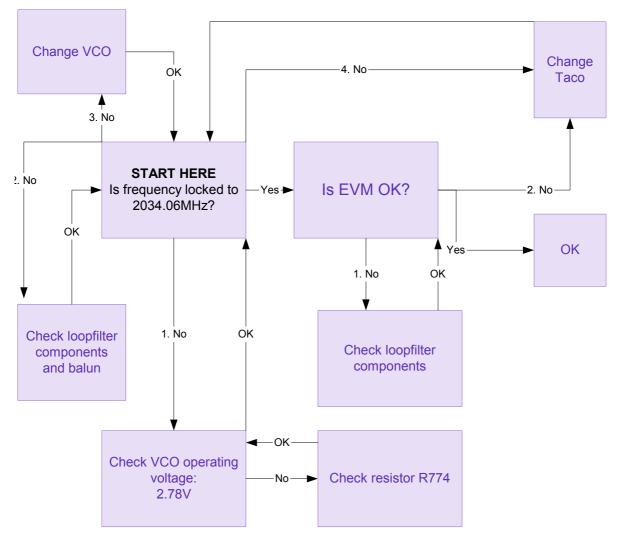
Figure 19: Fault tree: UHF Synthesizer

The UHF VCO signal is used for RF channel selection. This signal is fed as a local signal for 1st mixer of RX path and for upconverter of TX path. When operating on lower band the VCO signal is divided by 2 before feeding. This synthesizer is used for channel selection in all modes and both bands.

The UHF synthesizer consists of an external 2GHz VCO module with loop filter components and integrated PLL parts in Taco. Integrated charge pump circuit allows analog and digital operation modes. The VCO Oscillation frequency is from 2009.1 MHz to 2125.53 MHz. The output frequency of the VCO module depends on the DC control voltage which is controlled by PLL circuit inside Taco.
