**CCS Technical Documentation
NPM-10 Series Transceivers**

Troubleshooting Instructions

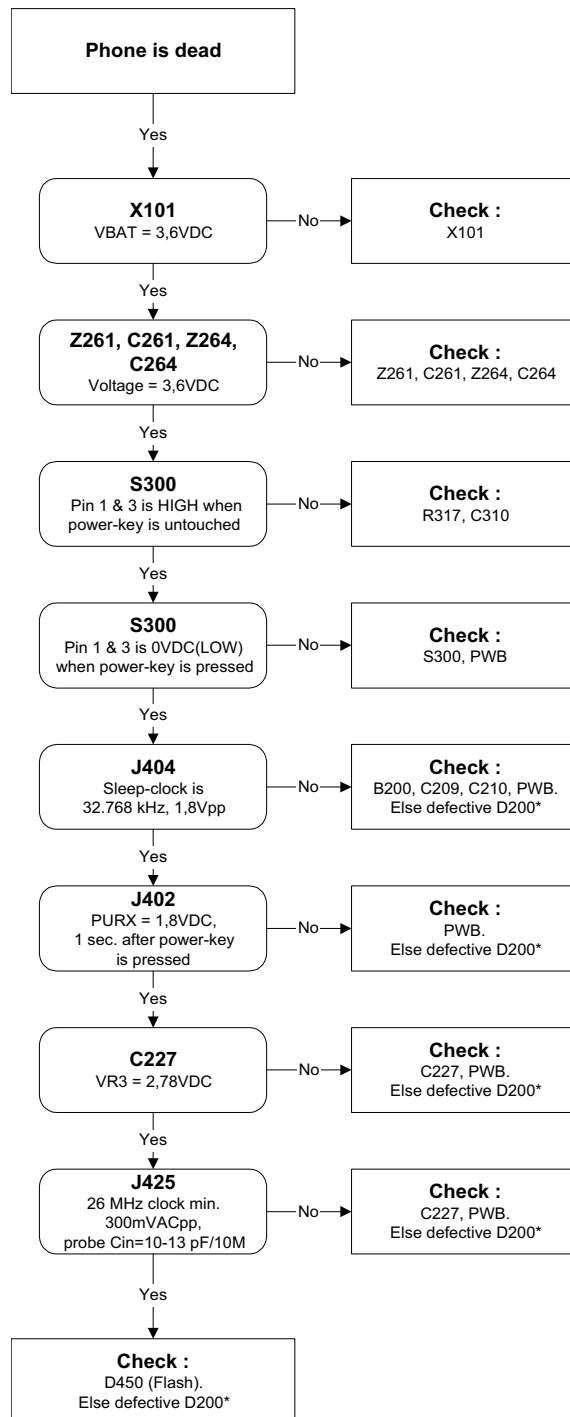
Phone is dead

This means that the phone does not draw any current at all when supply is connected and/or the power key is pressed.

It is assumed that the voltage supplied is 3.6 VDC. The UEM will prevent any functionality whatsoever at battery/supply levels below 2.9 VDC.

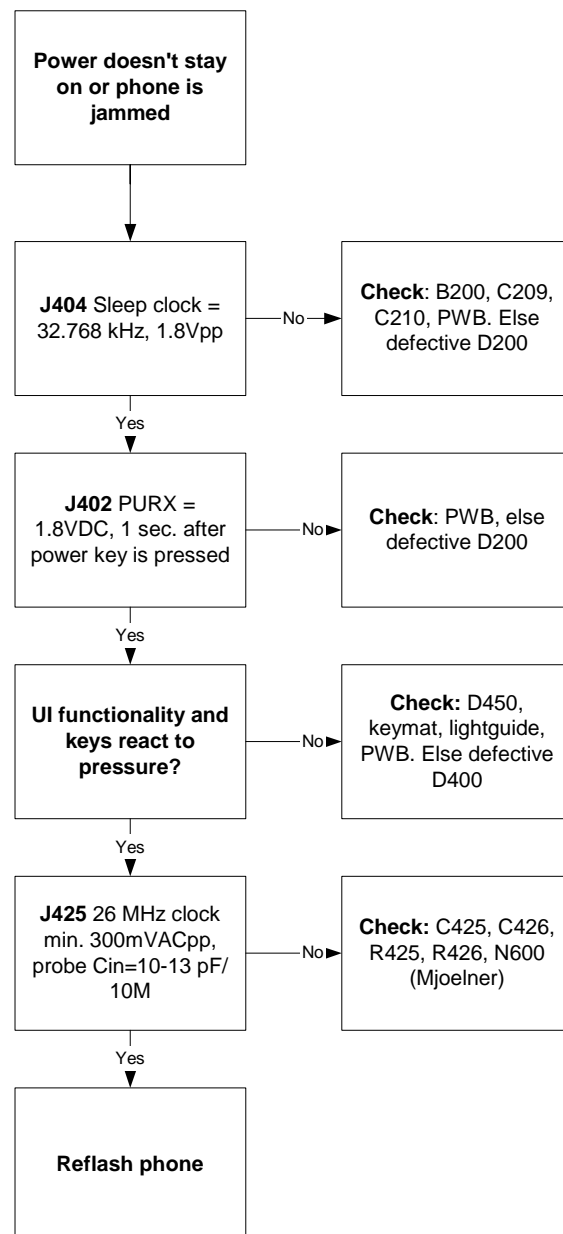
Power does not stay on or phone is jammed

If this kind of failure is presenting itself immediately after FLALI, it is most likely caused by ASICs missing contact with PWB.

If for some reason the MCU does not service the watchdog register within the UEM, the operations watchdog will run out after approximately 32 seconds. Unfortunately, the service routine cannot be measured.

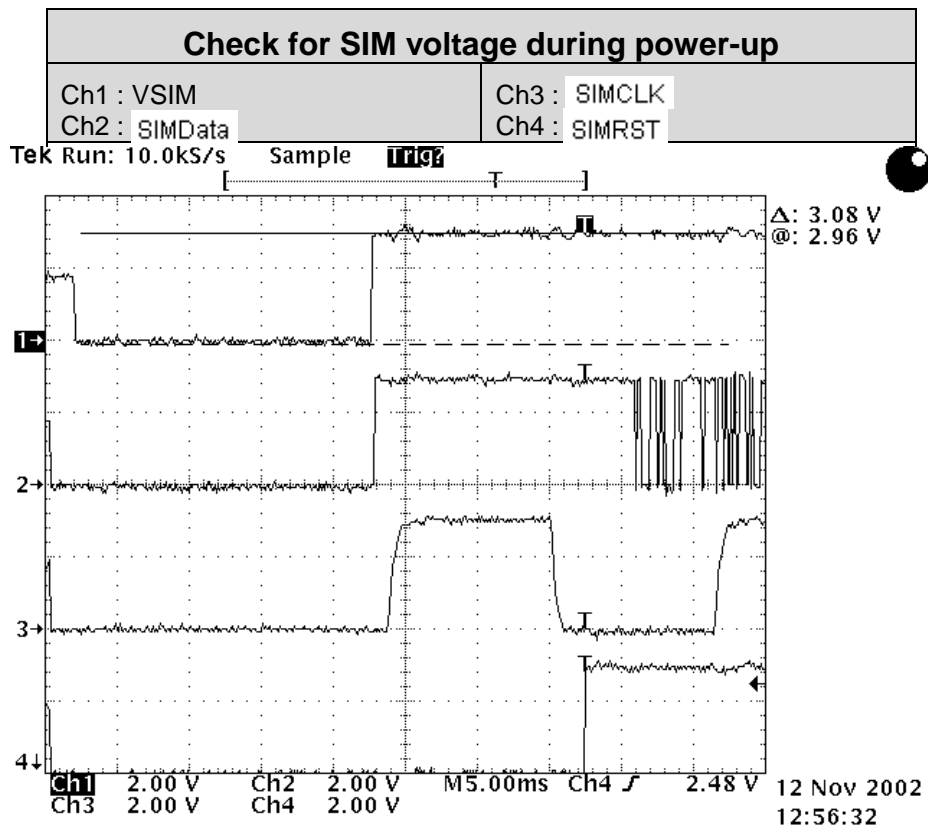
Insert SIM card fault

The hardware of the SIM interface from UEM (D200) to the SIM connector (X387) can be tested without a SIM card. When the power is switched on the phone first check for a 1.8V SIM card and then a 3V SIM card. The phone will try this four times, whereafter it will display "Insert SIM card".

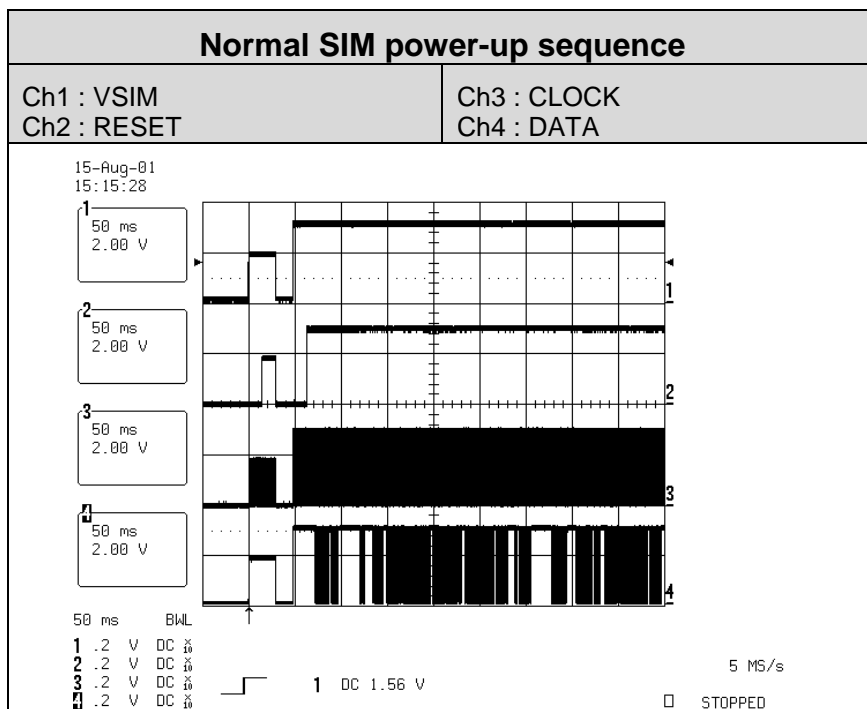
For reference a picture with normal SIM power-up is shown below.
