NHM-10 Series Transceivers

6(a) Baseband Troubleshooting

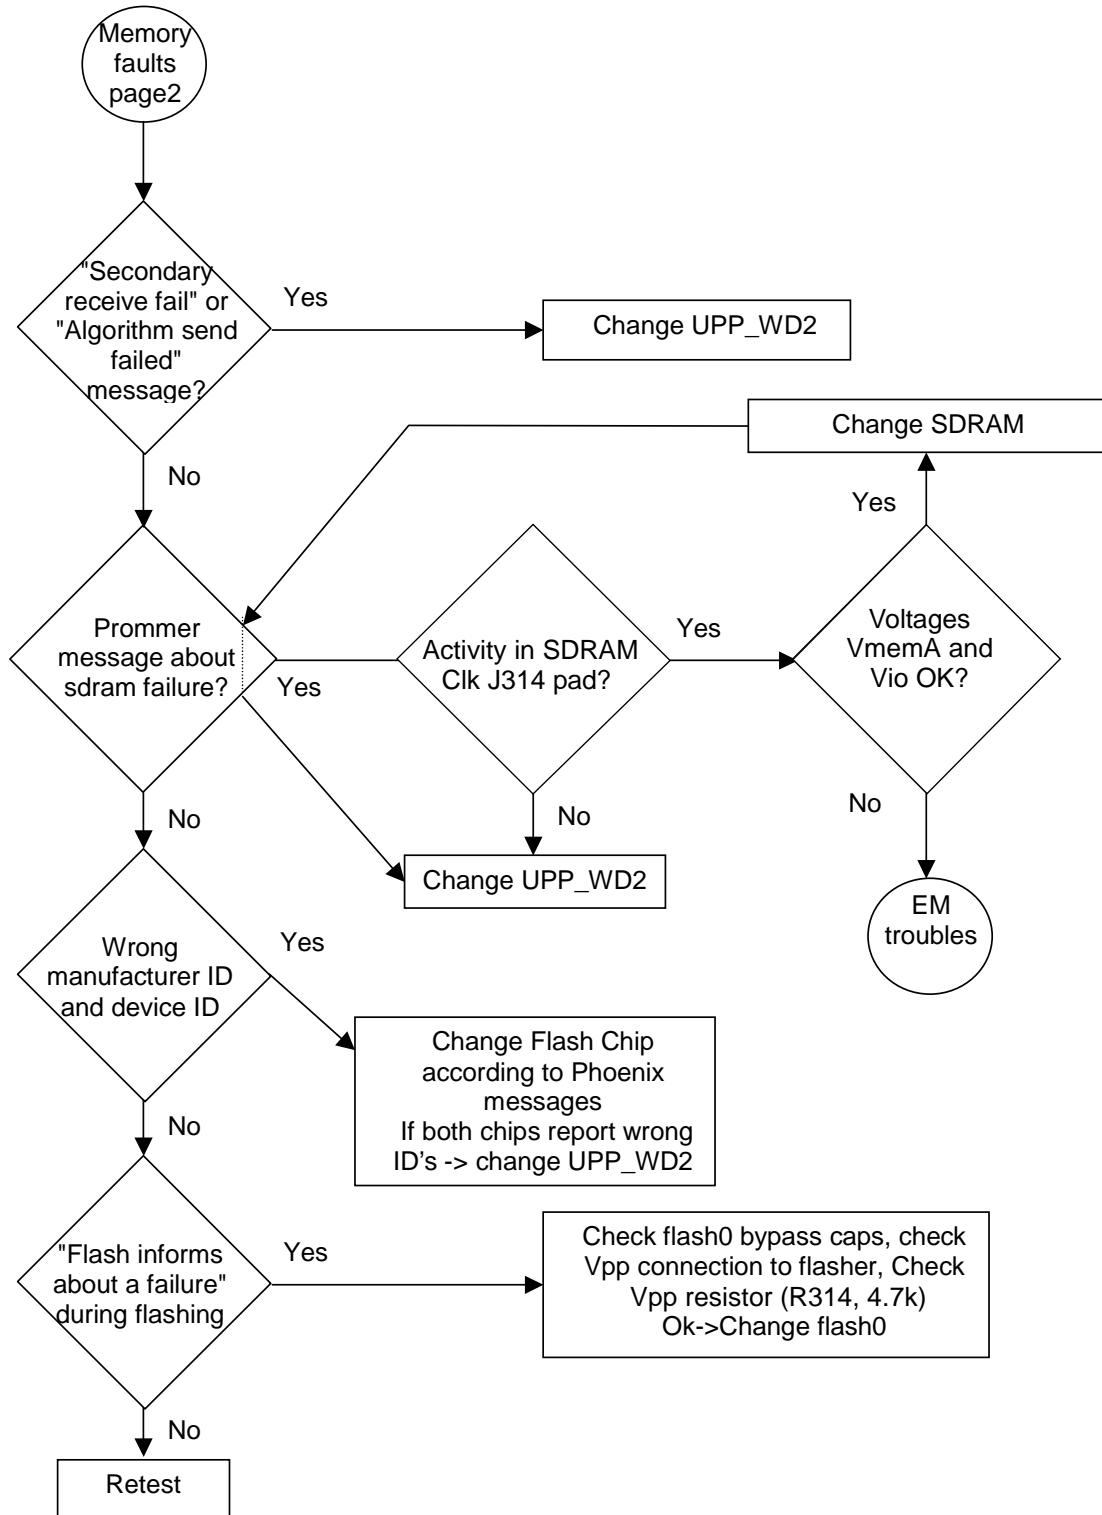
Flashing troubleshooting

NHM-10 has three memory components installed on the main pwb. The best indication of which one is causing problems can be obtained by flashing the device. It has to be kept in mind that all three flashes are interfaced with UPP WD2 asic that might it self have some problems. The necessary steps are described below. Phoenix error messages during flashing greatly help on defining what is wrong. To be able to flash the device, most device BB area components must function properly.

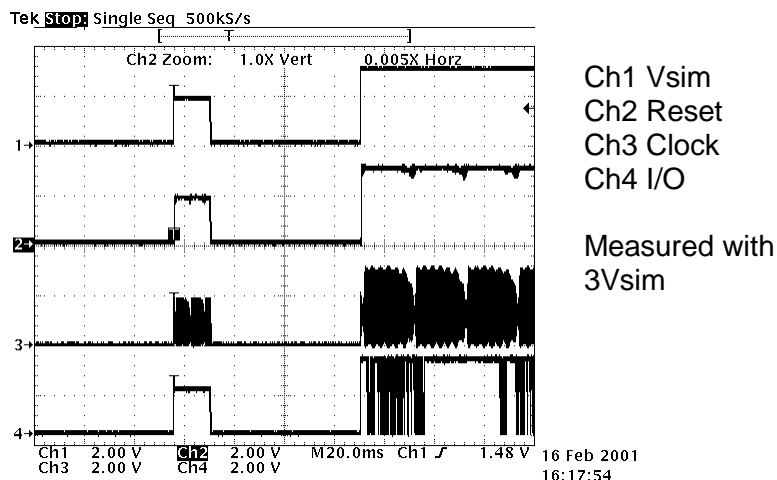
Figure 3: SIM Power Up.

The SIM power up/down sequence is generated in the UEM. This means that the UEM generates the RST signal to the SIM. Also the SIMCardDet signal is connected to UEM. The card detection is taken from the BSI signal, which detects the removal of the battery. Monitoring of the BSI signal is done by a comparator inside UEM. The threshold voltage is calculated from the battery size specifications.

The SIM interface is powered up when the SIMCardDet signal indicates "card in". This signal is derived from the BSI signal. SW tries first to power up the SIM with 1.8 V. If this doesn't succeed power up is repeated with VSIM switched to 3 V.

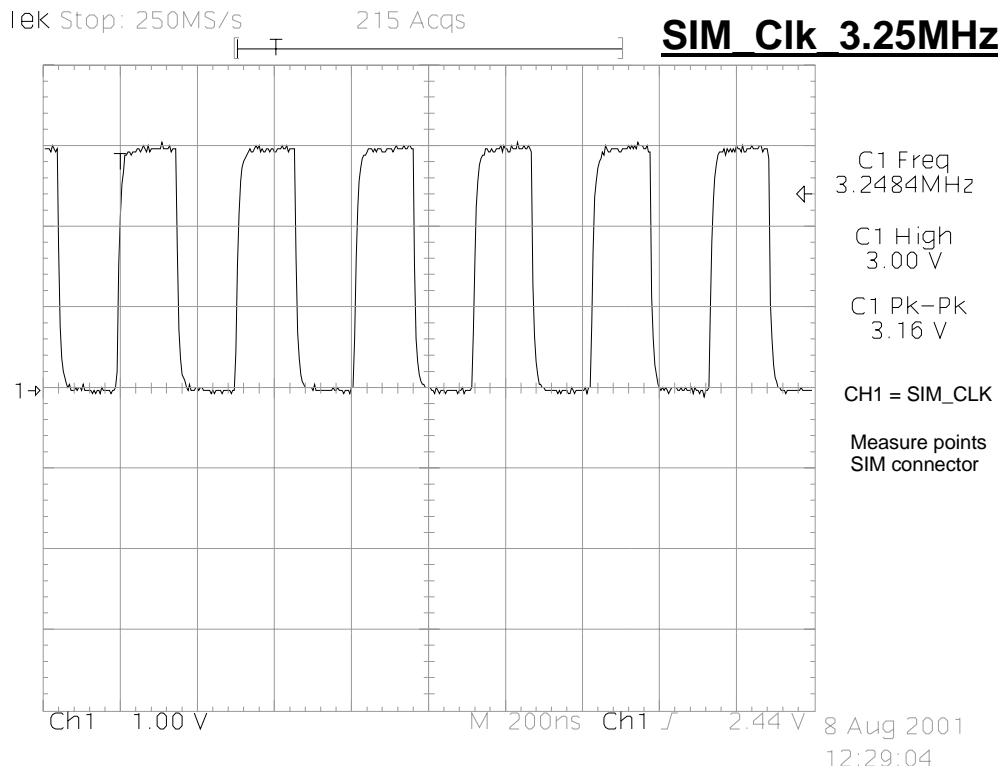
Figure 5: SIM Clk 3.25MHz.

The data communication between the card and the phone is asynchronous half duplex. The clock supplied to the card is in GSM system 1.083 MHz or 3.25 MHz. The data baudrate is SIM card clock frequency divided by 372 (by default), 64, 32 or 16.

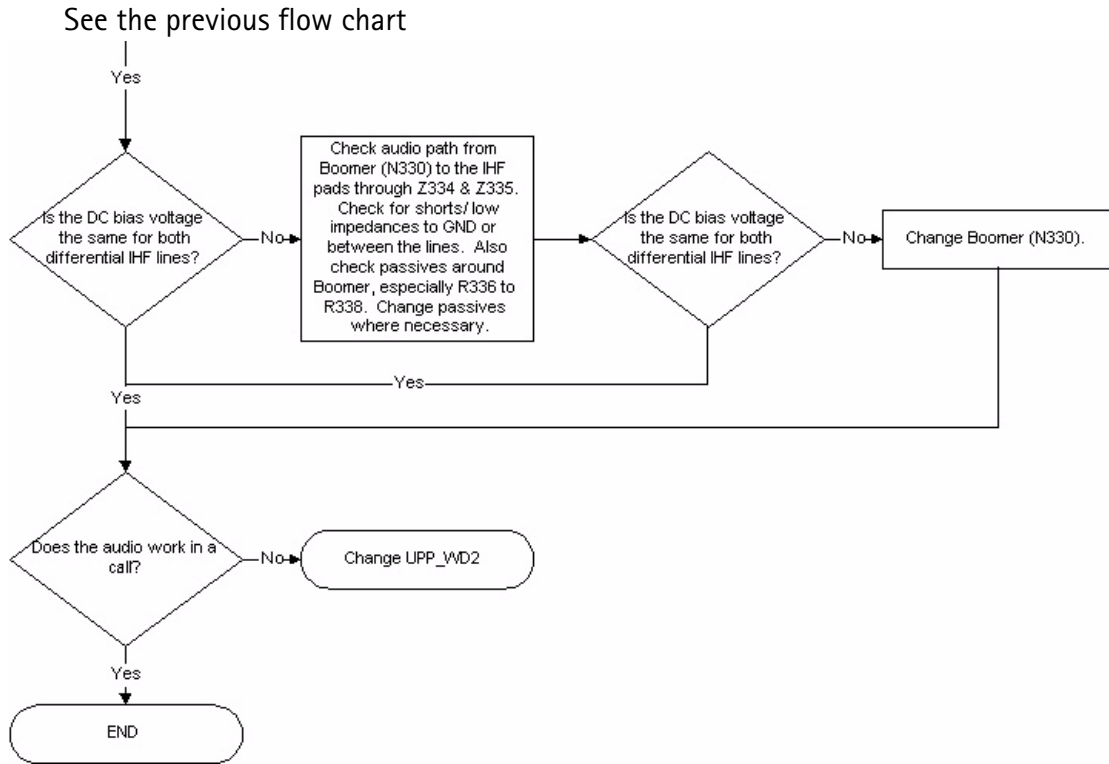
IHF

See the following flow chart

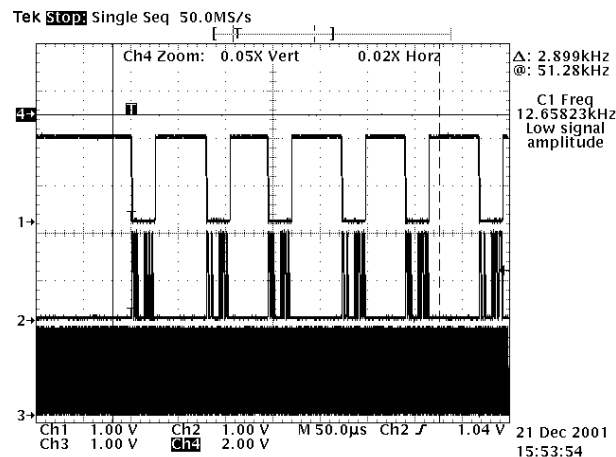
If the interface is faulty from the UPP WD2's end the phone won't boot properly as powering configurations don't work. Traffic on the bus can be monitored from three pins on the LPRF module. Pins 34, 35 and 36.

In the pictures below CBUS traffic at bootup is shown. CbusEnx is connected to Ch1, Cbus Da to Ch2 and CbusClk to Ch3.

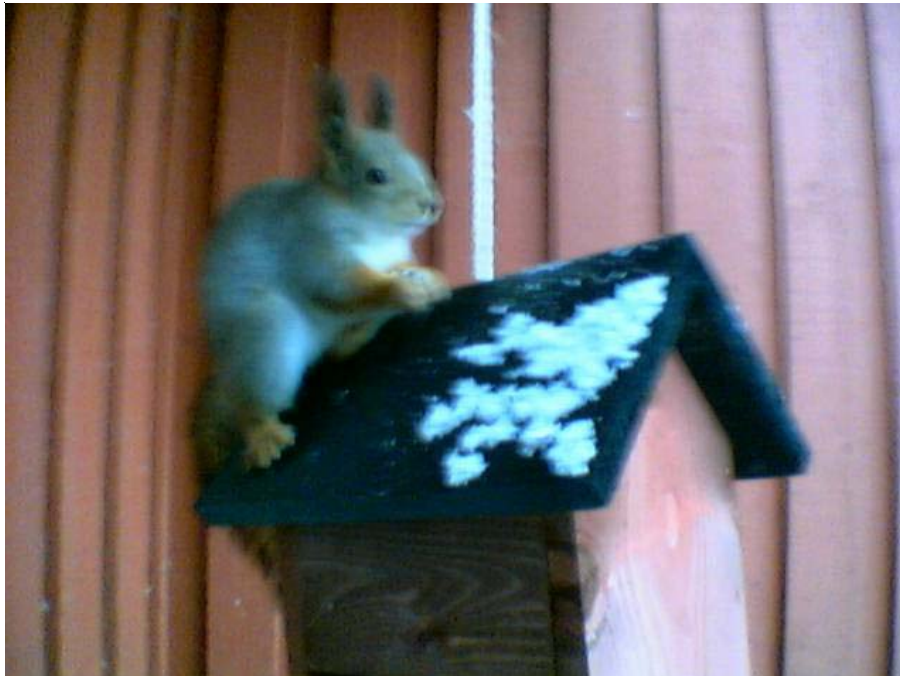
Geometrical distortion: camera lens will cause some amount of so called barrel distortion in images. In practice, this appears as bending of straight objects in edges of the image. See the following picture. Note geometrical barrel distortion in background (wall in the background).

Amount of light available: in dim conditions camera runs out of sensitivity. Exposure time is long (especially in night mode) and the risk of getting shaken images grows. Image noise level grows. The maximum exposure time in night mode is approximately 1/4 seconds, so images need to be taken with extreme care when the amount of light reflected from the target is low.

Figure 7: shaking hands caused blurring of this image. Note geometrical barrel distortion in background

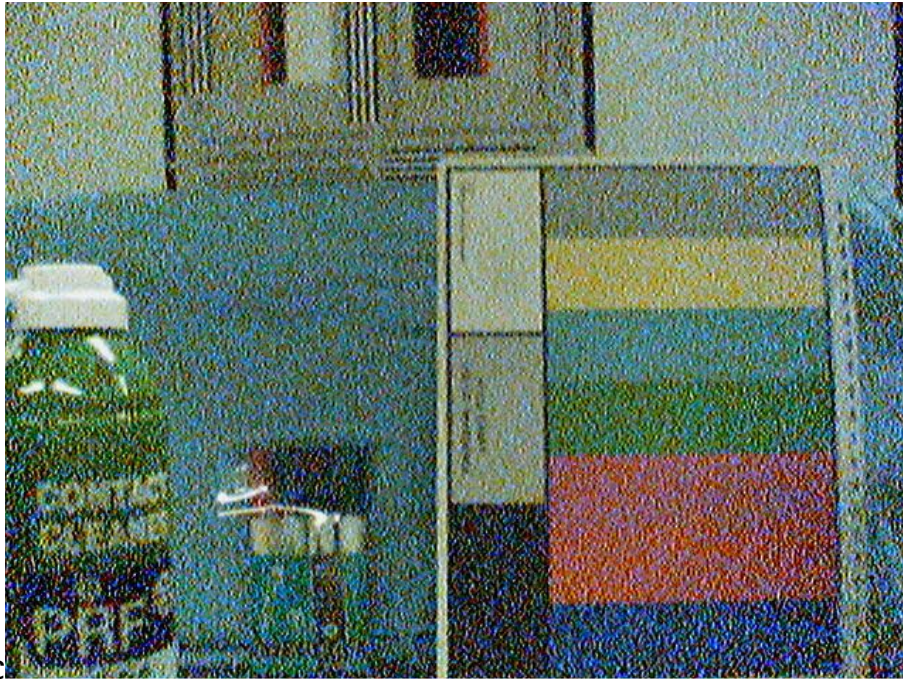
Temperature: high temperatures inside the mobile phone will cause more noise to appear in images, e.g. in +70 degrees of celsius the noise level may be very high, and it further grows if the conditions are dim. This is also normal to camera operation. (See Figure 9, "Noisy image taken in +70 deg C," on page 43)

Figure 9: Noisy image taken in +70 deg

Noise: Variation of response between pixels with same level of input illumination. See e.g. Figure 9, "Noisy image taken in +70 deg C," on page 43 for example of noisy image.

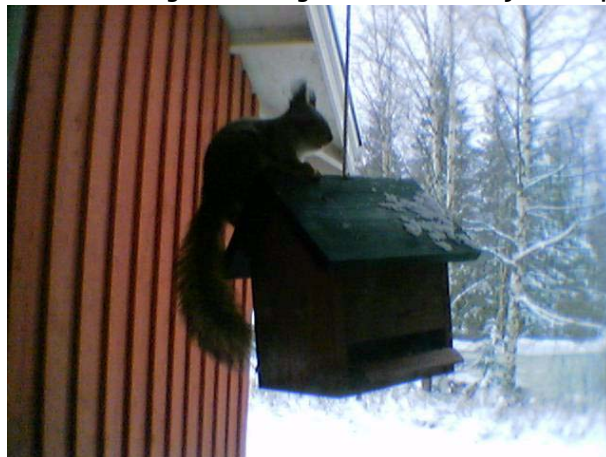
Basic rules of photography, especially shooting against light: electronic image sensors typically have much lower dynamic range than films. In practice this means that when taking a picture inside e.g. having a window behind object, will produce poor results.

Figure 10: Image which has been taken "against the light". The actual object (a squirrel) can not be seen well.

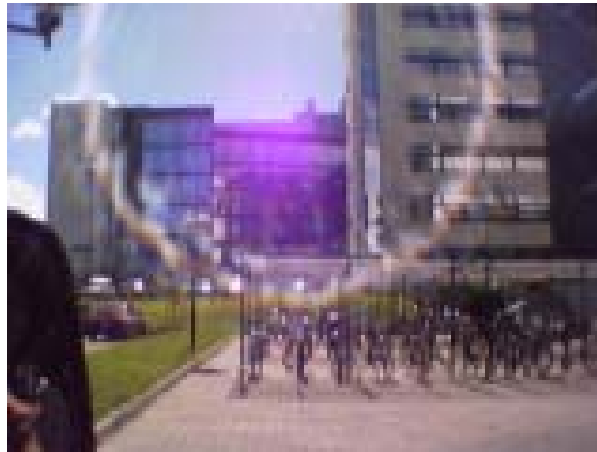
Bright light outside of image view: Especially sun can cause clearly visible 'halo' effects and poor contrast in images. This happens due to unwanted reflections inside camera optics.

Figure 12: A lens reflection effect caused by sun shining above the scene

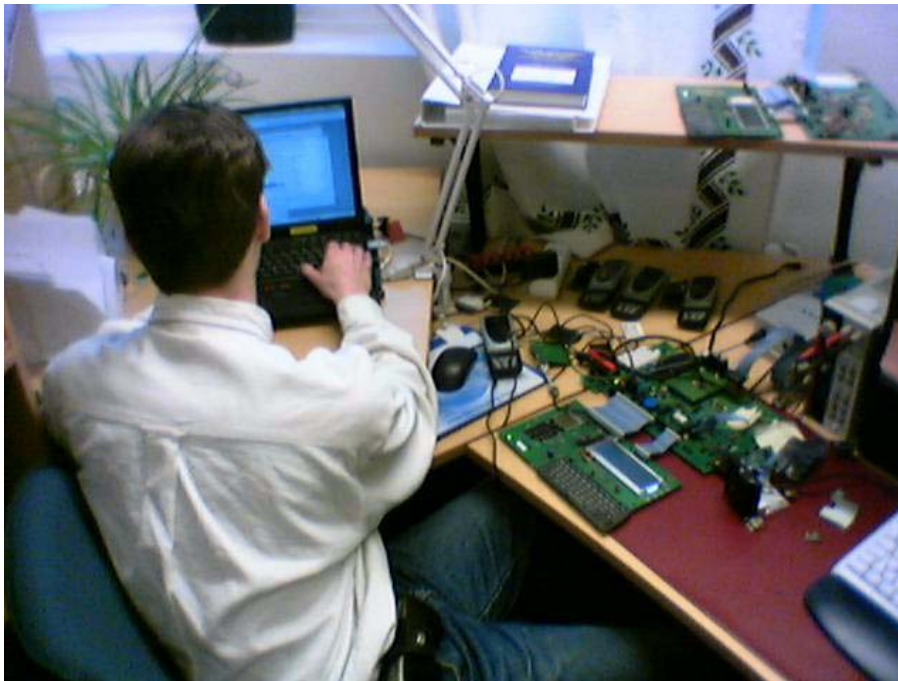
Figure 13: A good quality picture taken indoors

If no visible defects (items 2-4) can be found, a couple of test images should be taken and checked. Generally, a well illuminated typical indoor office scene, such as the one in Figure 13, "A good quality picture taken indoors," on page 45, can be used as a target. The main considerations are:
