Customer Care Solutions

NHL-8 Series Transceivers

6(a) Baseband Troubleshooting

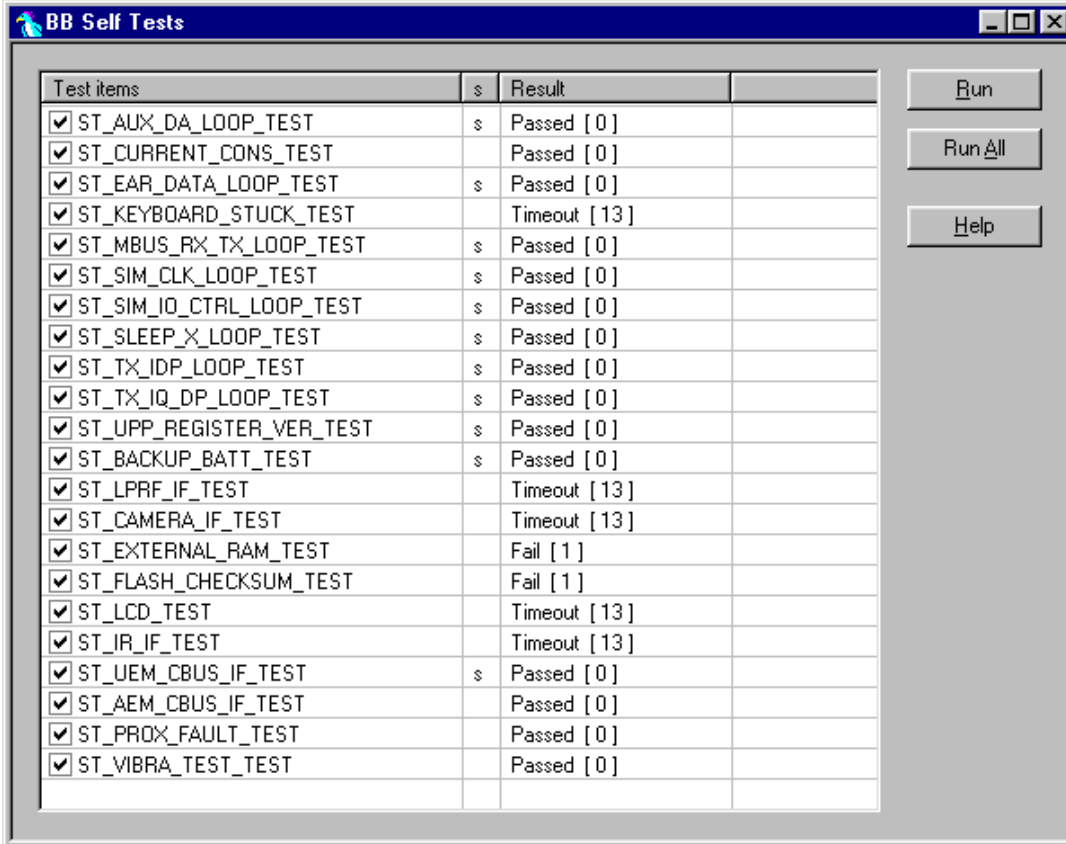
Selftest functions are executed when the phone is powered on and if one or more self-test functions fail, the message "Contact Service" is shown on the display.

MCU selftest cases can be split into two categories: The ones that are executed during power up and the ones that are executed only with a PC connected. These test and the items included are as follows:

If some selftest is failed, see relevant chapter in this troubleshooting document.

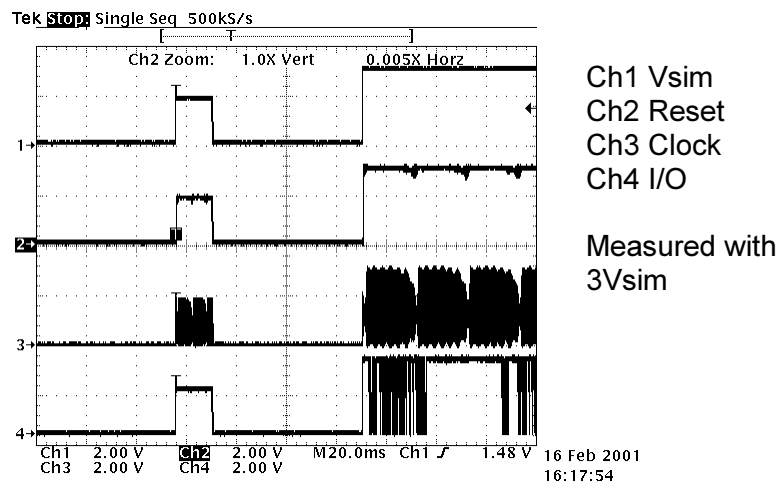
Figure 3: SIM Power Up.

The SIM interface is powered up when the SIMCardDet signal indicates "card in". This signal is derived from the BSI signal. SW tries first to power up the SIM with 1.8 V. If this doesn't succeed power up is repeated with VSIM switched to 3 V.

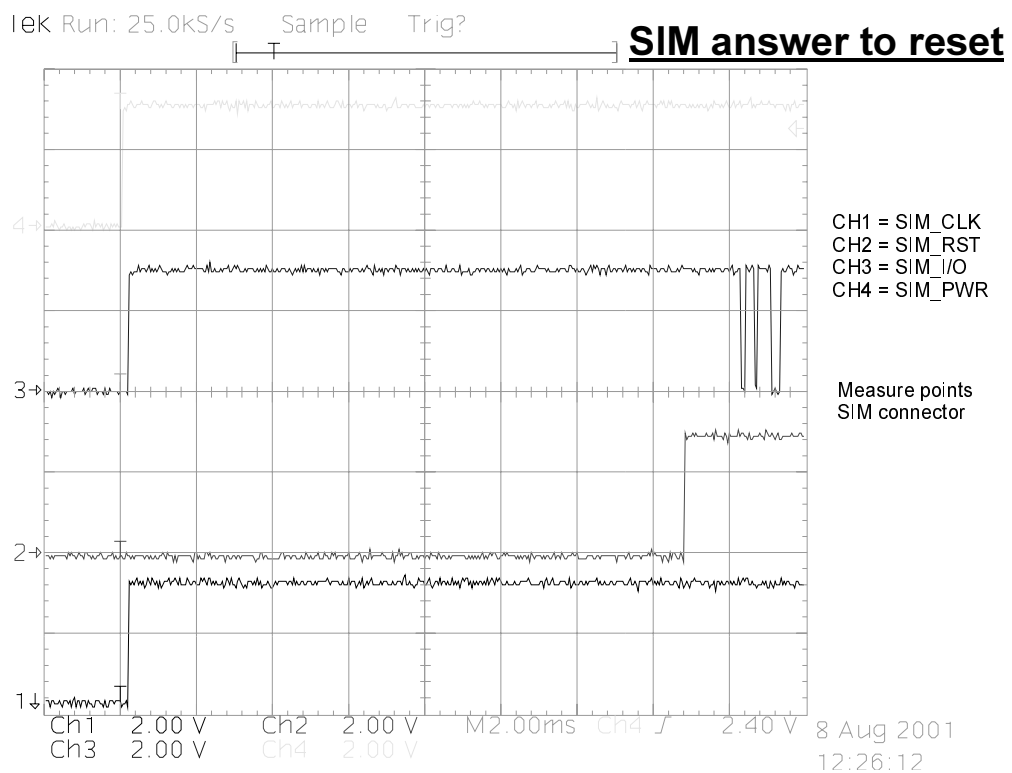
Figure 4: SIM answer to reset.

The data communication between the card and the phone is asynchronous half duplex. The clock supplied to the card is in GSM system 1.083 MHz or 3.25 MHz. The data baudrate is SIM card clock frequency divided by 372 (by default), 64, 32 or 16.

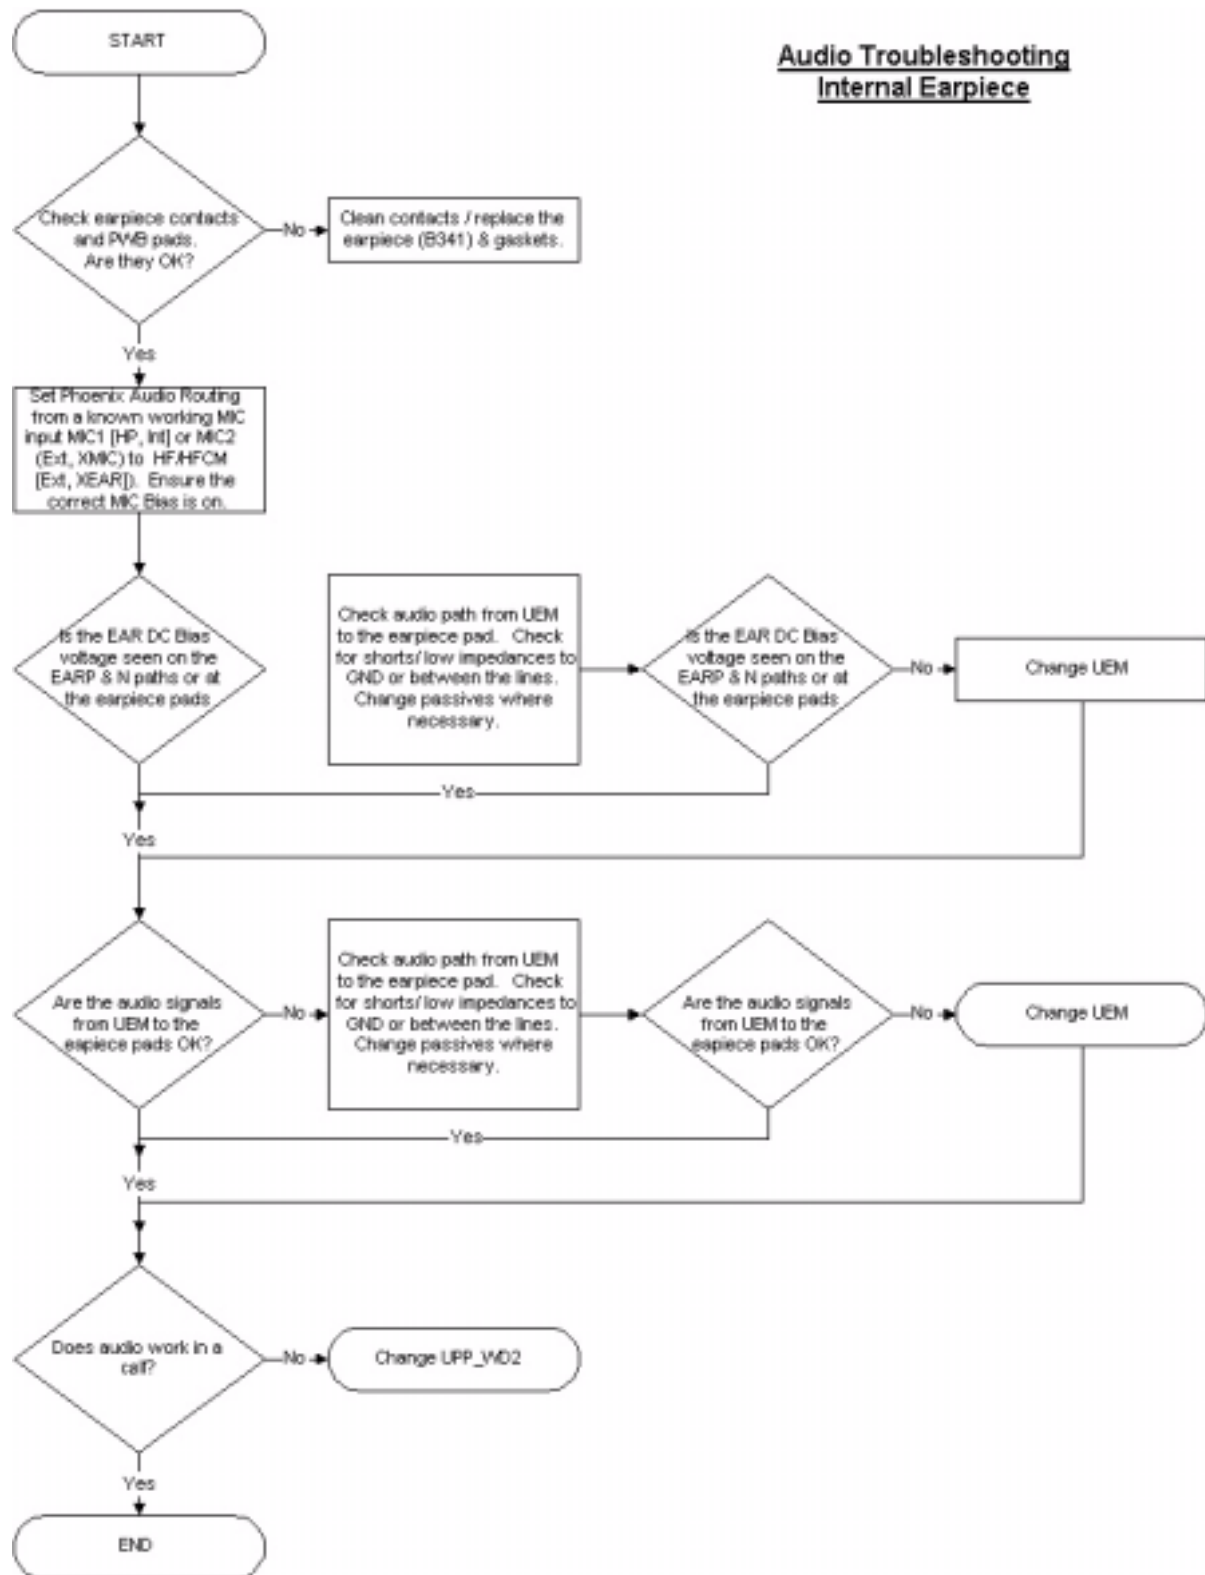
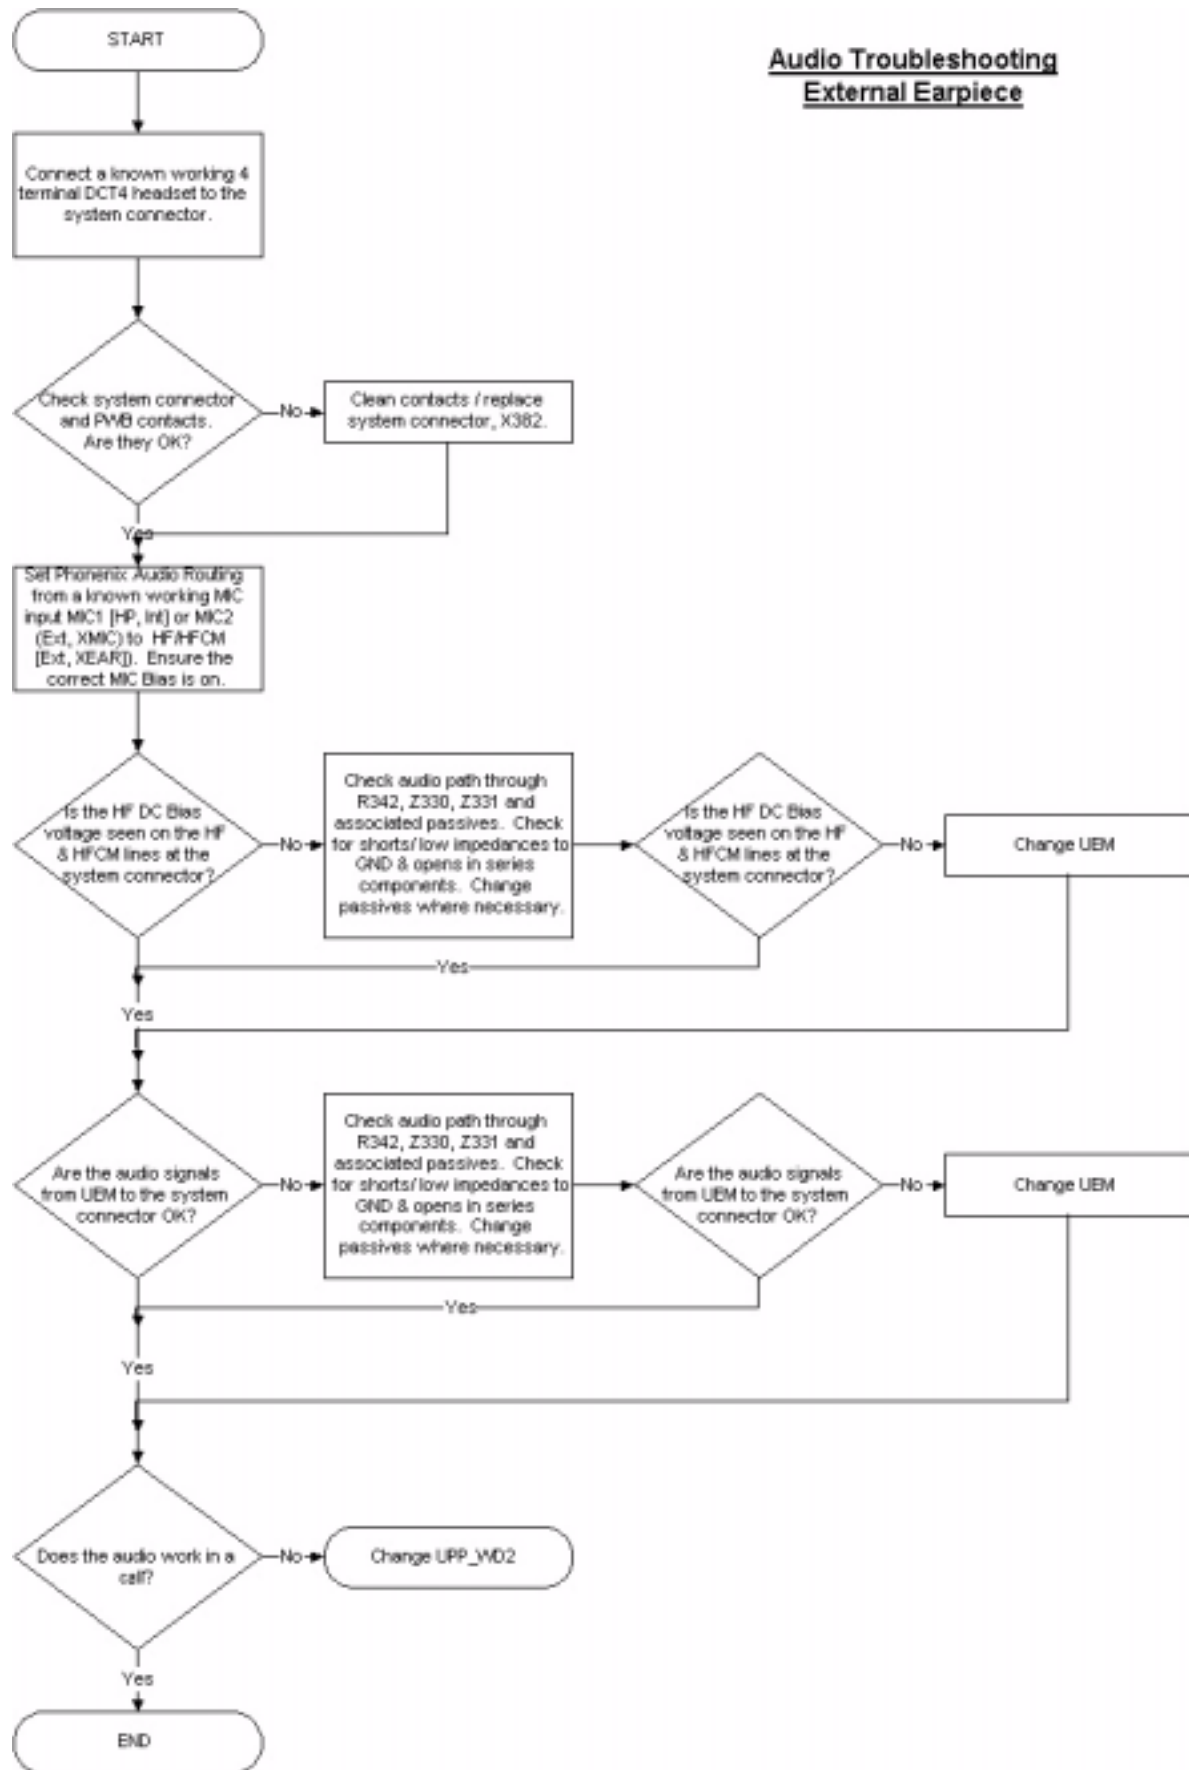
Earpiece

Check that holes are not coated.

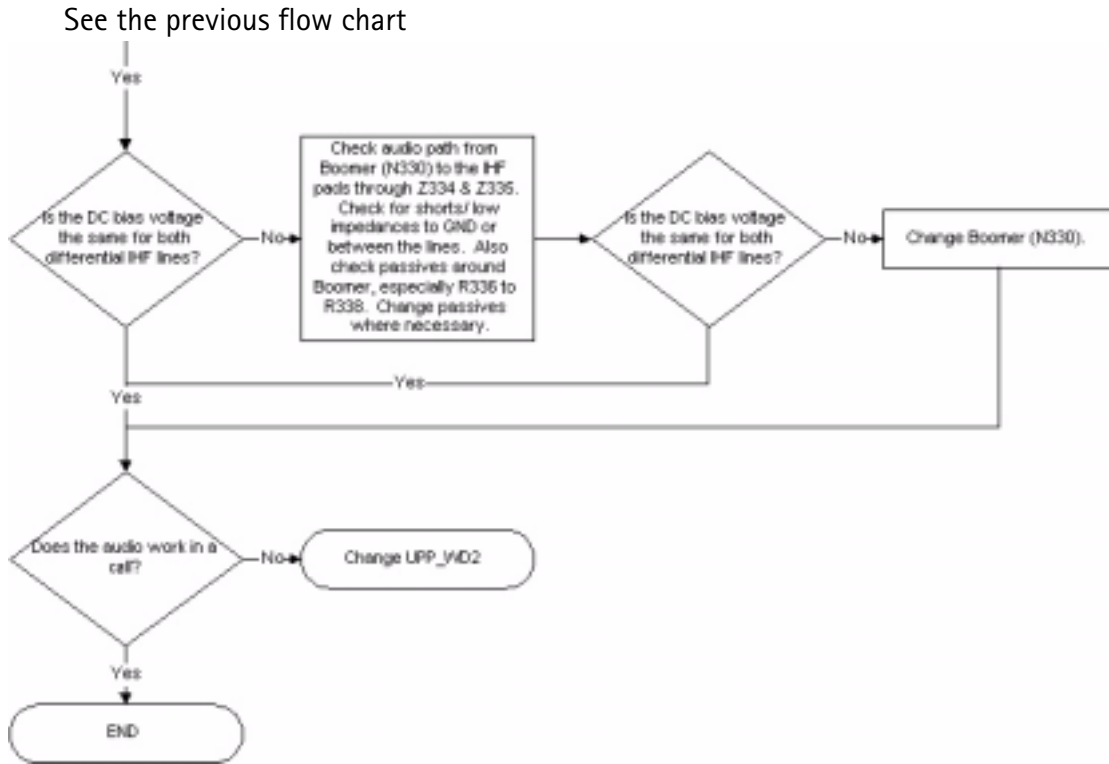
IHF

See the following flow chart

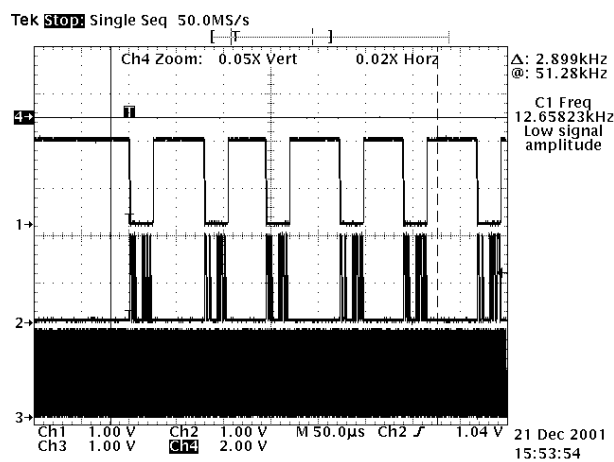
In the pictures below CBUS traffic at bootup is shown. CbusEnx is connected to Ch1, Cbus Da to Ch2 and CbusClk to Ch3.

If the interface is faulty from the UPP WD2's end the phone won't boot properly as powering configurations don't work. Traffic on the bus can be monitored from three pins on the LPRF module. Pins 34, 35 and 36.

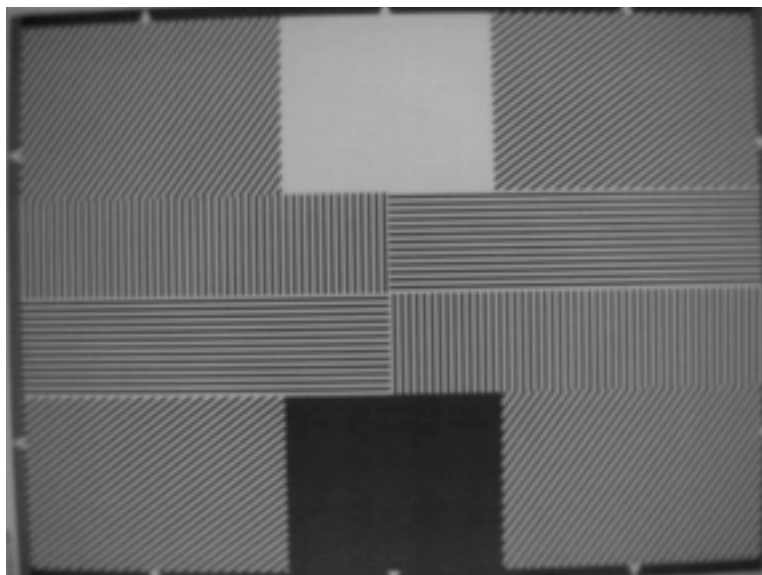
Figure 6: Sharpness of picture is worse in edges than in center

Sharpness of picture edges: lens performance degrades in image edges, and generally the image is sharpest in center part. Particularly this applies to distant objects (> 1 meter). See below.

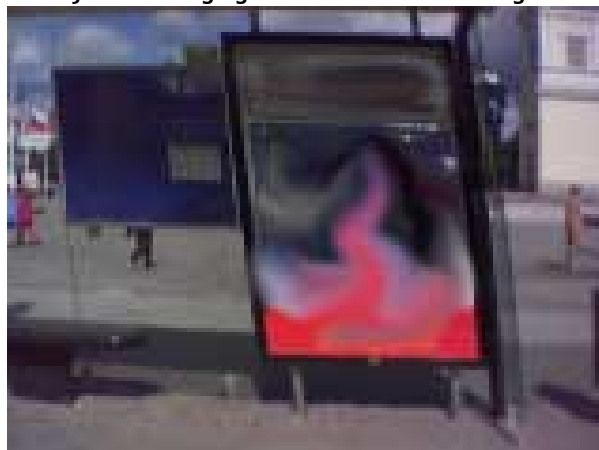
Figure 8: Near objects in image get skewed when shooting from a moving car

Movement in bright light: If pictures of moving objects are taken or if the device is used in a moving car, object 'skewing' or 'tilting' will occur. This phenomena is fundamental to most CMOS camera types and normal, and can not be helped. Movement of camera or object will usually cause blurring in inside or dim lighting conditions due to long exposure time.

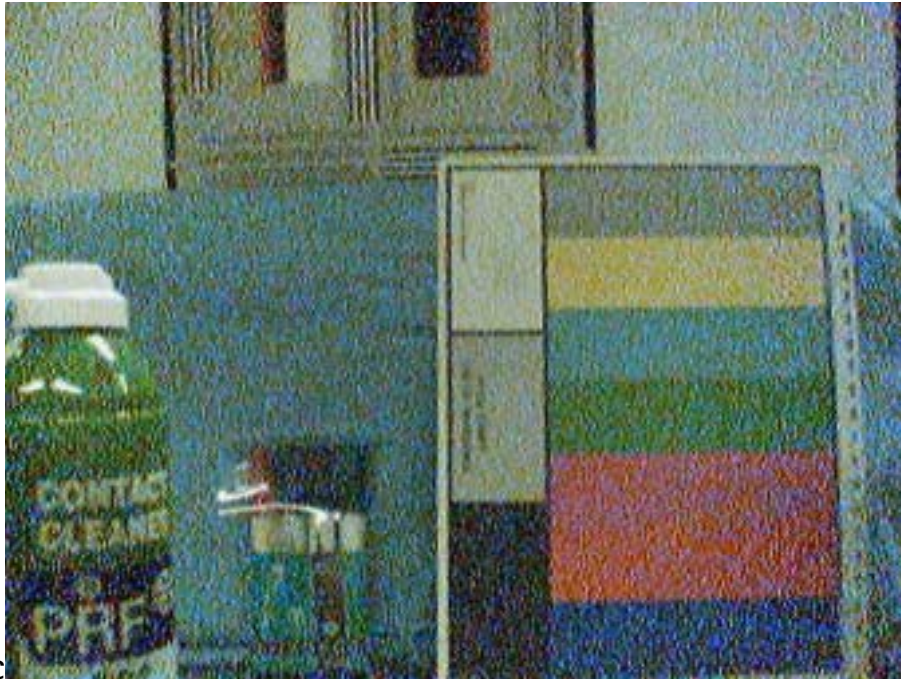
Figure 9: Noisy image taken in +70 deg

Temperature: high temperatures inside the mobile phone will cause more noise to appear in images, e.g. in +70 degrees of celsius the noise level may be very high, and it further grows if the conditions are dim. This is also normal to camera operation. (See Figure 9, "Noisy image taken in +70 deg C," on page 43)

Noise: Variation of response between pixels with same level of input illumination. See e.g. Figure 9, "Noisy image taken in +70 deg C," on page 43 for example of noisy image.

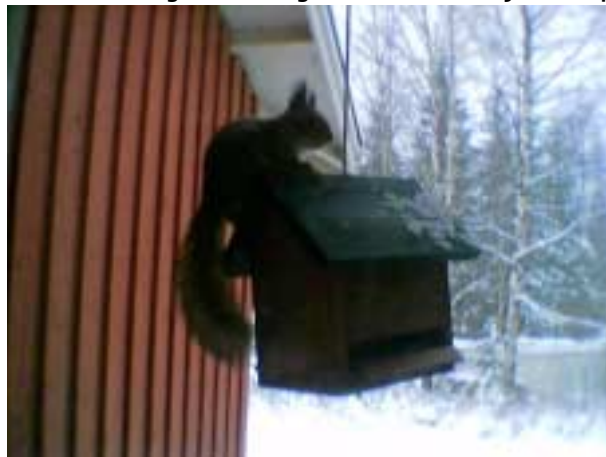
Figure 10: Image which has been taken "against the light". The actual object (a squirrel) can not be seen well.

Basic rules of photography, especially shooting against light: electronic image sensors typically have much lower dynamic range than films. In practice this means that when taking a picture inside e.g. having a window behind object, will produce poor results.

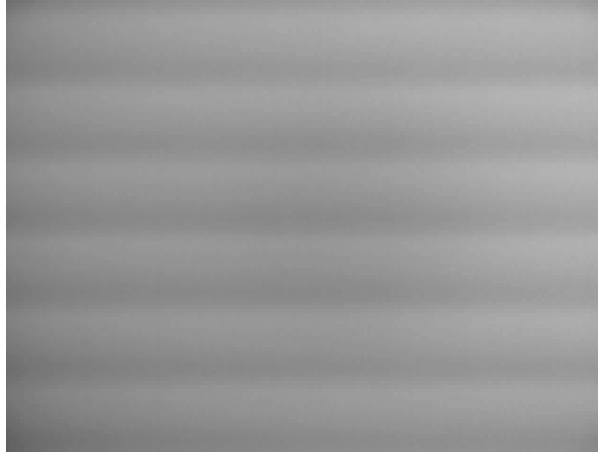
Figure 11: Flicker in image of white uniform object illuminated by strong fluorescent light

Flicker: in some rare occasions a very bright fluorescent light may cause flicker to be seen in the viewfinder image.

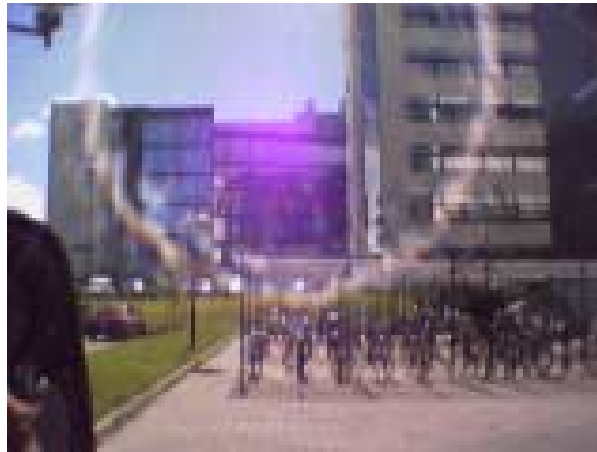
Figure 12: A lens reflection effect caused by sun shining above the scene

Bright light outside of image view: Especially sun can cause clearly visible 'halo' effects and poor contrast in images. This happens due to unwanted reflections inside camera optics.

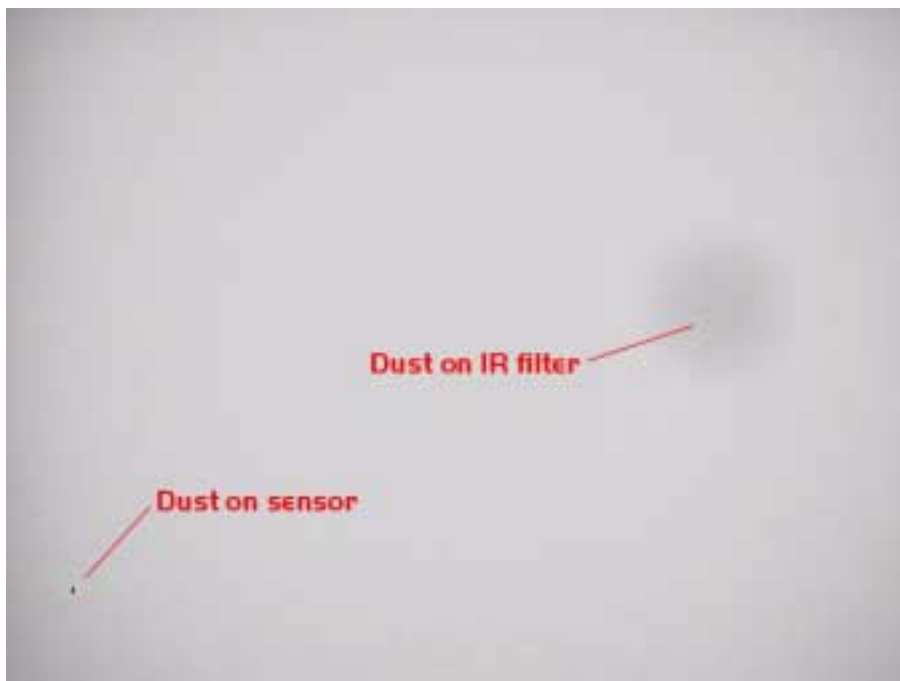
Black spots in image are caused by dirt particles trapped into the optical system: clearly visible and sharp edged black dots in image are typically dust particles on image sensor. These spots are searched for in manufacturing phase, but it is possible that the lens holder cavity contains a particle, which may move onto the image sensor active surface, e.g. when the phone is dropped. Thus it is also possible that the problem will disappear before the phone is brought to service. The camera should be replaced if it has been in some phase *verified* that the problem has been present.

If dust particles are located on infrared filter surface on either side, they are much harder to locate because they will be out of focus, and appear in image as large, grayish and fading-edge 'blobs'. Sometimes they will be very hard to find, and thus the user probably will not notice them at all since they do no harm. But it is possible that a larger particle disturbs the user, causing need for service.

For detecting this kind of problems, take an image of uniform white surface and analyze it in full resolution; search carefully – finding these defects is not always easy. Figure 10. Effects of dust in optical path is an example of image containing easily detectable dust problems.

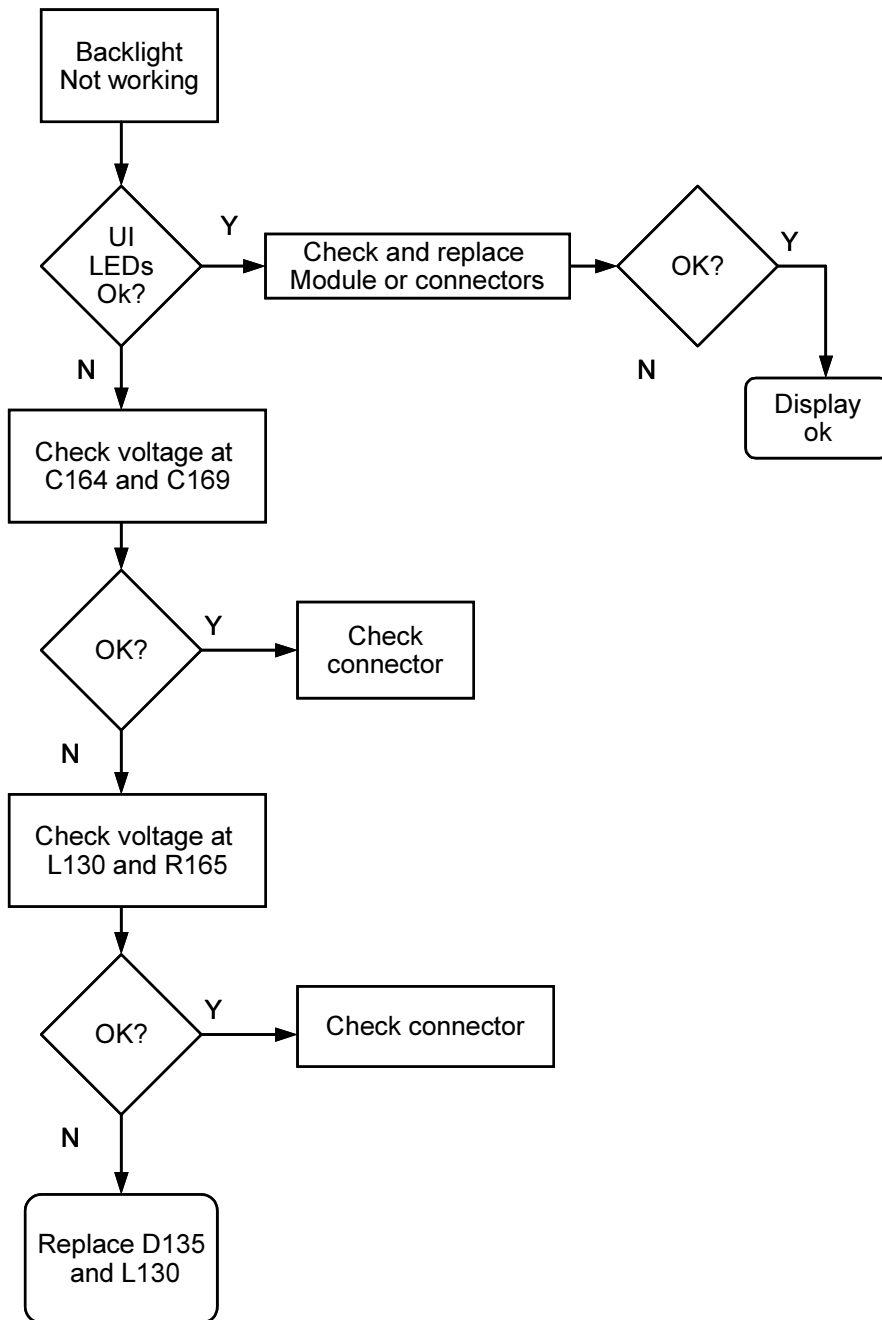
Figure 14:

Backlight does not turn on
