Programmes After Market Services NPM-5 Series Phones

Troubleshooting

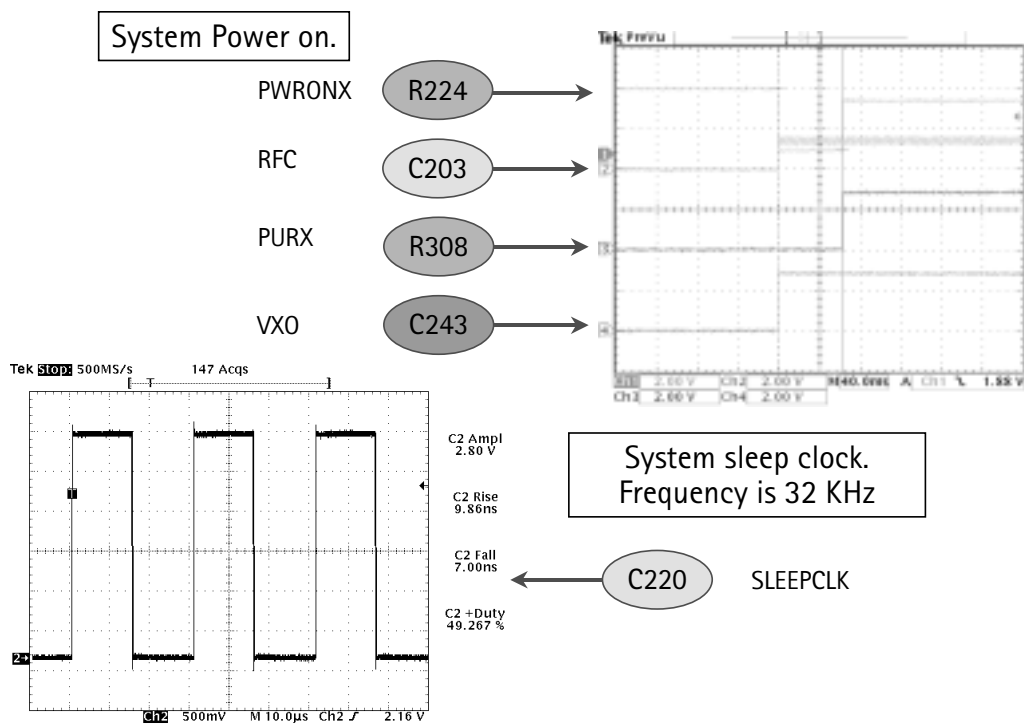
Figure 3: Power test points

Power Schematic - Plots

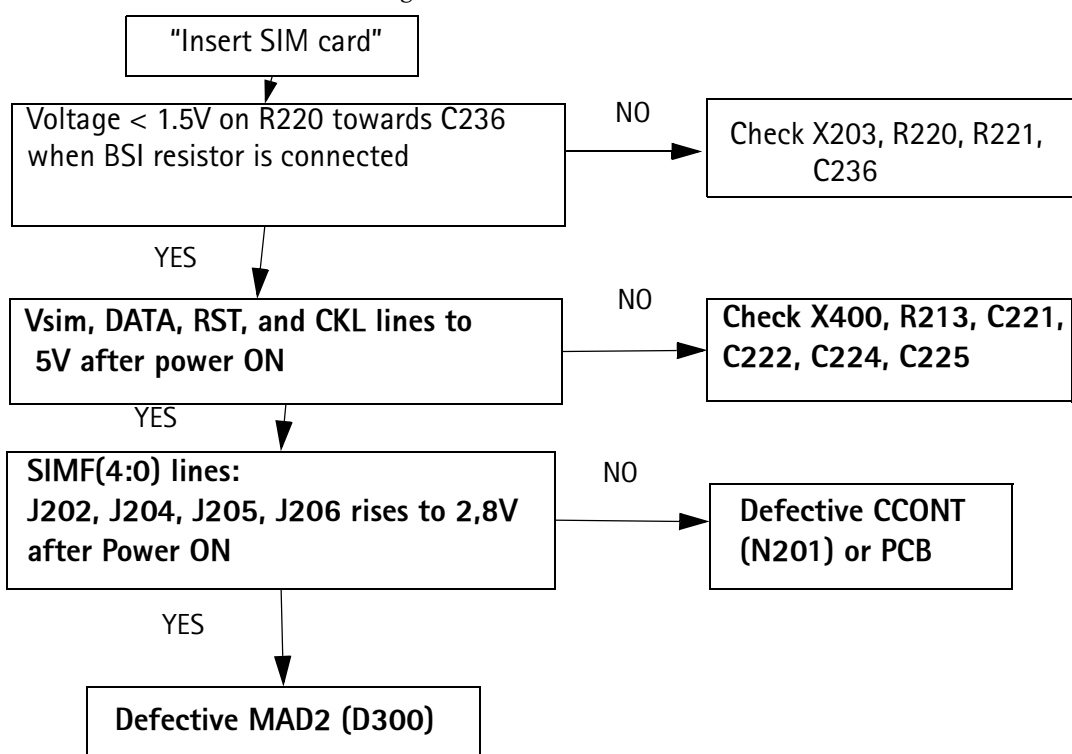
Figure 12: SIM error 1

The SIM interface from the MAD2WD1 (D300) to the SIM connector (X400) can be tested without a SIM card. When the power is switched on and the BSI terminal is grounded by a resistor, all interface lines (VSIM, DATA_A, SIMRST_A, SIMCLK) rises, first to 3V the to 5V. This is repeated four times. In this way it is possible to find errors in the SIM interface without a SIM card.

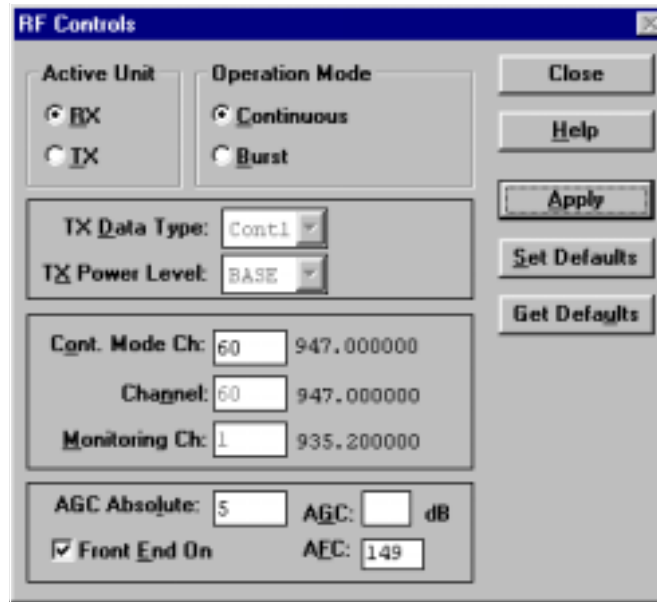
Figure 22: RF Controls window

Connect the phone to a PC with the module repair jig.

Cont. Mode Ch: 60Alt+o, 60

AGC Absolute: 5

The set-up should now look like this:

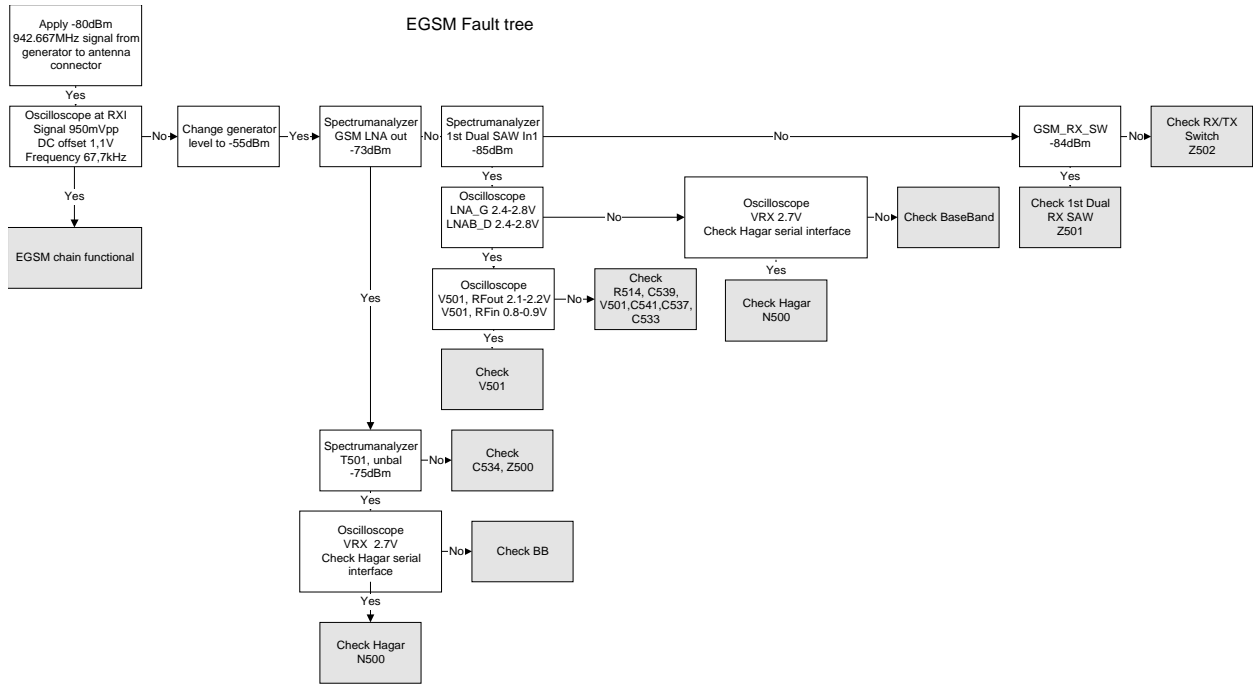
Figure 23: EGSM Fault tree

10. Troubleshooting chart for GSM900 receiver

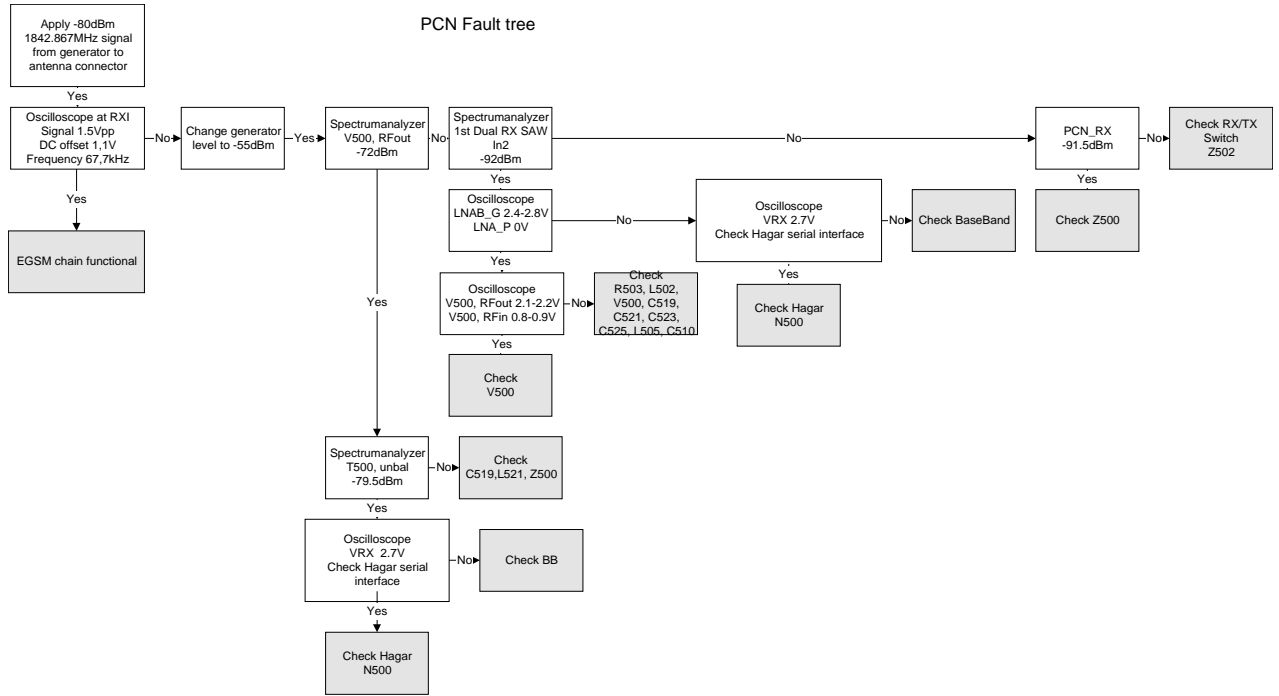
Figure 26: PCN fault tree

11. Troubleshooting chart for GSM1800 receiver

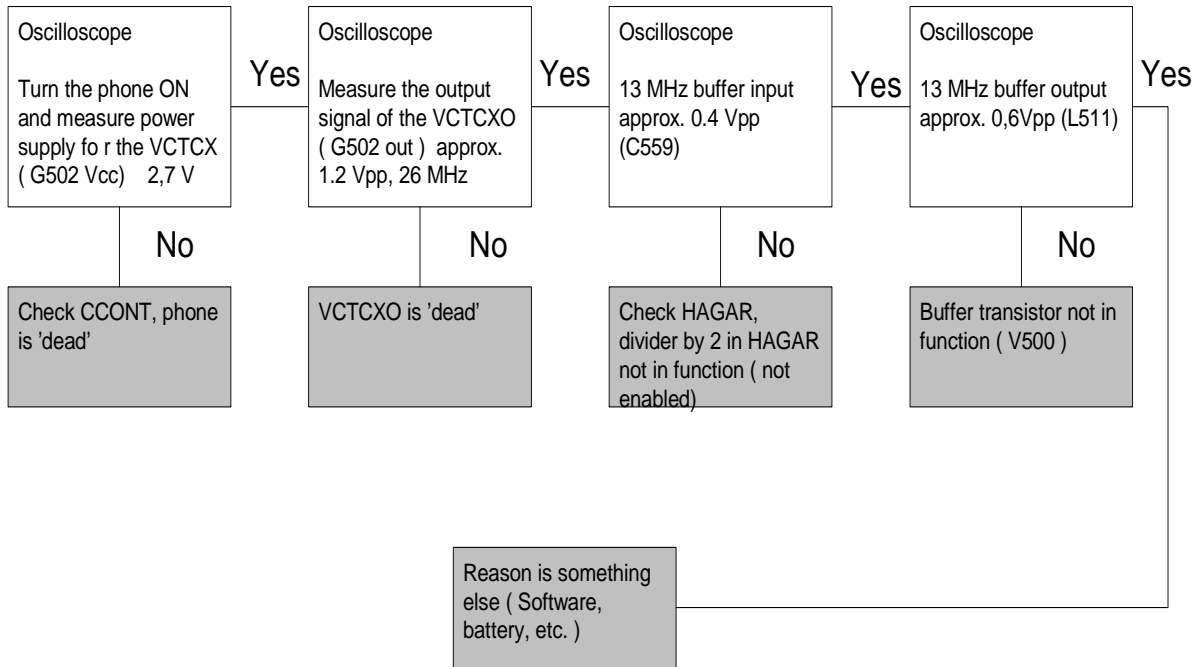
Figure 42: PLL synthesizer troubleshooting 2

If the phone goes 'dead' very short time after the power is turned ON, possible reason for this might be that 13 MHz system clock signal is not coming to the BB. Use the following chart (Figure 42, "PLL synthesizer troubleshooting 2," on page 49) to locate the problem.

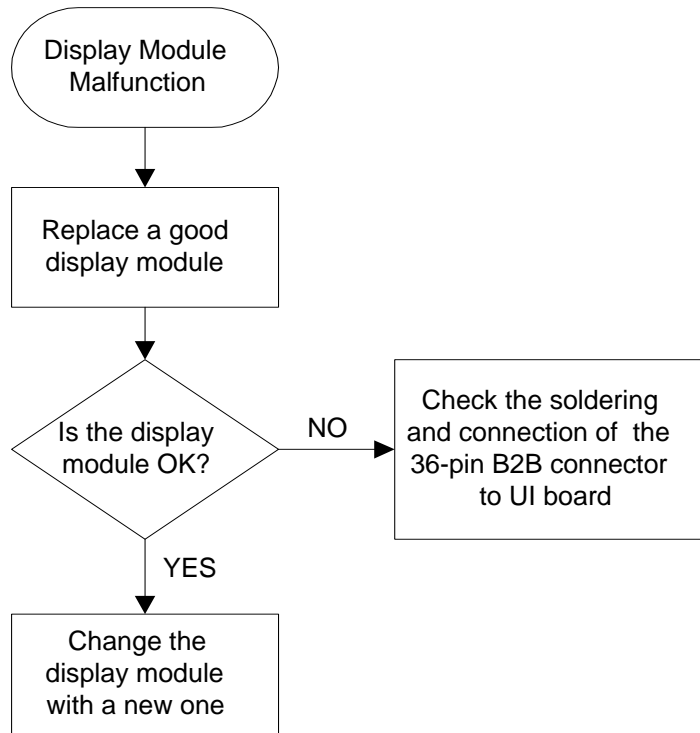
Figure 52: Display Module - No Display,

16. Display module malfunction

- Replace a good display module and verify.
- Visual inspection of the 36-pin B2B connector.

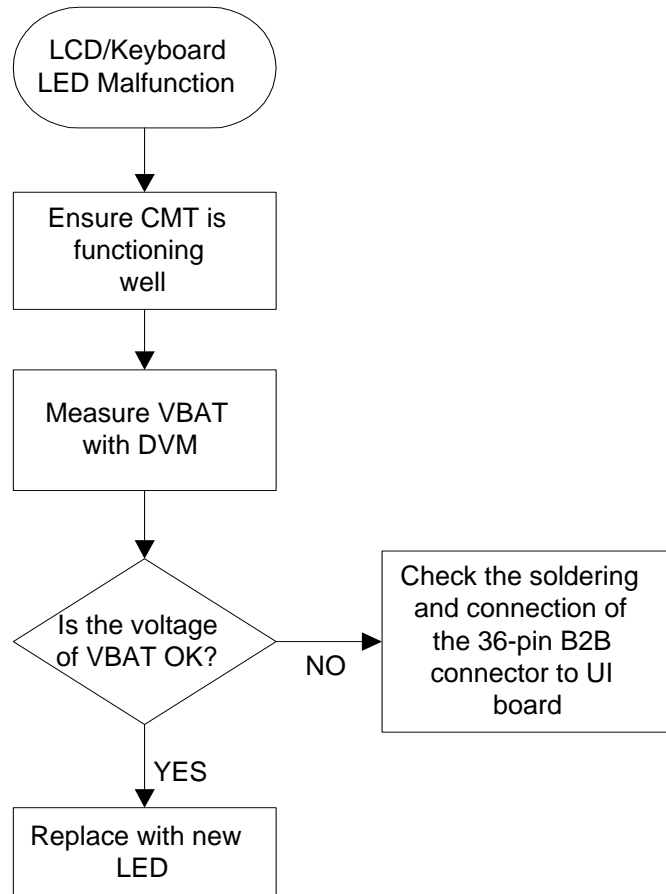
Figure 53: LCD/Keyboard LED - No Light

17. No backlight in LCD or keyboard

- Check VBAT with DVM
- Replace failed LED
- Visual inspection of the 36-pin B2B connector.

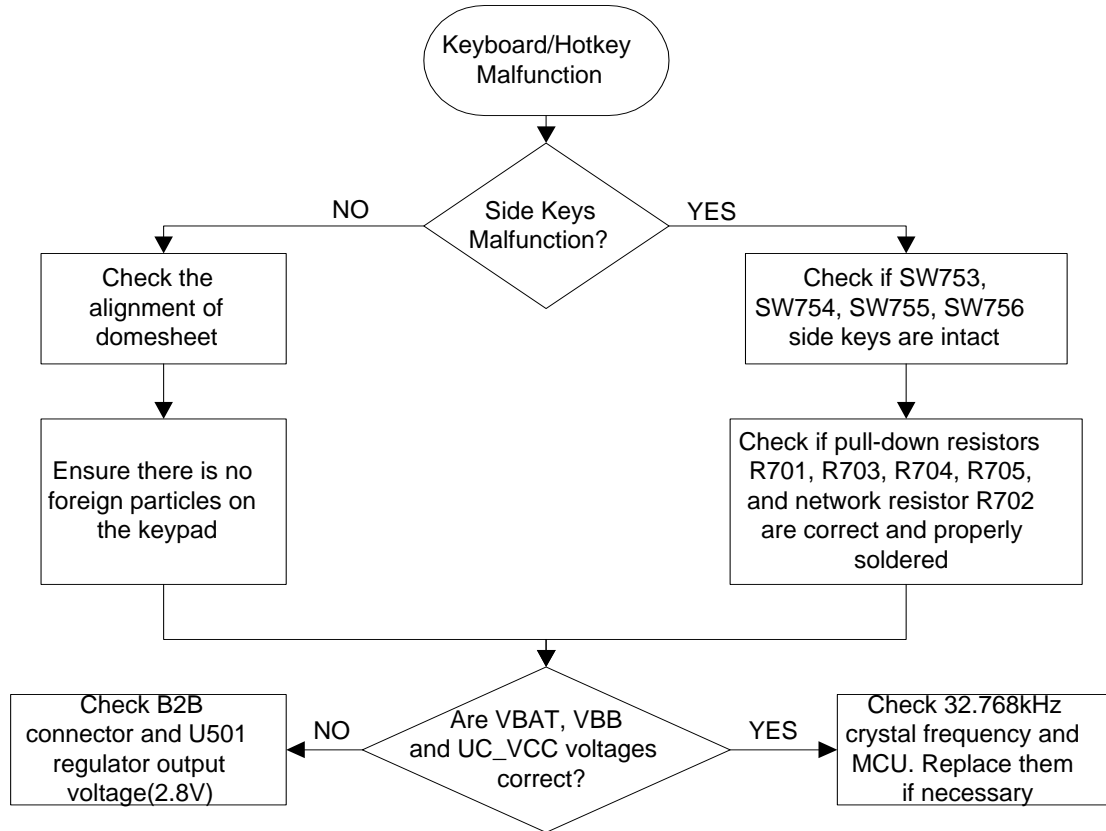
Figure 54: Keyboard/Hotkey do not respond

18. Keyboard or hot keys do not respond

All the keys including the four hot keys are controlled by the MCU. The following failures may disable fully or partially keyboard functions.

- Check pull-down resistors R701, R703, R704, R705, and network resistor R702.
- Check presence of clock frequency 32.768kHz @ U301-Pin9 using oscilloscope (Figure 47, “MCU Clock Waveform – 32.768kHz,” on page 74).
- Check PURX @U301-Pin58 = 2.8V

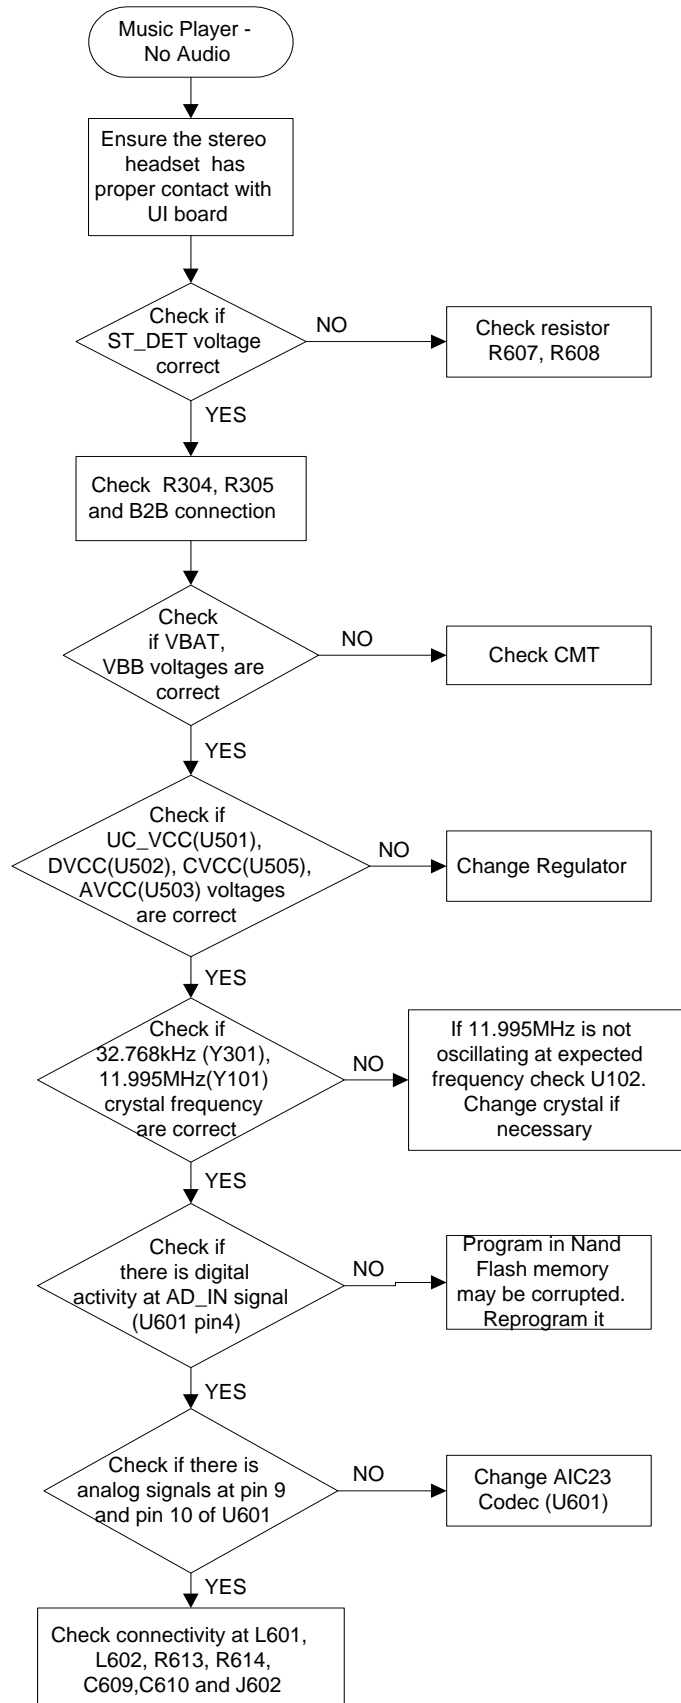
Figure 55: Music player - no audio

19. No audio in Music Player

These main devices are to be in good condition for the music player to function properly:

- Check present of clock frequency 32.768kHz @ U301-Pin9 using oscilloscope (Figure 47, “MCU Clock Waveform – 32.768kHz,” on page 74).
- Check present of clock frequency 11.9952MHz @ U101-Pin97 and U601-Pin25 (Figure 48, “DSP Clock Waveform – 11.9952MHz,” on page 75).

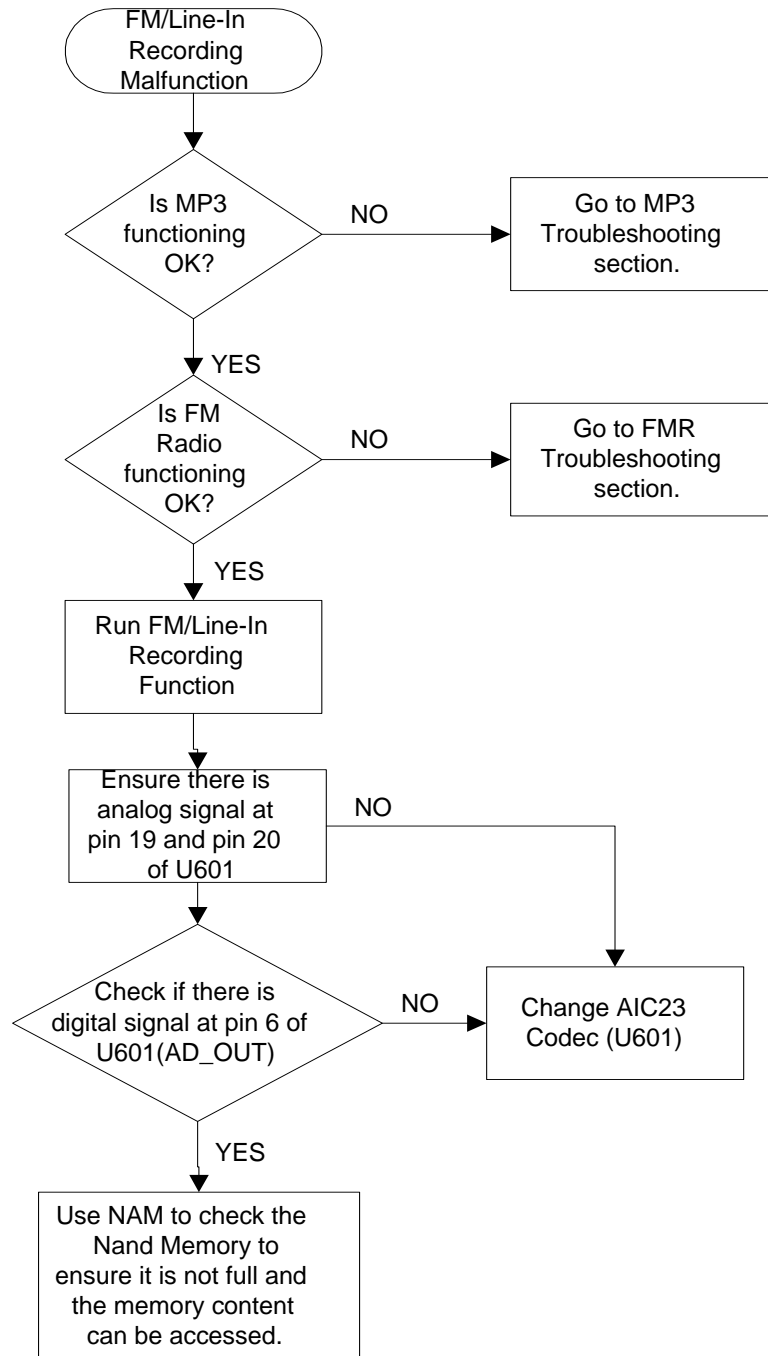
Figure 57: FM recording not possible

21. FM recording not possible

NPM-5 is capable of recording from "live" FM station. These main devices are to be in good condition for the music player to function properly:

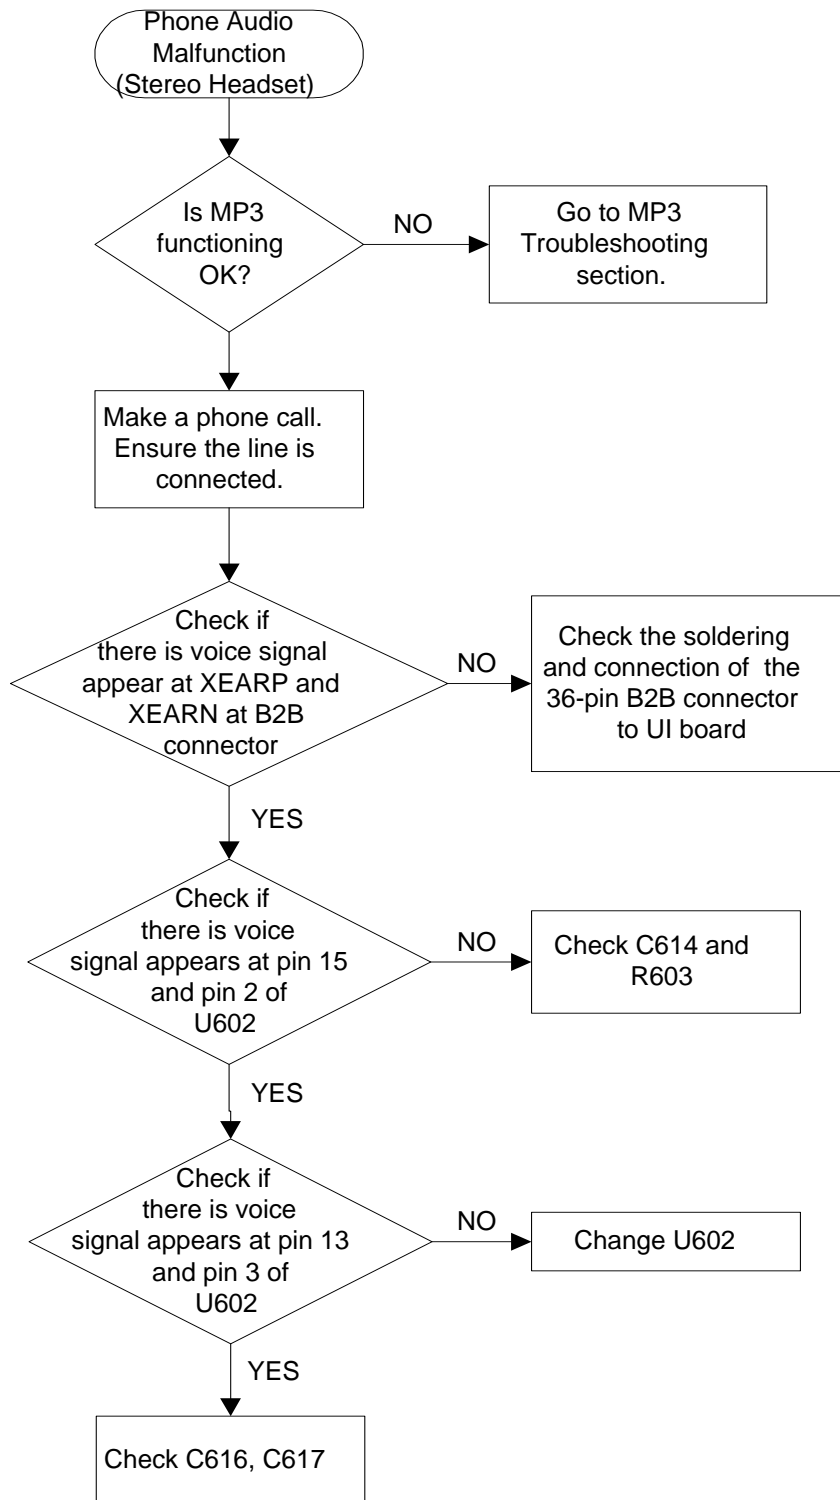
Figure 58: Stereo audio malfunction

22. Stereo audio malfunction

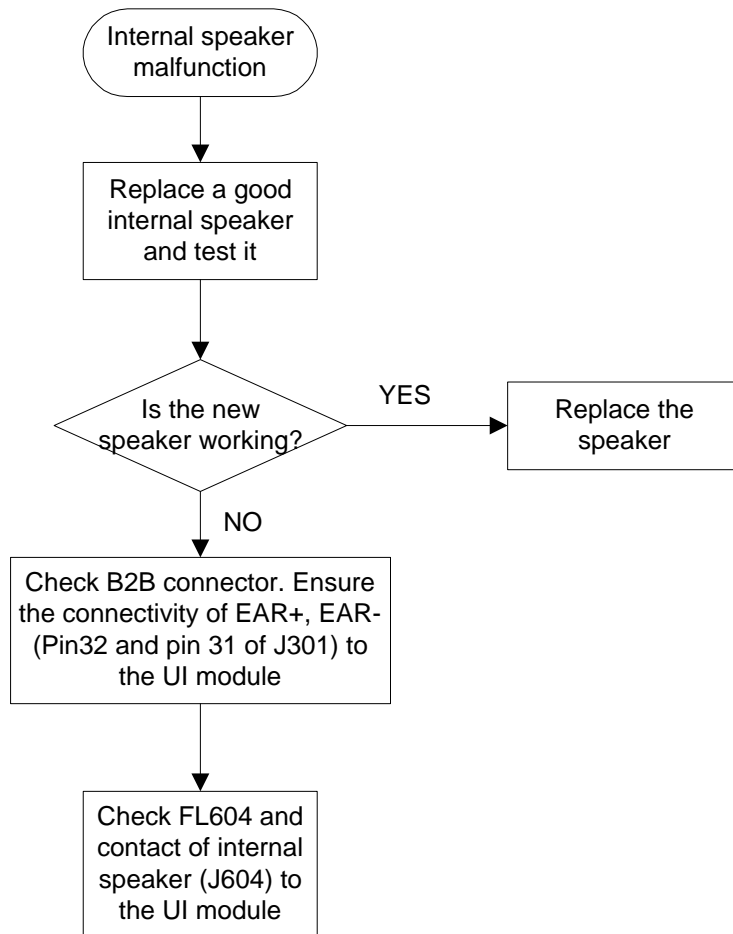
Figure 61: Phone speaker malfunction

25. Phone speaker malfunction

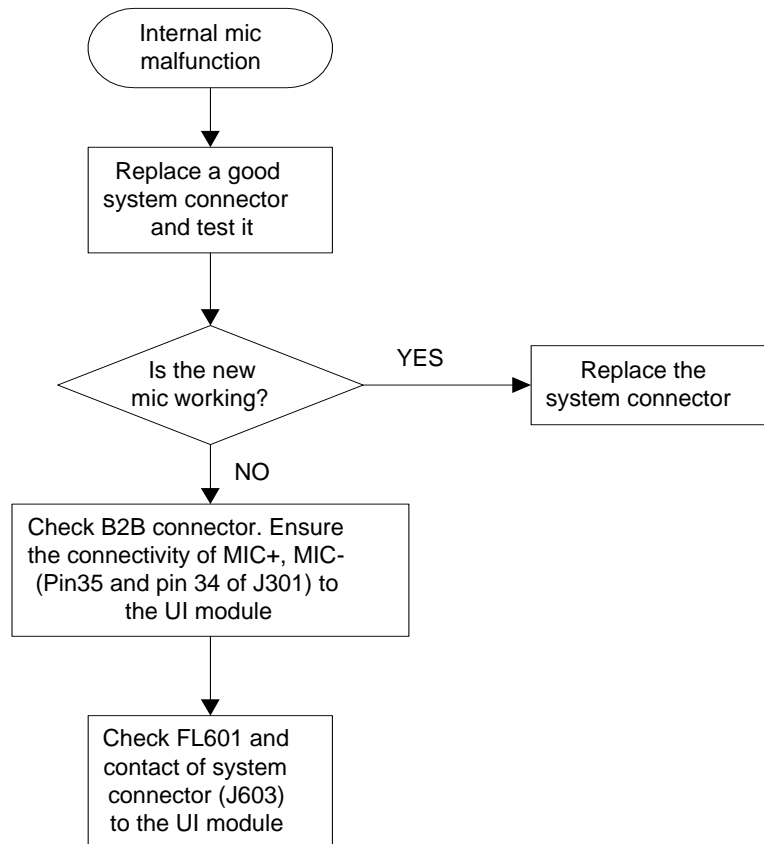
Figure 62: Phone microphone malfunction

26. Phone microphone malfunction
