**Nokia Customer Care
RH-27 Series Transceivers**

Troubleshooting – RF (Part 2)

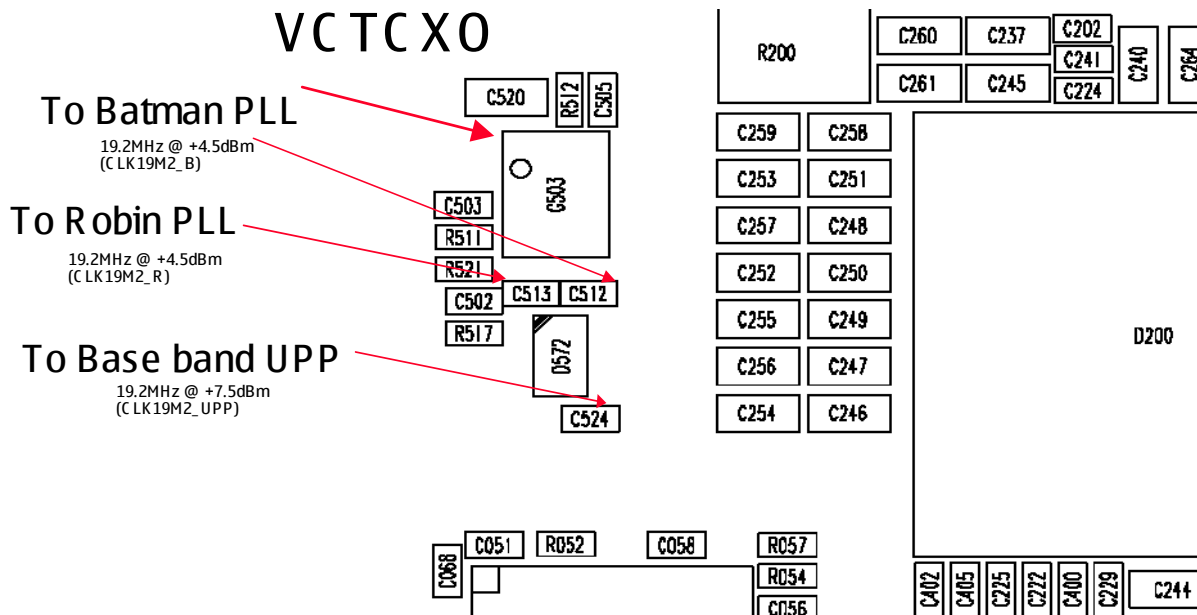
Check for the presence of the signal at the following points (use a high-impedance RF probe):

- CLK19M2_B, clock reference to Batman, should be +4.5dBm
- CLK19M2_R, clock reference to Robin, should be +4.5dBm
- CLK19M2_UPP, clock reference to UPP, should be +7.5dBm

(See the following figure for details)

- VR3, main supply line for VCTCXO circuitry, should be 2.78VDC
- VIO, supply line for buffer amplifier, should be 1.8VDC

VR3 = 2.78VDC

VIO = 1.8VDC

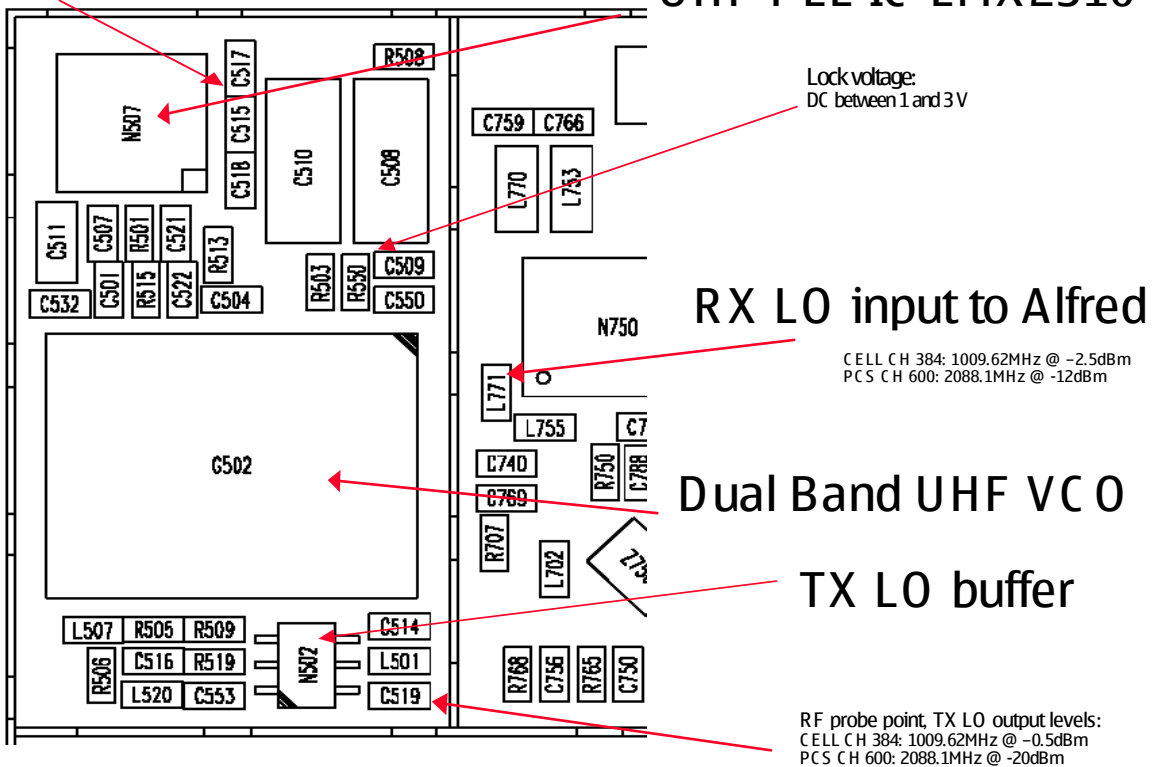
UHF Synthesizer Layout

VC T XO reference probing point:
19.2MHz @ +4.5dBm

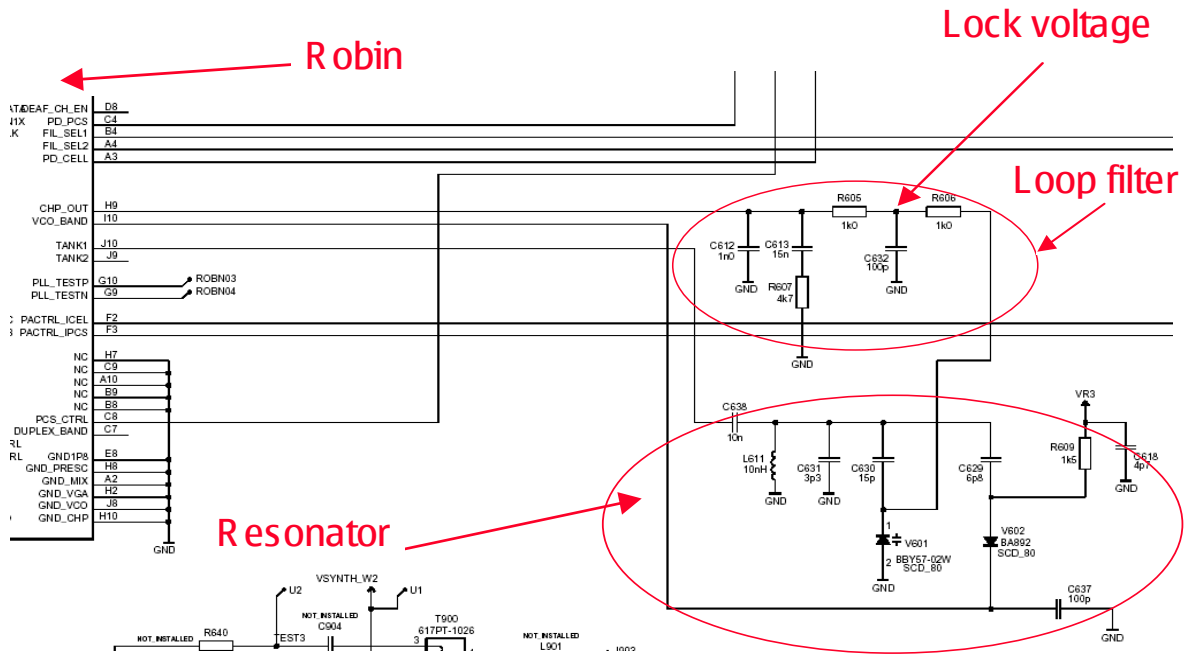
TX VHF Schematic

- There are two fixed LOs – 346.2MHz for CELL band and 416.2MHz for PCS band. This is the first LO for up-conversion. Refer to frequency plan.
- Monitor probing point at C638 with a high-impedance RF probe for Robin LO. A sufficiently strong and stable signal should be observed on the spectrum analyzer.
- Monitor control voltage at C632. At this control voltage, the Robin LO is locked (it should be between 1.2 and 1.8VDC).
