## CCS Technical Documentation RH-12/RH-28 Series Transceivers

# 6(a) – Baseband Troubleshooting Instructions

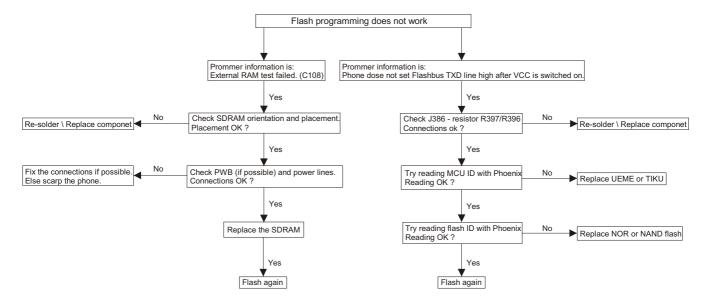
Figure 2: Flash programming does not work

These errors are some of the most common errors and based on this, a fault finding diagram for flash programming is shown below. Various errors can appear from the prommer when flashing the phone – not all of them can be directly linked to the HW or phone.

Because of the use of uBGA components, it is not possible to verify on the diagram, if there is a short circuit in control and address/data lines on TIKUEDGE, NOR flash, NAND flash or SDRAM.

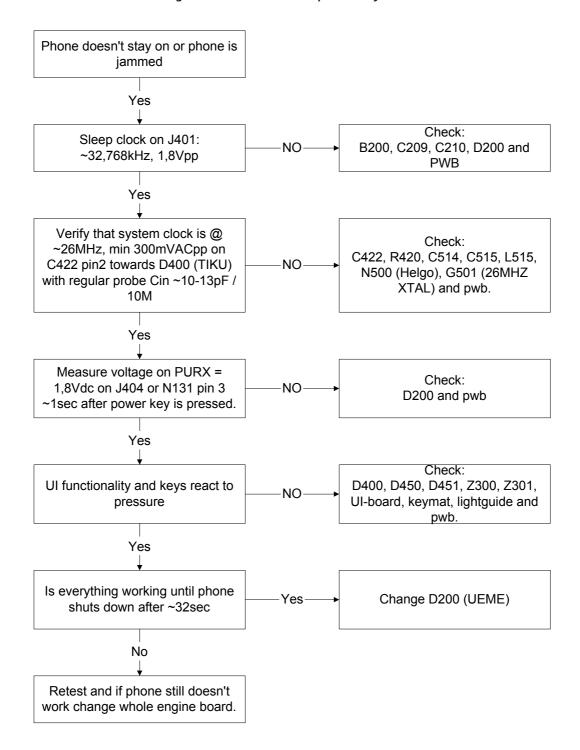
Figure 3: Phone doesn't stay on, or is jammed

If this kind of a failure is presenting itself immediately after FLALI, it is most likely caused by ASICs missing contact with PWB.

If the MCU doesn't service the watchdog register within the UEME, the operations watchdog will run out after approximately 32 seconds. It is not possible to measure this service routine.

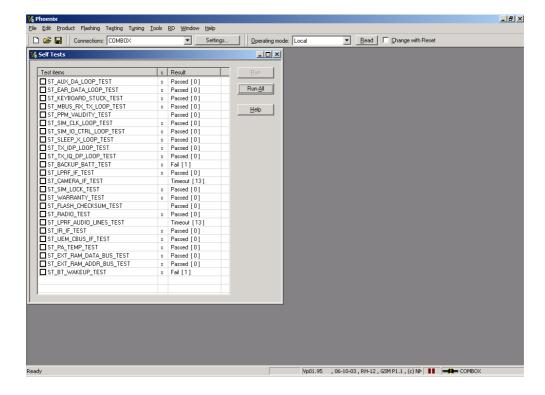
Figure 4: Display Information: "Contact Service"

When this error appears in the display it means that one or more of the internal base-band tests has failed. The baseband tests (self tests) are performed each time the phone is powered on. The self tests are divided into those performed while powering up (Start up tests) and the ones that can be executed with a PC using Phoenix (Runtime tests). The following Start-up tests are performed during power up:

From Phoenix it's possible to run all the self tests and the additional "Runtime test". The test cases can be seen below.

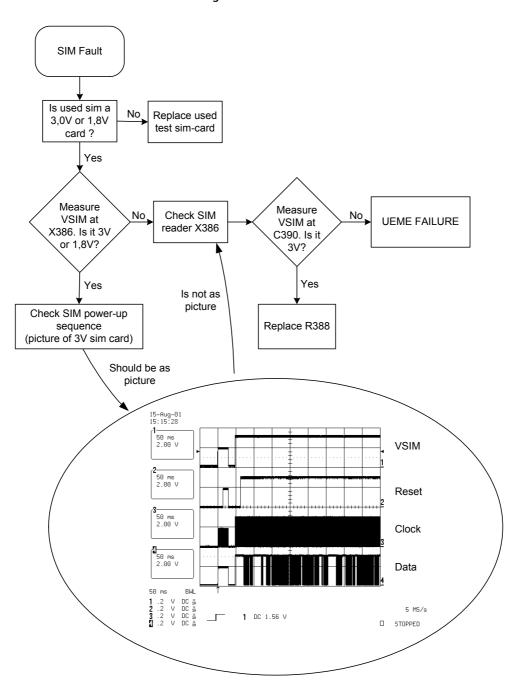
Figure 5: SIM Failure

The hardware of the SIM interface from the UEME (D200) to the SIM connector (X386) can be tested without a SIM card. When the power is switched on, the phone first checks for a 1,8V SIM card and then a 3V SIM card. The phone will try this four times, whereafter it will display "Insert SIM card".

The error "SIM card rejected" means that the ATR message received from the SIM card is corrupted, e.g. data signal levels are wrong. The first data is always ATR and it is sent from card to phone.
