Programmes After Market Services

NPL-1 Series Cellular Phones

6 - Troubleshooting

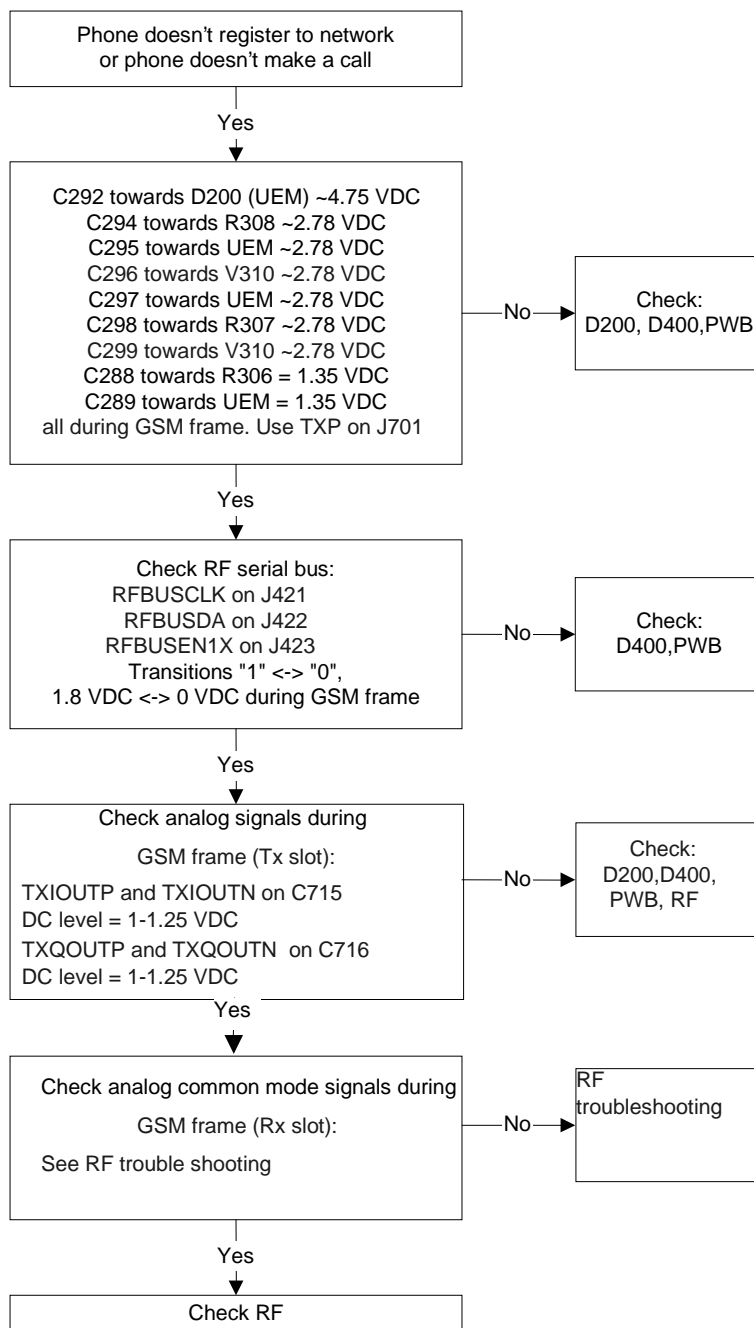
The phone doesn't register to the network or phone doesn't make a call

If the phone doesn't register to the network, the fault can be in either BB or RF. Due to the highly module design of the BB area, very few signals can be measured.
