CCS Technical Documentation

RH-13 Series Transceivers

Troubleshooting

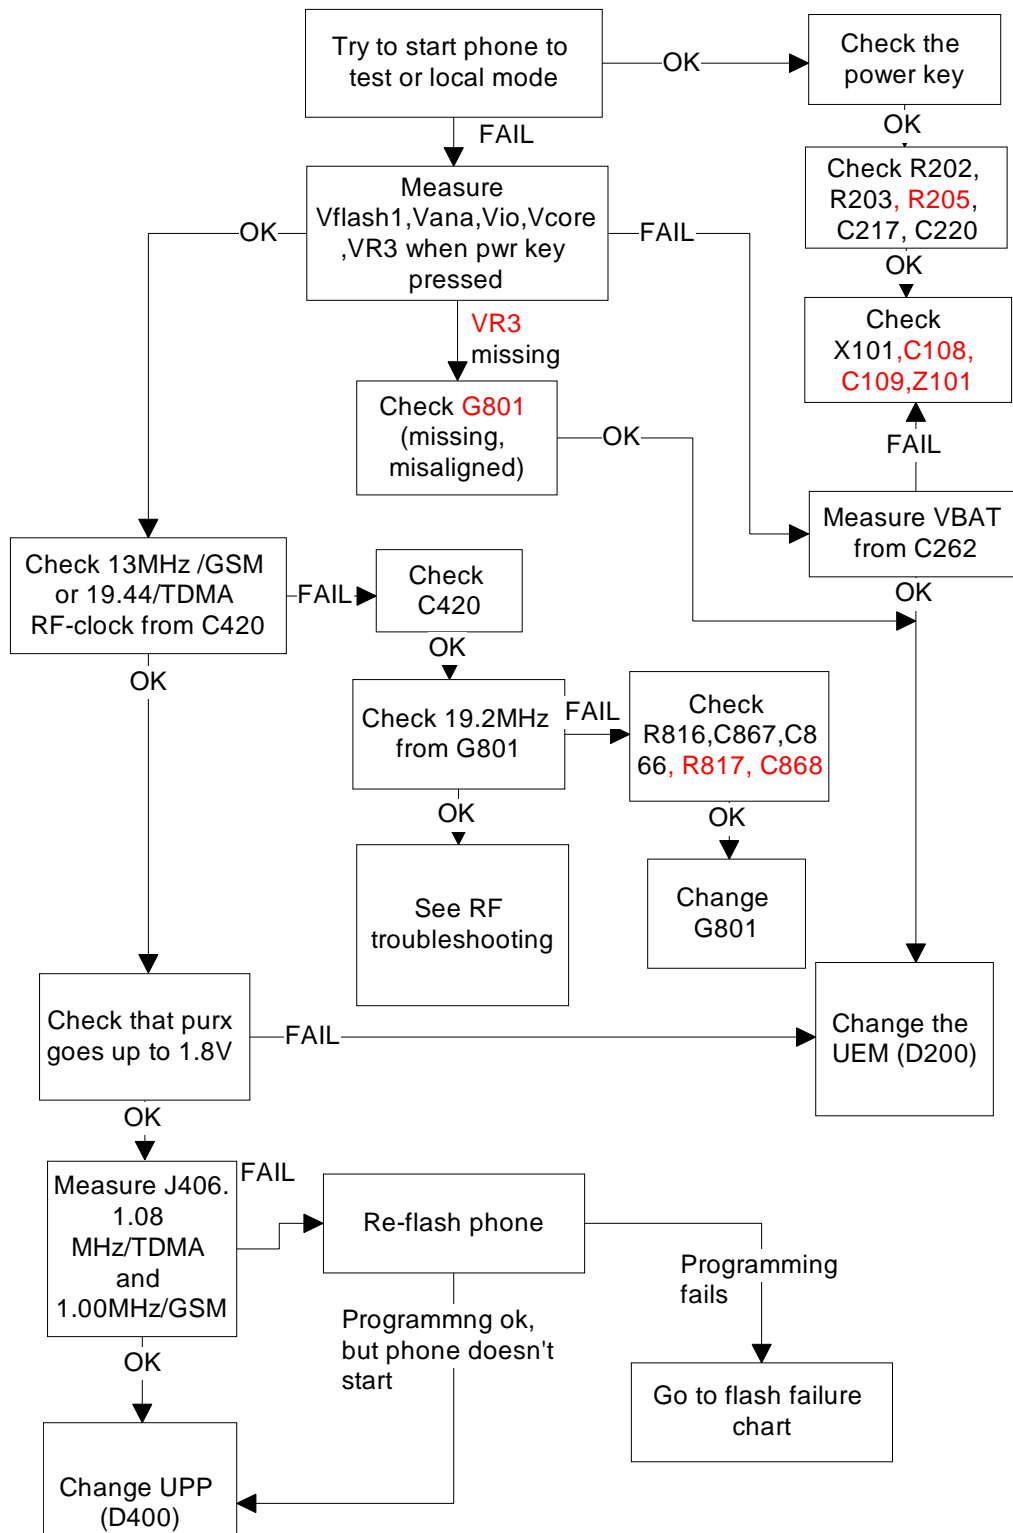
Figure 4: Fault tree, phone does not power up

Note! In case of power up faults, it's not possible to force phone on by disabling watchdog. Instead, measurements should be done immediately when power key pressed or when battery voltage connected to phone (local/test mode).

The easiest way to check if software is running when phone takes abnormal amount of current is to measure cbusclk and Vcore.

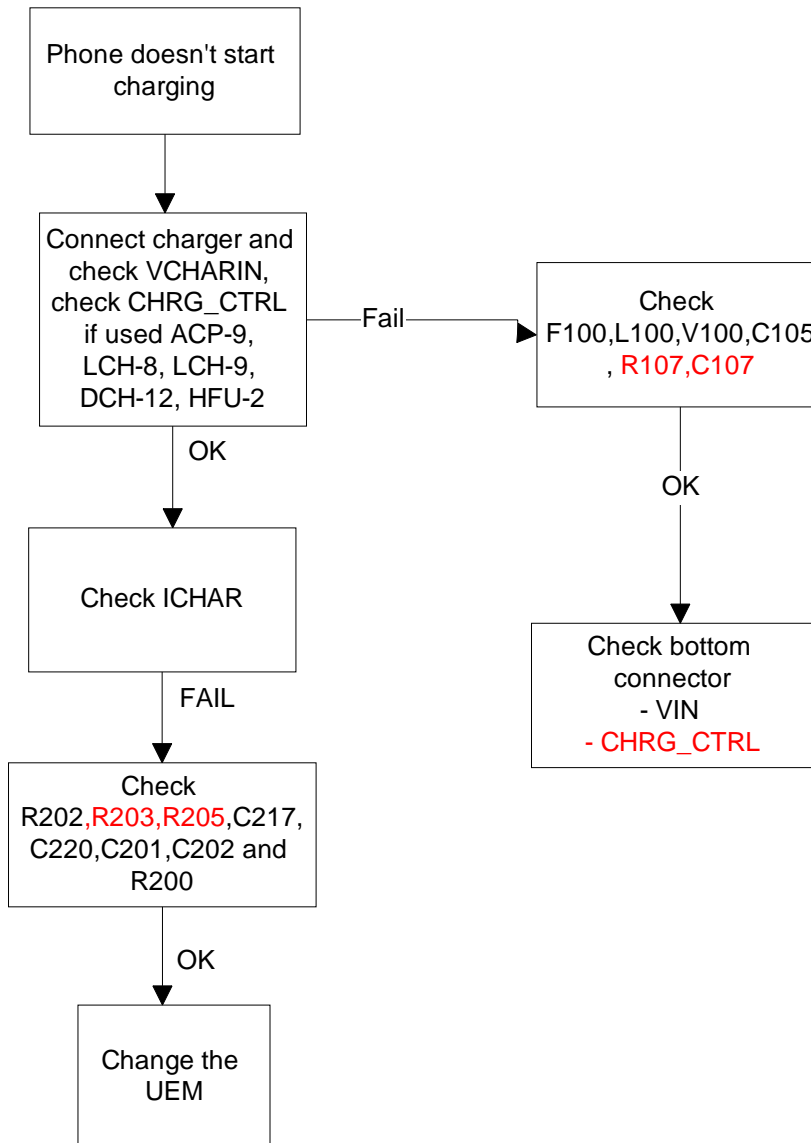
Figure 5: Fault tree, charging

Note: Charging voltage and current can be checked by connecting phone to service software and reading ad- converter values of vchar and ichar.

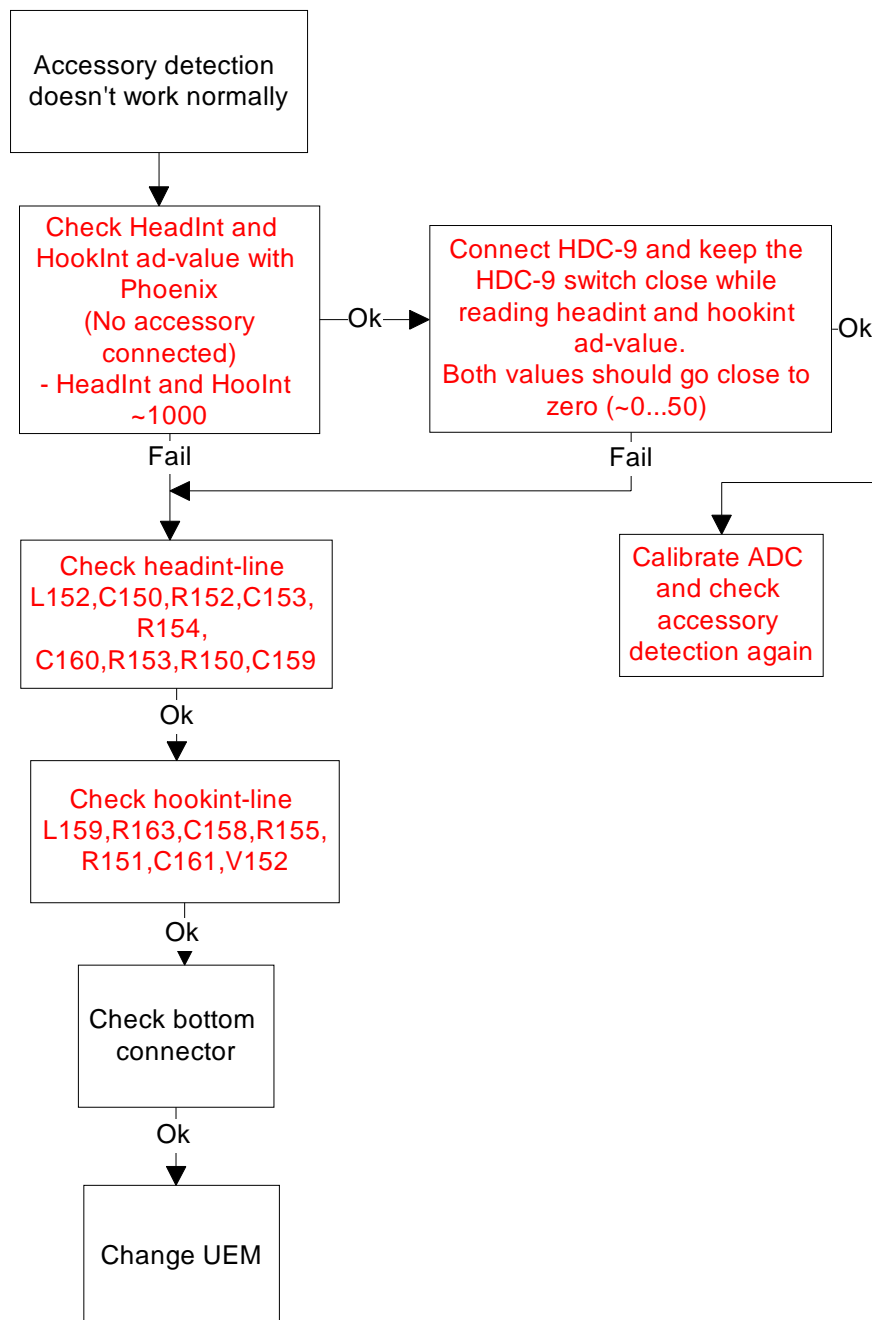
Figure 8: Fault tree, accessory detection

- - Start phone to normal mode when checking accessory detection.
- - Ad- converter value of headint and hookint - lines can be checked with Phoenix ADC-reading.
- - When headset HDC-9 connected and headset push button is held down, head- int- value should be between 10 and 50 and hookint- value between 0-30.

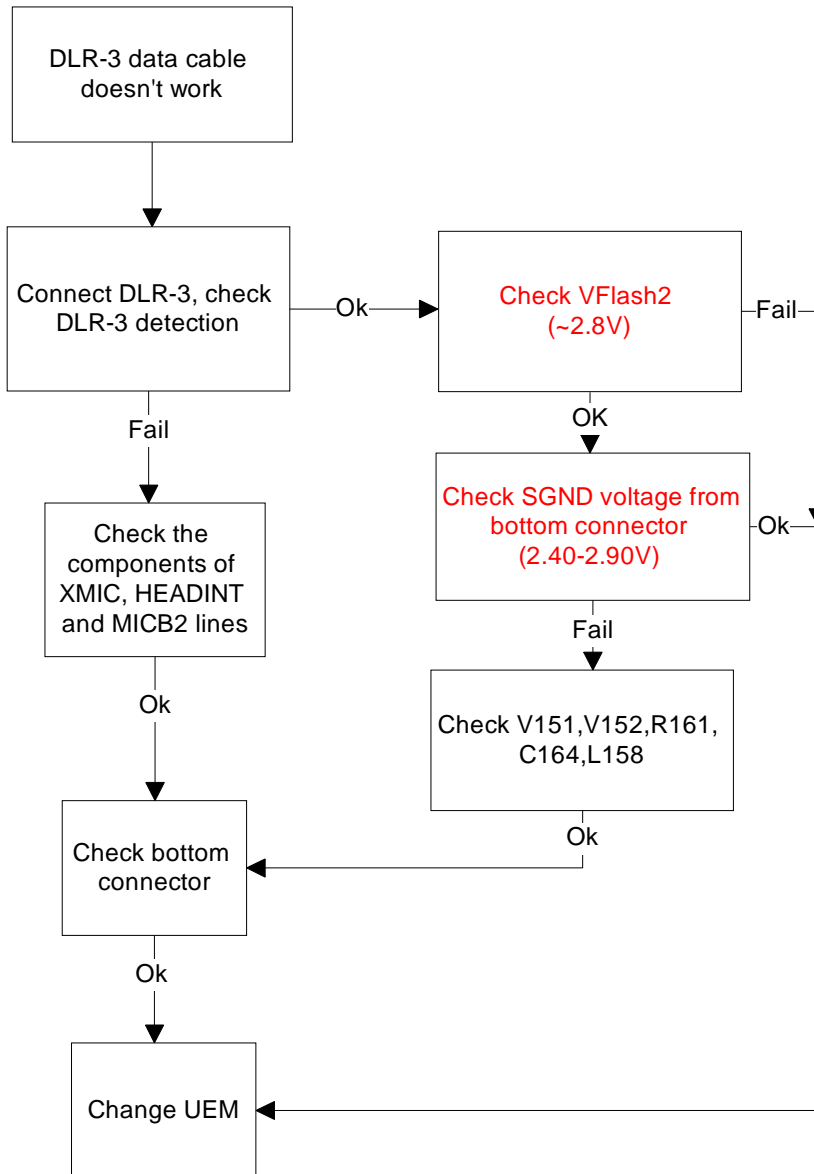
Figure 9: Fault tree, data cable.

DLR-3 needs power supply for data transferring. SGND will supply 2.8V to DLR-3.

- Start phone to normal mode when checking DLR-3 detection

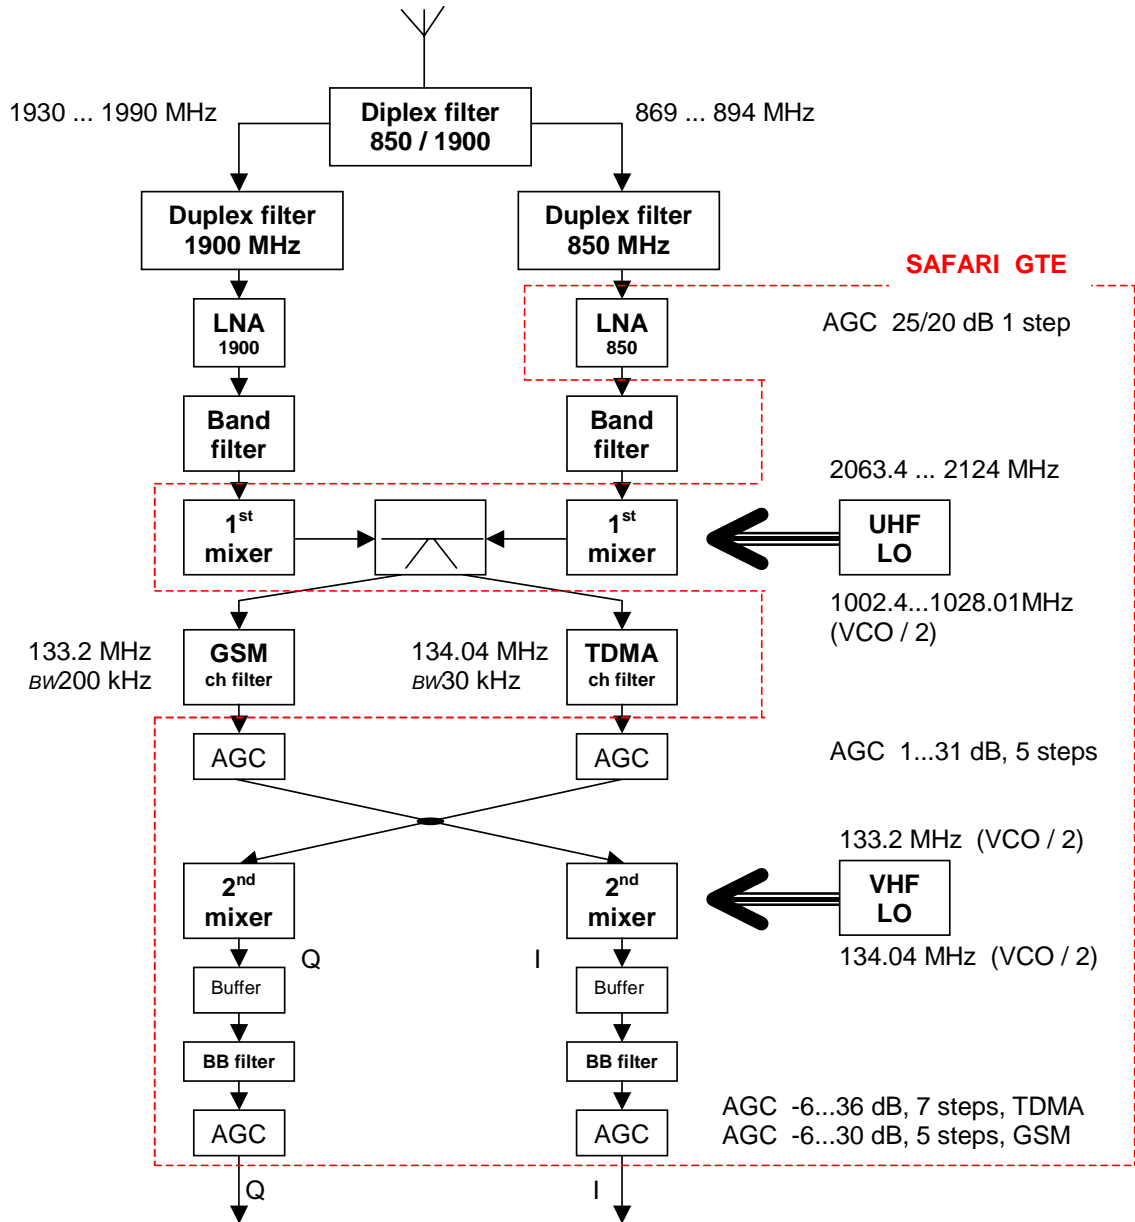
Figure 14: Receiver block diagram

Block level description of the receiver:

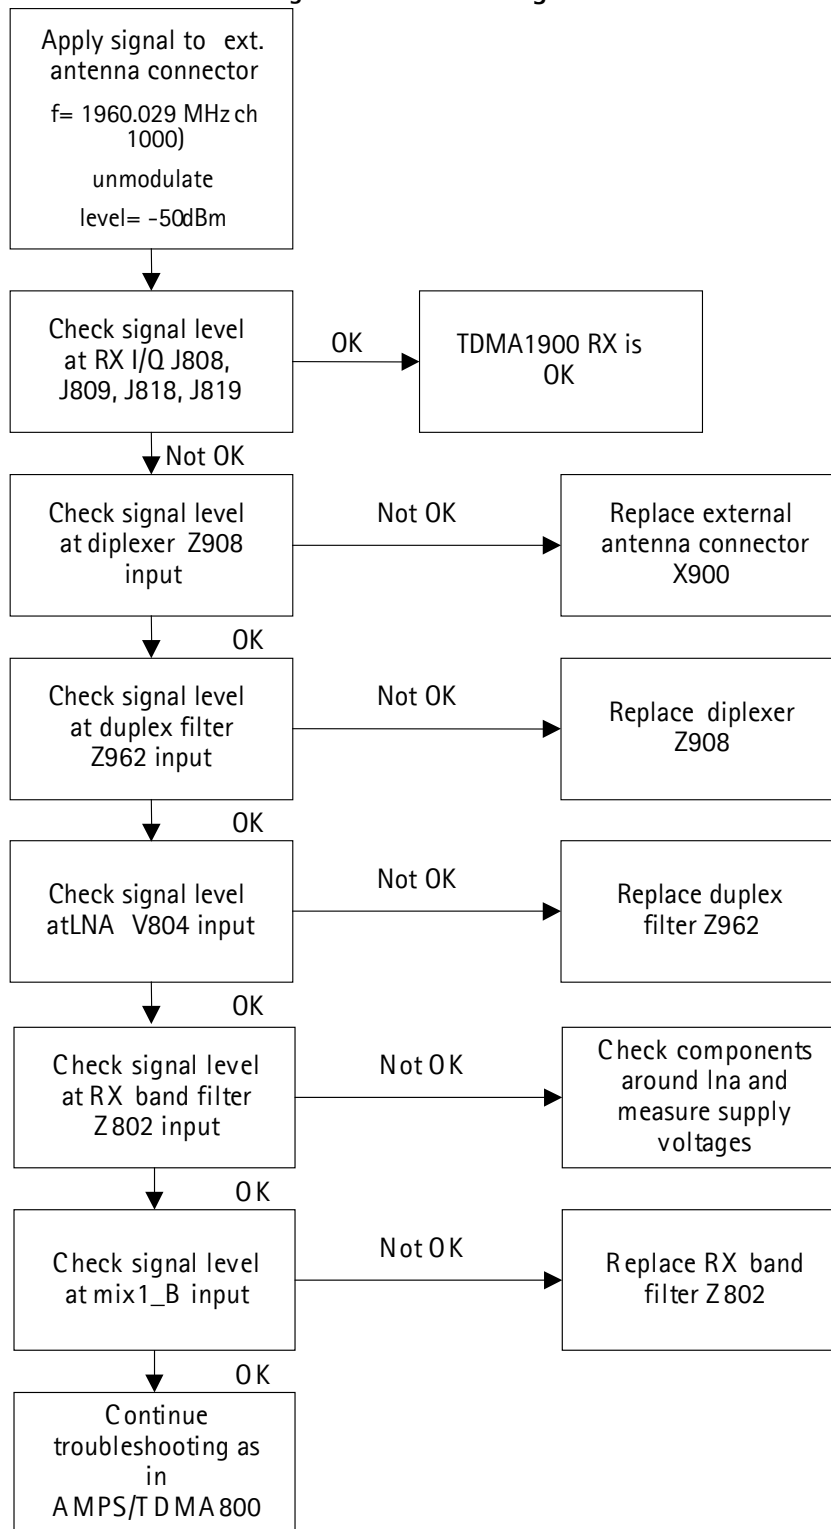
Figure 26: Fault finding chart.

Only path from external RF connector to IF needs to be checked if AMPS/TDMA800/GSM850 RX chain is OK. After down conversion (from RF to 134.04 MHz IF) both lower and upper band use same signal path.

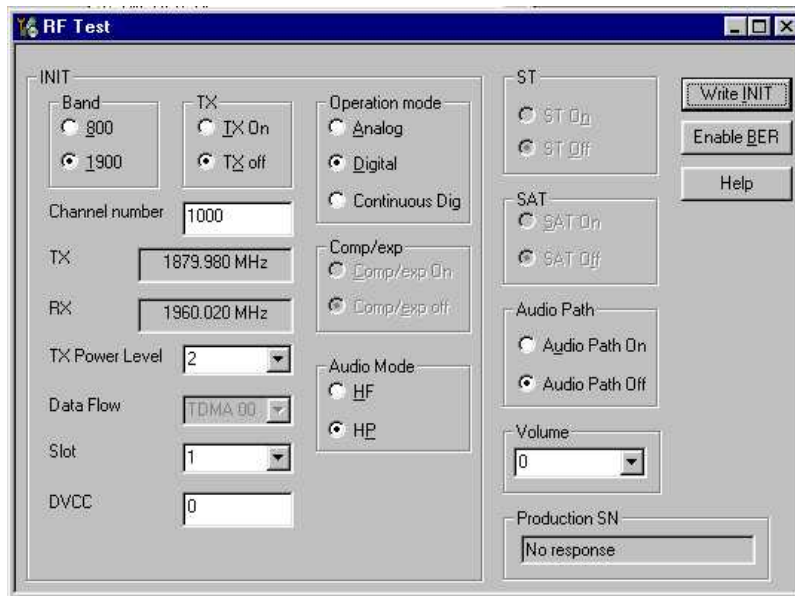
Figure 27: RF Test.

- 1 Set signal generator frequency to 1960.0230375 MHz and level to -80 dBm.
- 2 Set phone to TDMA mode and select RF Test UI in Phoenix (Maintenance => Testing => RF Test).

- 3 Set channel to 1000 and press "Write Init".
- 4 Set spectrum analyzer settings as following:
 - Center frequency: 268.08 MHz, Span: 200 kHz
 - RBW: 3 kHz, reference level: 0 dBm
- 5 Connect spectrum analyzer probe on the inductor L818 and record RX VHF VCO signal level and frequency. Signal level should be around -25 dBm and frequency 268.08 MHz.
- 6 Set spectrum analyzer settings as following:
 - Center frequency: 2094.06 MHz, Span: 200 kHz
 - RBW: 3 kHz, reference level: 10 dBm
- 7 Connect spectrum analyzer probe to the UHF VCO output and record signal level and frequency. Signal level should be around -5 dBm and frequency 2094.06

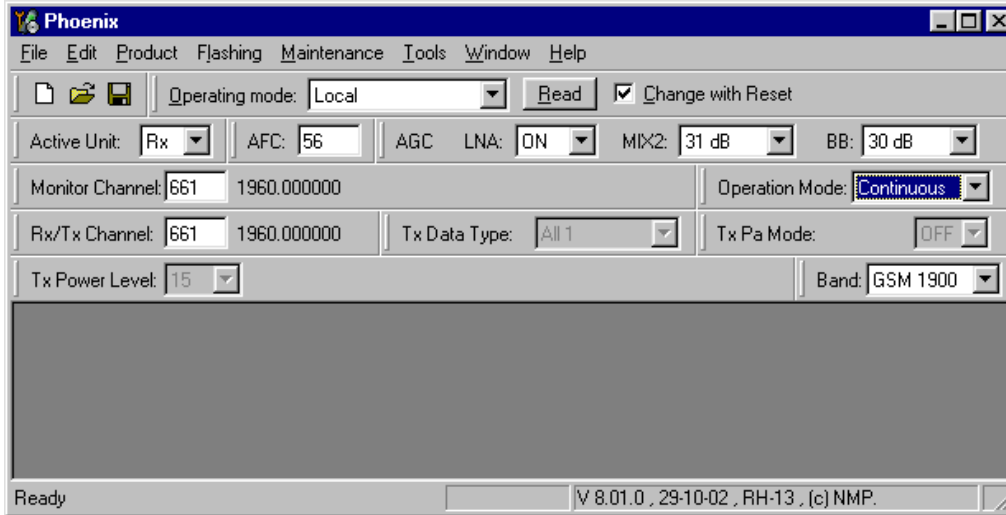
Figure 30: RF controls.

- 1 Set phone receiver to continuous mode using Phoenix.
- 2 Set spectrum analyzer settings as following:

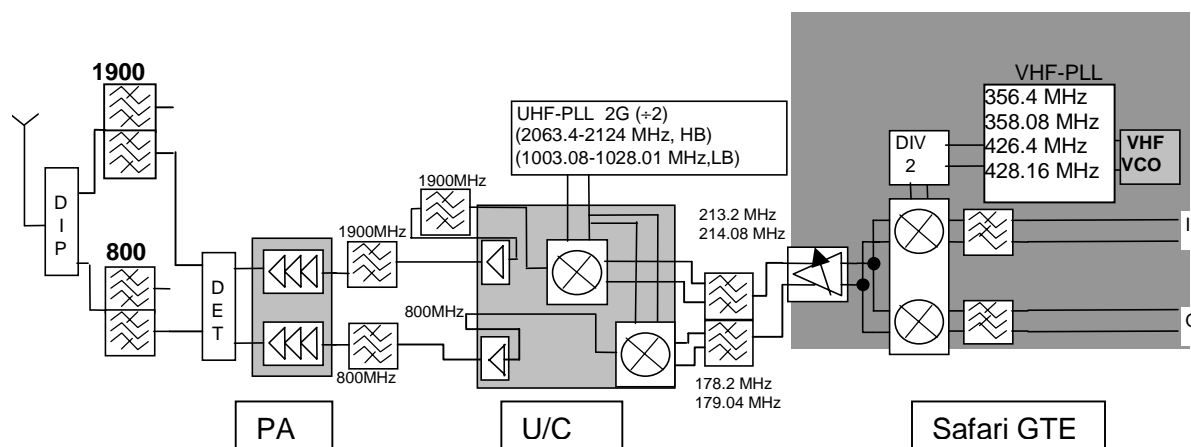
Figure 36: TX signal path.

The power detection and power control circuit belongs under power control part of this guide.

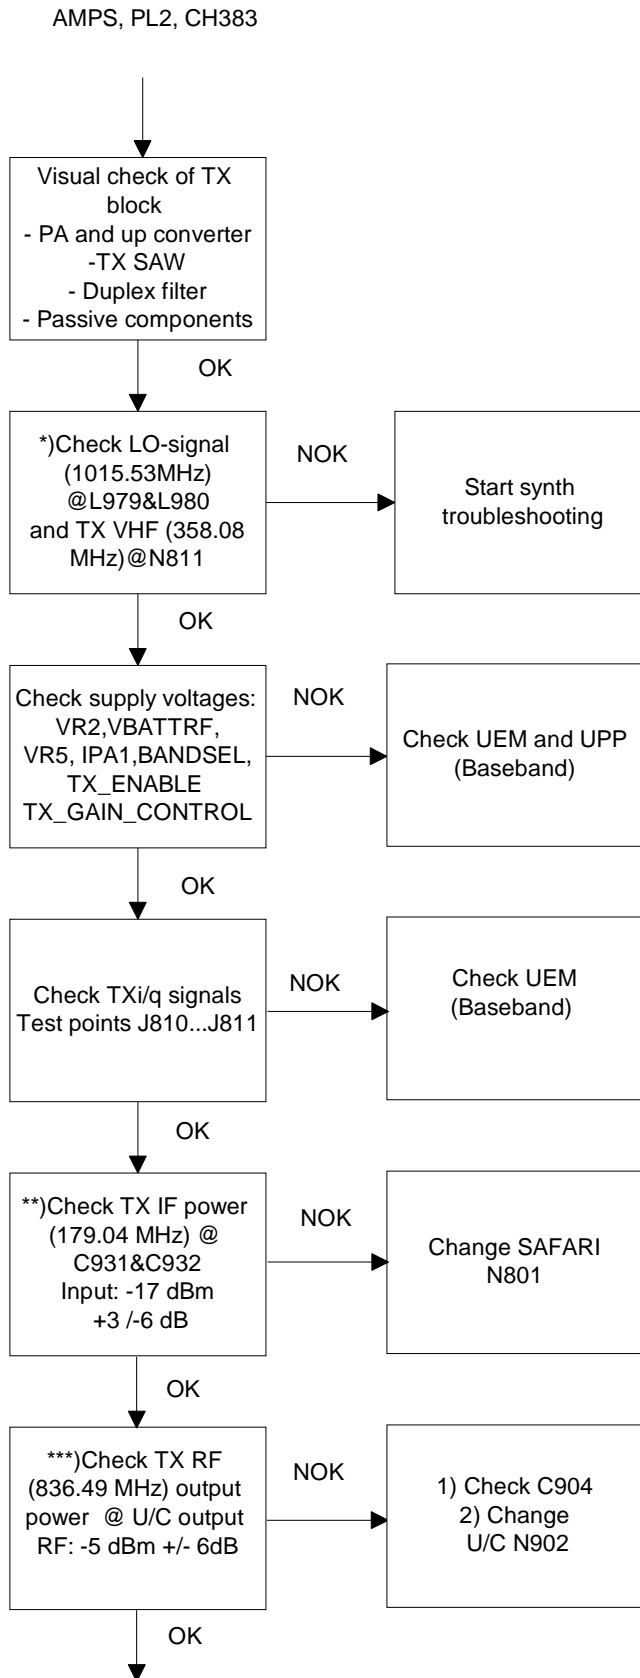
Figure 39: Fault finding chart

*) GSM850 LO-signal freq. 1014.6 MHz and TX VHF-signal freq. 356.4 MHz

**) GSM850 TX IF freq. 178.2 MHz and level -17 dBm

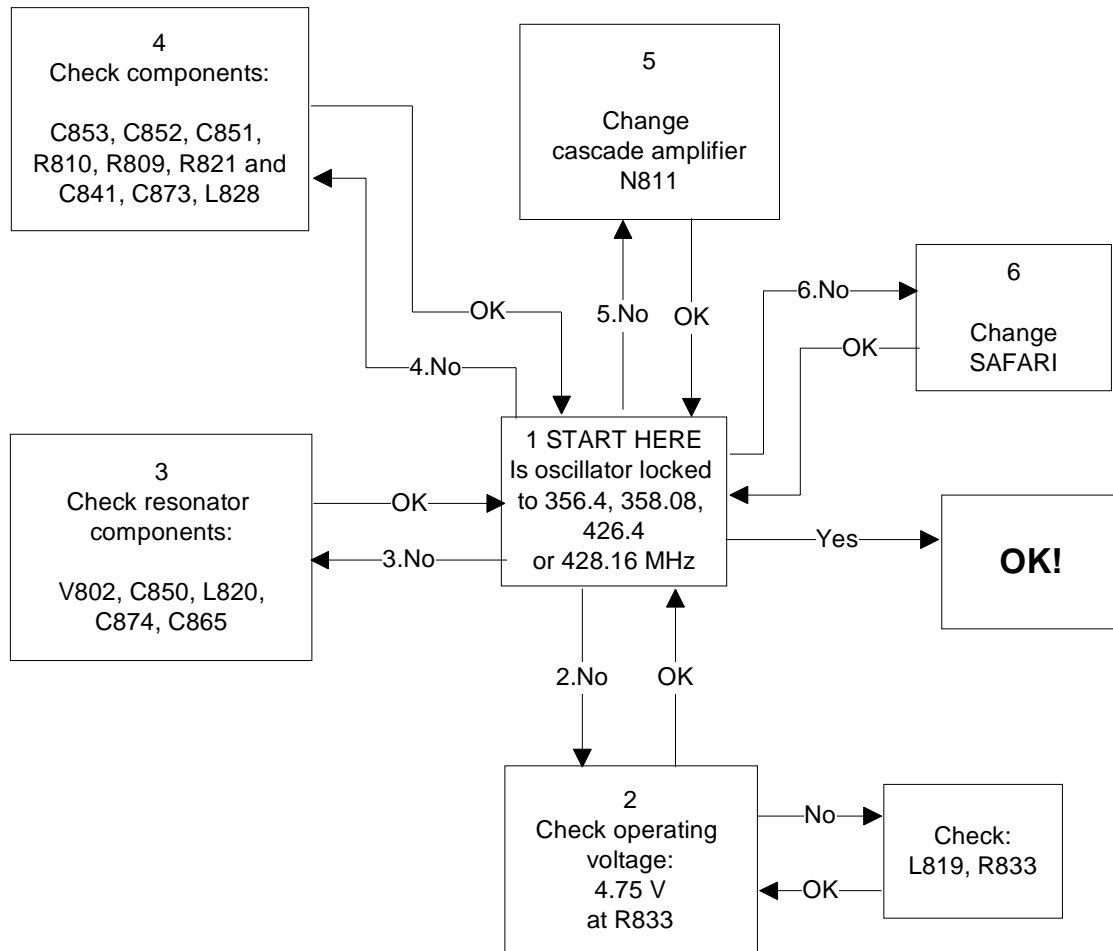
Figure 48: Fault finding chart for TX VHF VCO.

The TX VHF VCO signal is used to generate transmitter Intermediate frequency. TX VHF VCO has three fixed frequencies 358.08 MHz for lower band and TDMA 428.16 MHz and GSM 426.4 MHz for upper band. Operating frequency is locked in Phase locked Loop and frequency is divided by two before modulator.

- AMPS, CH383 -> TX VHF frequency 358.08 MHz
- TDMA1900, CH1000 -> TX VHF frequency 428.16 MHz
- GSM850, CH189 -> TX VHF frequency 356.4 MHz
- GSM1900, CH661 -> TX VHF frequency 426.4 MHz

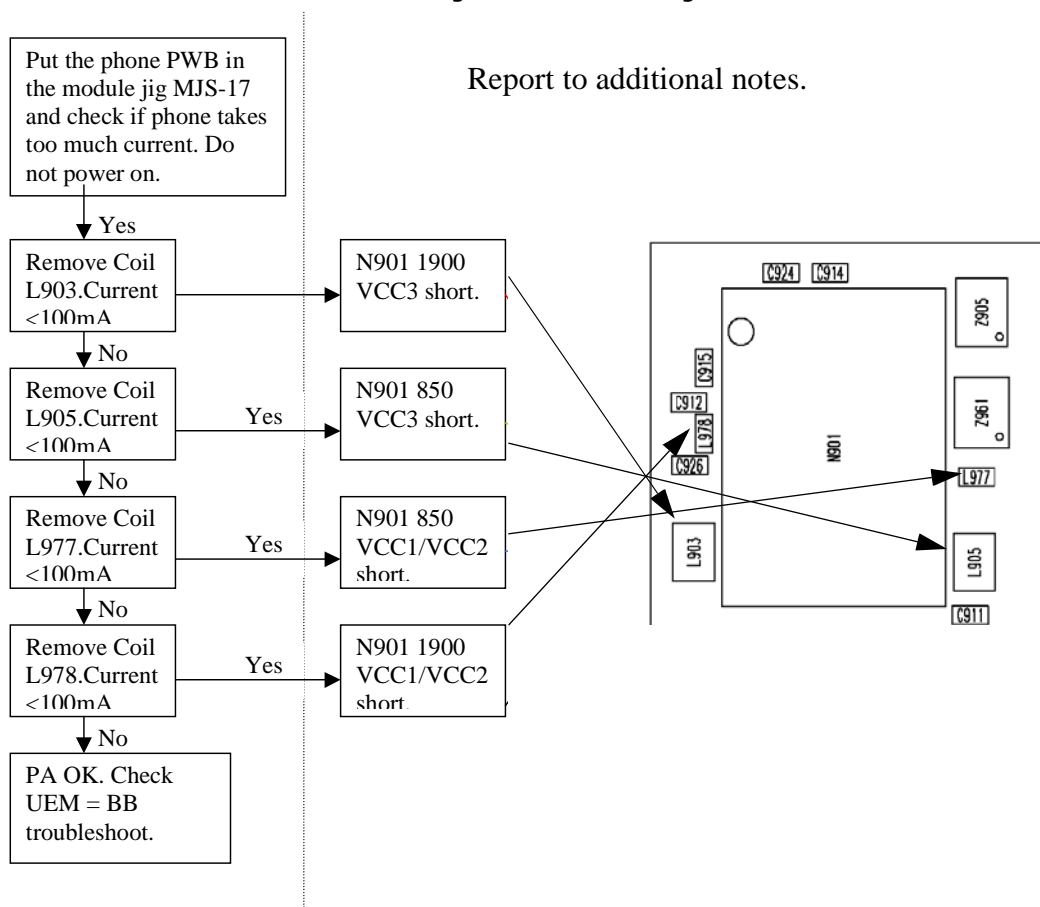
Figure 52: Fault finding chart

This document has been done to get exact information of defect PA. In case is excessive current consumption is found during normal trouble shooting, follow this trouble shooting instructions to find out, if the reason is PA. If the failure is due to PA, change the PA and replace the removed components.

NOTE! To get specified current readings, turn module jig MJS-17 switches 2 and 3 ON for local mode.
