Programmes After Market Services NPW-2NX Series Transceivers

9. Troubleshooting

Issue 01 01/02 ©Nokia Corporation

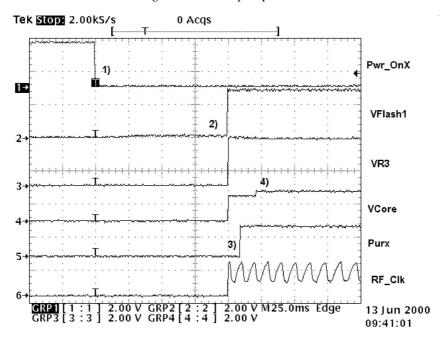
Figure 1: Power-up sequence

Note: In the following figure, the RF_Clk frequency appears to be lower than 19.44MHz because of a too low oscilloscope sampling frequency (2kS/s).

1 Power key pressed

- After 20ms, UEM enters RESET MODE if VBAT>Vmstr+
- VFLASH1, Vana, Vcore, Vio, and VR3 goes high
- VCTCXO enabled by VR3 -> RFClk 19.44 MHz running

2 Purx released

Purx released by UEM, UEMINT goes high for 100 ms, SleepX goes high, and SleepClk (32 KHz) starts running.

3 Software running

- Default value for Vcore is 1.5 volts and, if software is running, Vcore will rise to 1.8 volts
- Cbus (1.08MHz) and Dbus clocks start running

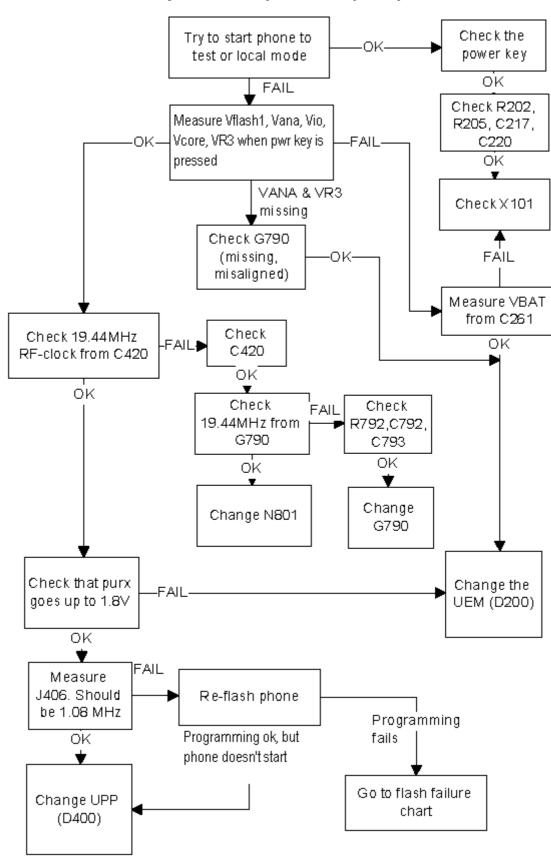
Figure 2: Fault tree, phone does not power up

The easiest way to check if the software is running when the phone takes an abnormal amount of current is to measure the *cbusclk* and *Vcore*.

The Dbus clock (programmable 9.72MHz) is not automatically visible in the test and local modes.

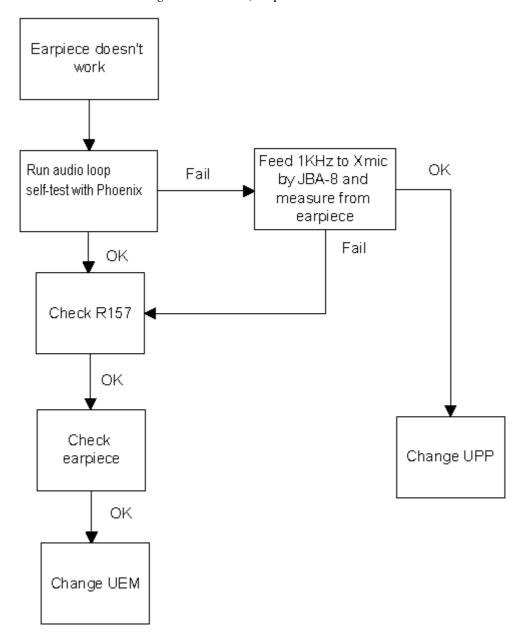
Figure 4: Fault tree, earpiece failure

Earpiece or external microphone line does not work

- 1 Make a phone call against tester and check audios.
- If the earpiece/XMIC fails: Feed a 1Khz signal to the XMIC line and measure the signal from the earpiece line. The Audio test box JBA-8 is needed. The Audio loop (Audio test/Ext In Hp Out) must be switched on by the Phoenix service software. This loop will connect audios only through the UEM. In this case, the UPP is not used.

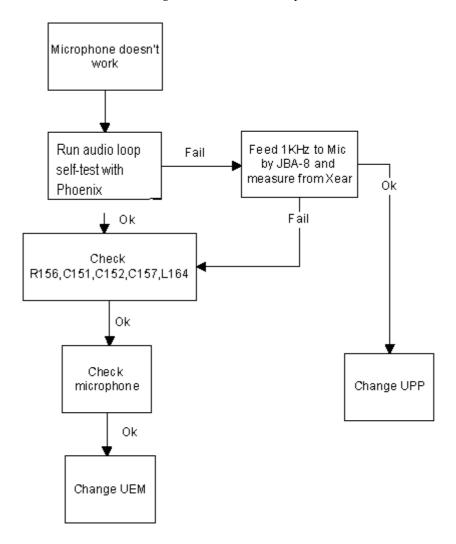
Figure 5: Fault tree, microphone failure

Microphone or XEAR line does not work

If the internal microphone/XEAR fails: Feed the tone to the microphone and measure the signal from the XEAR line. The Audio test box JBA-8 is needed. The Audio loop (Audio test/Hp In Ext Out) must be switched on by the Phoenix service software. This loop will connect audios only through the UEM. In this case, the

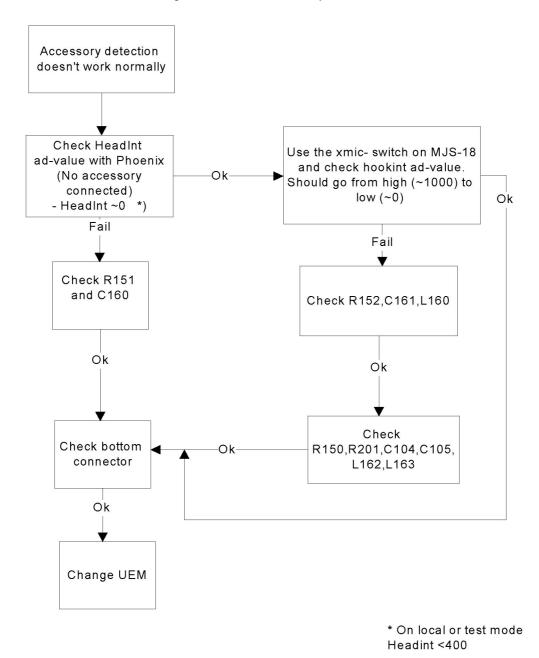
Figure 6: Fault tree, accessory detection

- 1 Start the phone in the normal mode when checking for accessory detection.
- The Ad-converter value of the hookint-line can be checked with the Xmic switch on an MJS-18 test jig. Changes normally from high to low when no accessory is connected.
- When the headset HDC-5 is connected, the hookint-value should be between 600 and 800.

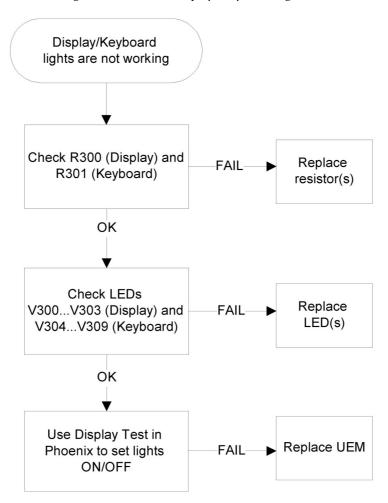
Figure 8: Fault tree, Display/Keyboard lights

Display/Keyboard lights do not work

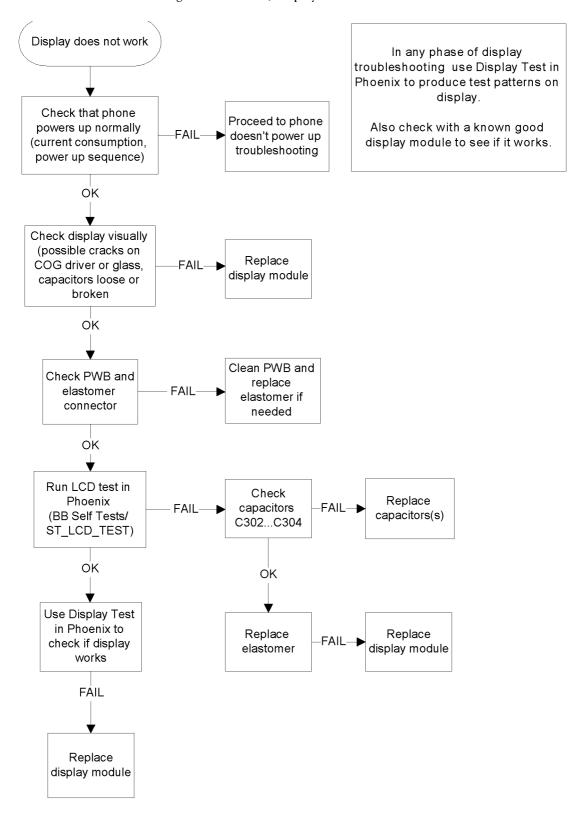
Figure 9: Fault tree, Display does not work

Display does not work

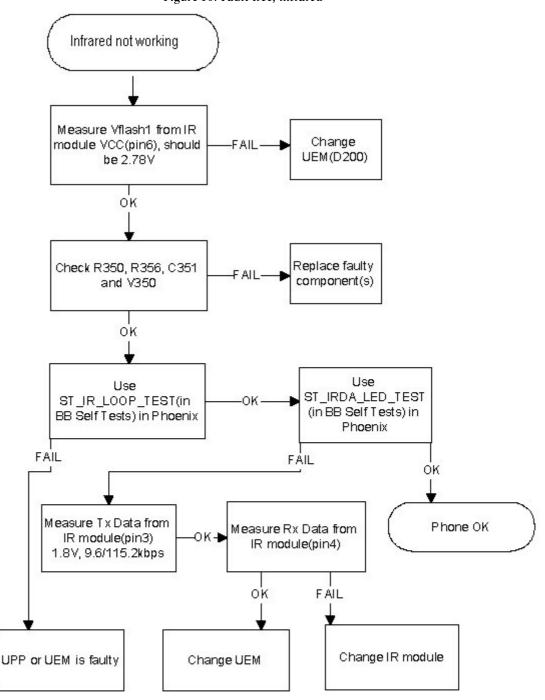
Figure 10: Fault tree, infrared

Infrared does not work

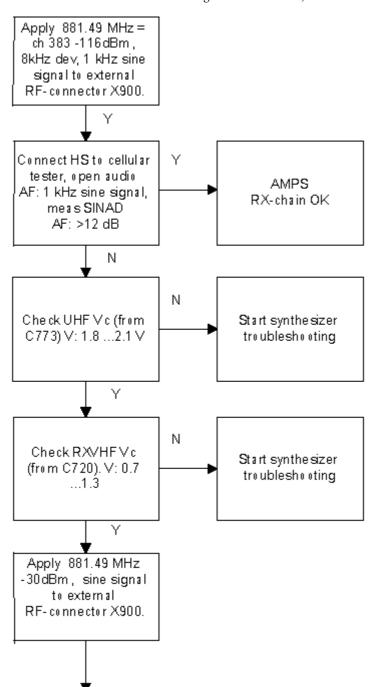
Figure 11: Fault tree, AMPS

AMPS

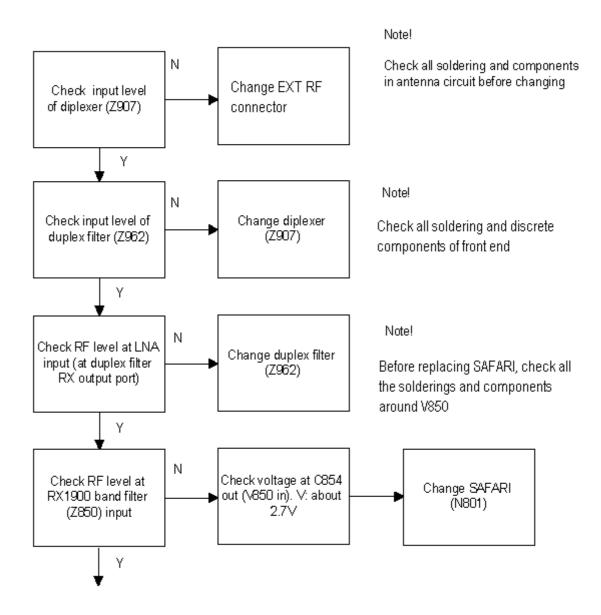
Figure 12: Fault tree, TDMA1900 troubleshooting

Note! Apply 1960.02 MHz = ch 1000 -110 dBm These tests are done signal to external in local mode by using RF-connector X900. RF Test UI. Υ Υ Enable loop back BER TDMA1900 using RF Test UI and RX-chain is OK check sensitivity: -110 dBm BER < 3% N Ν Check UHF Vc (from Start synthesizer C773) V: 2.2 ... 2.6 V troubleshooting Υ Ν Check RXVHF Vc Start synthesizer (from C720). V: 0.7 troubleshooting ...1.3

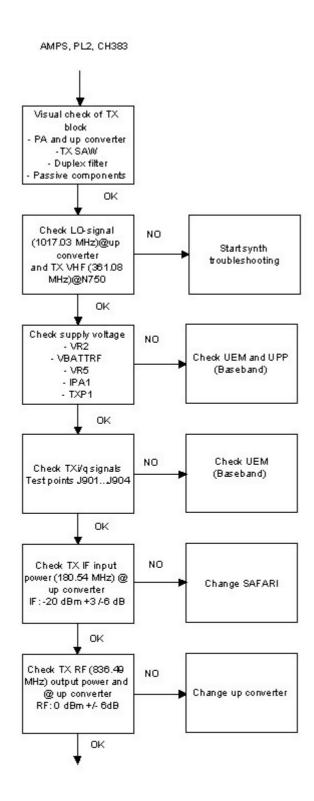
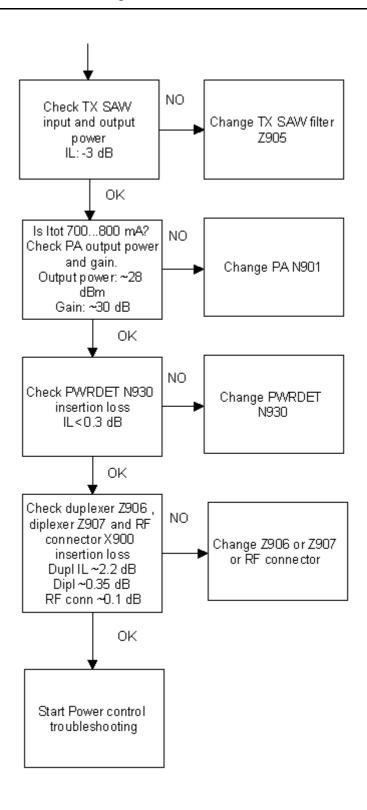
AMPS

Start Phoenix software and set phone to the Analog mode. Set channel 383 and Power level 2. Connect RF cable to EXT RF connector and connect cable to Spectrum analyze input, and measure RF level. Notice insertion loss of the cable and attenuations.

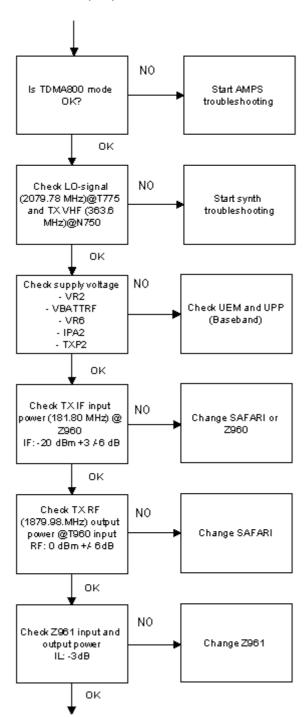
TDMA 1900, PL2, CH1000

TDMA1900 mode and DAMPS mode have a common RF modulator, making it important that the DAMPS mode has no faults.

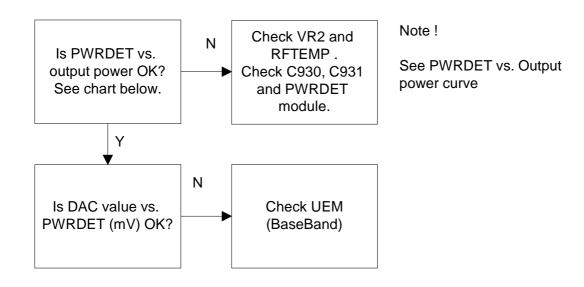
Power control loop

Basically power detection is done with the Power detector module and power control is done inside SAFARI. Power detection is basically similar for both bands, except both bands have individual couplers.

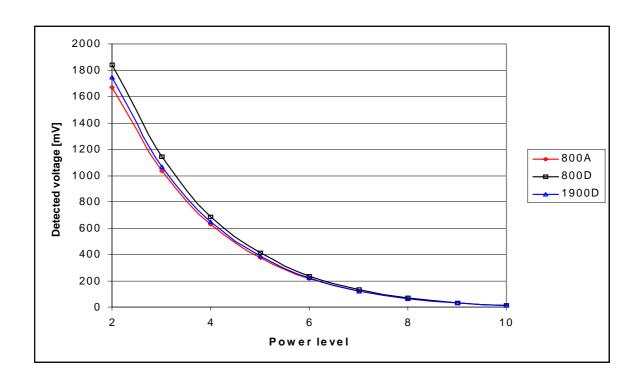
TYPICAL DETECTED VOLTAGES AT POWER LEVELS PL2...PL10 FOR DUALBANDER

Detected voltages are described in the next table and diagram.

NOTE: DAC VALUES MAY VARY ABOUT +/- 20%

NOTE: TXPWRDET is difference between TX on burst and off burst.

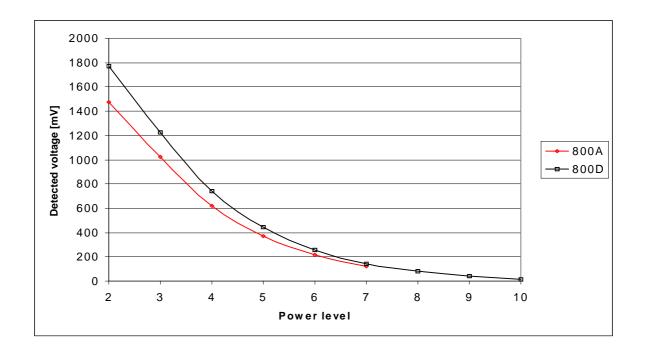
TYPICAL DETECTED VOLTAGES AT POWER LEVELS PL2. PL10 FOR SINGLE BANDER

800A					800D		
	Pout	TXPWRDET			Pout	TXPWF	RDET
PL	dBm	dac	dac mV		dBm	dac	mV
2	25.5	559	1475		27.3	671	1771
3	21.5	388	1023		23.3	465	1228
4	17.5	234	618		19.3	281	742
5	13.5	140	371		15.3	168	445
6	9.5	81	215		11.3	98	258
7	5.5	45	120		7.3	54	144
8	-	-	-		3.3	31	82
9	-	-	-		-0.7	15	40
10	-	-	-		-4.7	5	14

NOTE: TXPWRDET is difference between TX on burst and off burst.

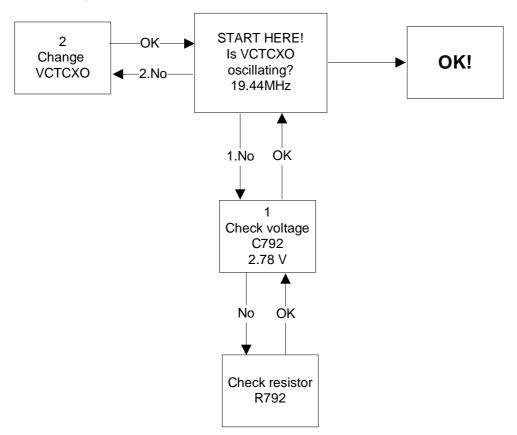
Fault-finding chart for 19.44 MHz oscillator

Baseband also needs a reference signal where it can generate the necessary clock signals and VCTCXO output signal is also buffered and connected to UPP.

There are four oscillators generating the needed frequencies for the RF section: 19.44 MHz reference oscillator, 2GHz UHF VCO, TX VHF cascade amplifier VCO, and RX VHF VCO integrated in Safari. RX VHF frequency is fixed at 271.08 MHz and TX VHF has two fixed frequencies, 361.08 MHz for lowband and 363.6 MHz for upper band. The VCO operating frequencies are controlled by the SAFARI PLL circuit. All locals are locked to stable 19.44MHz reference oscillator.

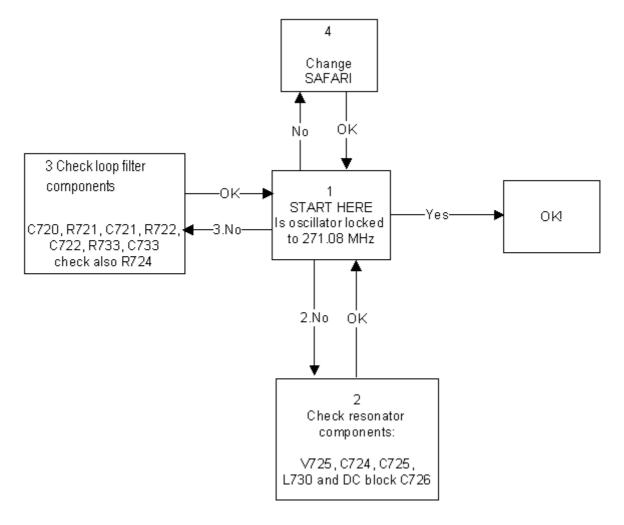
AMPS, CH383

The RX VHF VCO signal is used to generate receiver Intermediate frequency. RX VHF VCO has one fixed frequency (271.08 MHz). Operating frequency is locked in Phase-locked loop.

Measure oscillator frequency over L730 coil. Don't connect probe to pads!

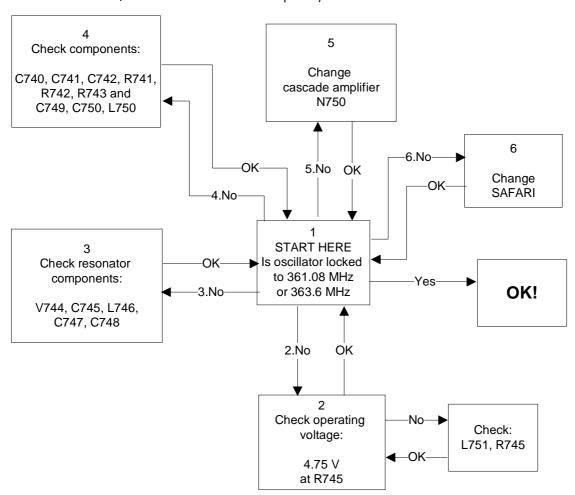
The TX VHF VCO signal is used to generate transmitter Intermediate frequency. TX VHF VCO has two fixed frequencies (361.08 MHz for lower band and 363.6 MHz for upper band). Operating frequency is locked in Phase-locked loop and frequency is divided by two before modulator.

AMPS, CH383 -> TX VHF frequency 361.08 MHz

TDMA1900, CH1000 -> TX VHF frequency 363.6 MHz

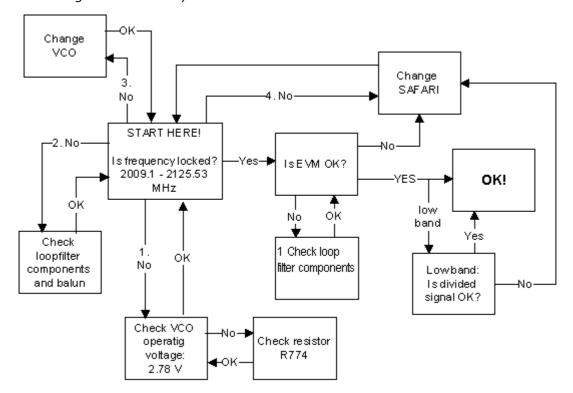
Fault-finding chart for UHF Synthesizer

The UHF Synthesizer consists of an external 2GHz UHF VCO, loop filter and an integrated PLL in the Safari RF IC. Safari T IC contains stages like counters, prescaler, divider by two, phase and frequency comparator, and a charge pump circuit which allows two operational modes—analog and digital. The UHF VCO Oscillation frequency is from 2009.1MHz to 2125.53 MHz.

the VCO depends on the DC control voltage, which is controlled by the PLL circuit inside SAFARI.
