CCS Technical Documentation

RH-34 Series Transceivers

Troubleshooting – RF (Part 2)

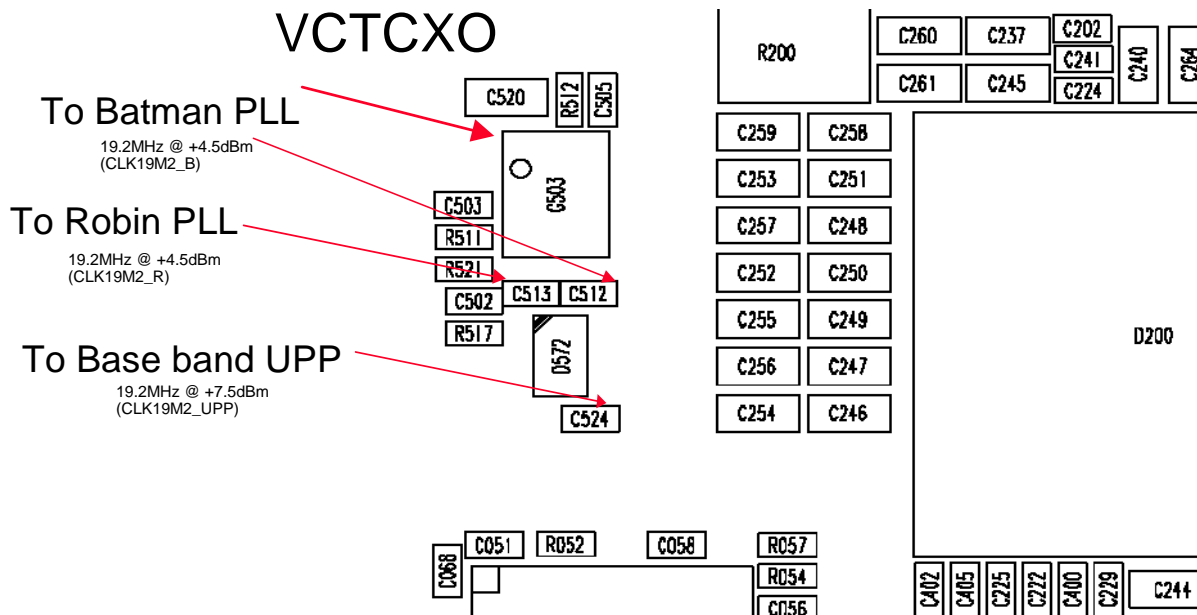
Check for the presence of the signal at the following points (use a high-impedance RF probe):

- CLK19M2_B, clock reference to Batman, should be +4.5dBm
- CLK19M2_R, clock reference to Robin, should be +4.5dBm
- CLK19M2_UPP, clock reference to UPP, should be +7.5dBm

(See the following figure for details)

If you do not see the VCTCXO signal at any of these points, check the voltages at the following supply lines:

- VR3, main supply line for VCTCXO circuitry, should be 2.78VDC
- VIO, supply line for buffer amplifier, should be 1.8VDC

VR3 = 2.78VDC

VIO = 1.8VDC

VCTCXO frequency is 19.2MHz. This is the reference signal. Without 19.2MHz, the phone

will not power up. This signal goes to Batman, Robin, UHF PLL, and also to the UPP via a buffer amplifier (D572).

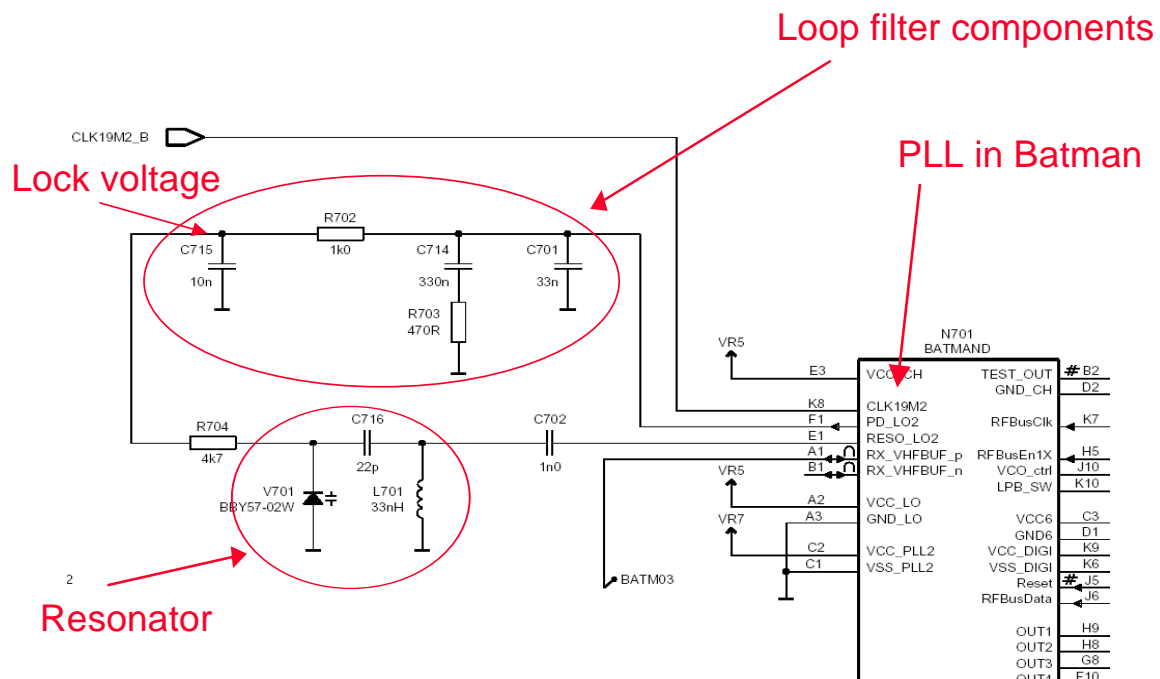
RX VHF (Batman LO) Schematic

- Operates at a fixed frequency of 256.2MHz. It is the second LO for down-conversion to I and Q for baseband processing. Refer to frequency plan.
- Monitor probing point at C702 for Batman LO. A locked and stable 256.2MHz with amplitude $\sim -2.5\text{dBm}$ should be observed on the spectrum analyzer.
- Monitor control voltage at C715. The control voltage at locked state should be between 1.2 and 1.7VDV for the proper operation of Batman LO.

- Power supplies to PLL portion of Batman IC (N701) missing or low (VR7).
- Loop filter or resonator components missing or incorrectly installed.
- 19.2MHz reference clock missing or low (C512).
- Programming is incorrect.
- Component failure (PLL IC).

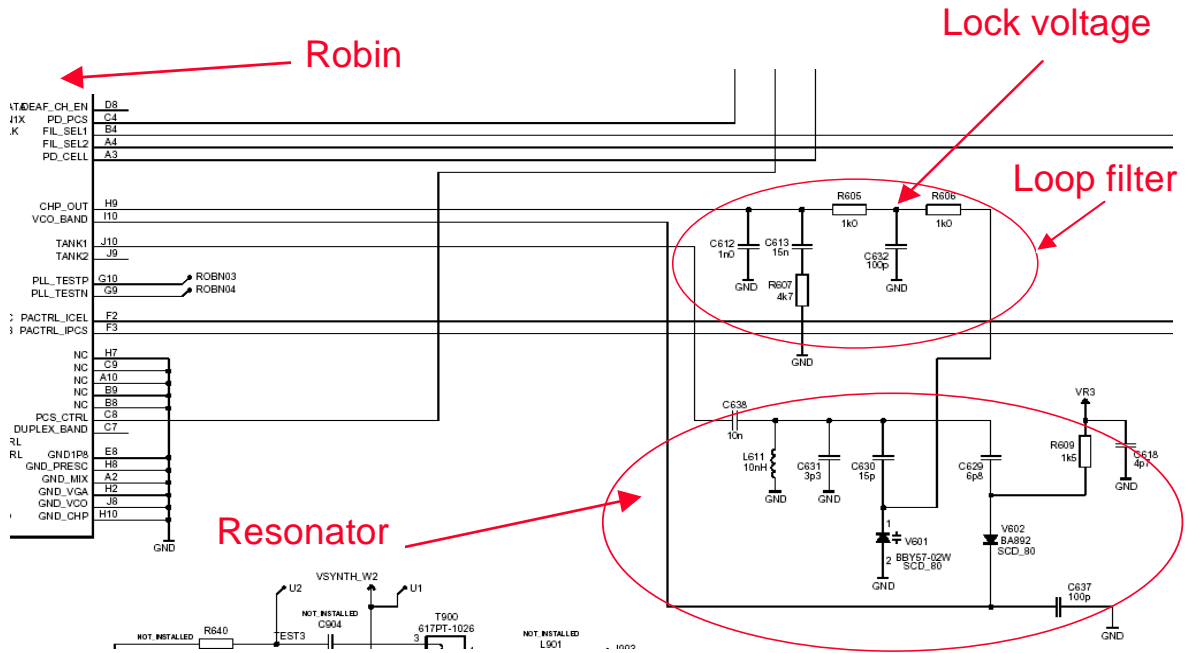
TX VHF Schematic

- There are two fixed LOs – 346.2MHz for CELL band and 416.2MHz for PCS band. This is the first LO for up-conversion. Refer to frequency plan.
- Monitor probing point at C638 with a high-impedance RF probe for Robin LO. A sufficiently strong and stable signal should be observed on the spectrum analyzer.
- Monitor control voltage at C632. At this control voltage, the Robin LO is locked (it should be between 1.2 and 1.8VDC).

Possible causes:

- Power supplies to PLL portion of Robin IC (N601) missing or low (VR3).

- Loop filter or resonator components missing or incorrectly installed.
- 19.2MHz reference clock missing or low (G513).
- Programming is incorrect.
- Component failure (PLL IC).
