6(a) - Baseband Troubleshooting and Manual Tuning Guide

Introduction to NHL-10 troubleshooting

This document is intended to be a guide for localizing and repairing electrical faults in the NHL-10 device. The fault repairing is divided into troubleshooting paths.

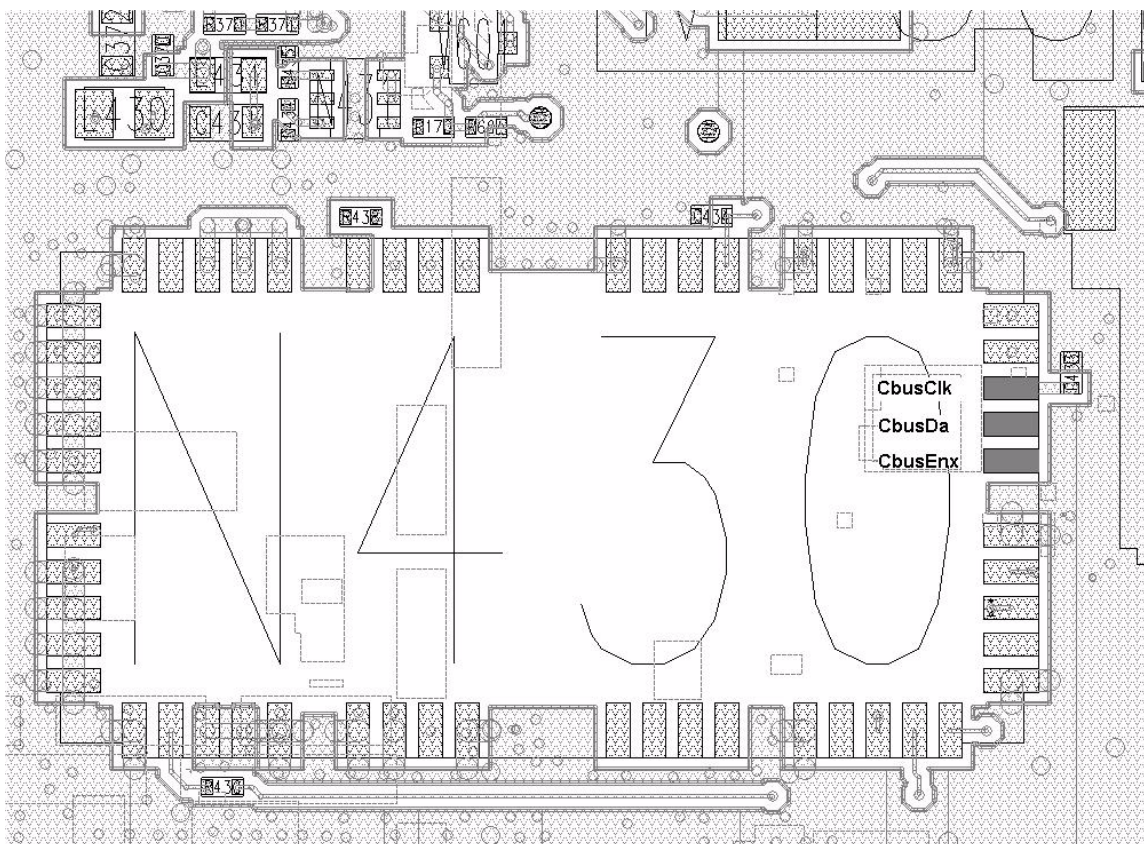
Figure 6: CBUS test points

If the interface is faulty from the UPP WD2's end the phone will not boot properly as powering configurations do not work. Traffic on the bus can be monitored from three pins on the BT module.

Pins are shown below.

CBUS is a three wire serial interface between the main baseband components. The bus consists of data, clock and bus_enable signals. In NHL-10 the bus is connected from UPP_WD2 to UEM and the BT module. UPP_WD2 takes care of controlling the traffic on the bus.

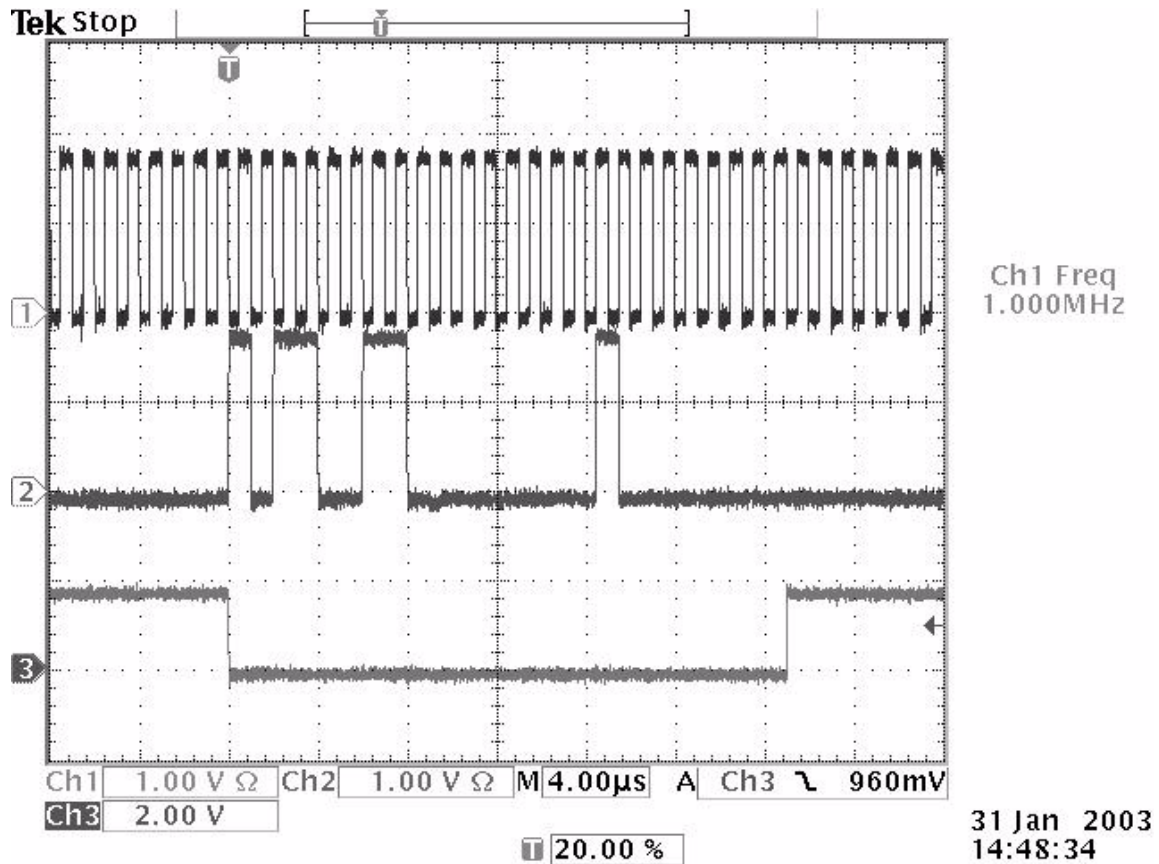
Figure 7: CBUS waveform

CBUS traffic is shown in the figure below (Read command to Zocus, LM3819, N380).

CbusClk is connected to Ch1, Cbus Da to Ch2 and CbusEnx to Ch3.

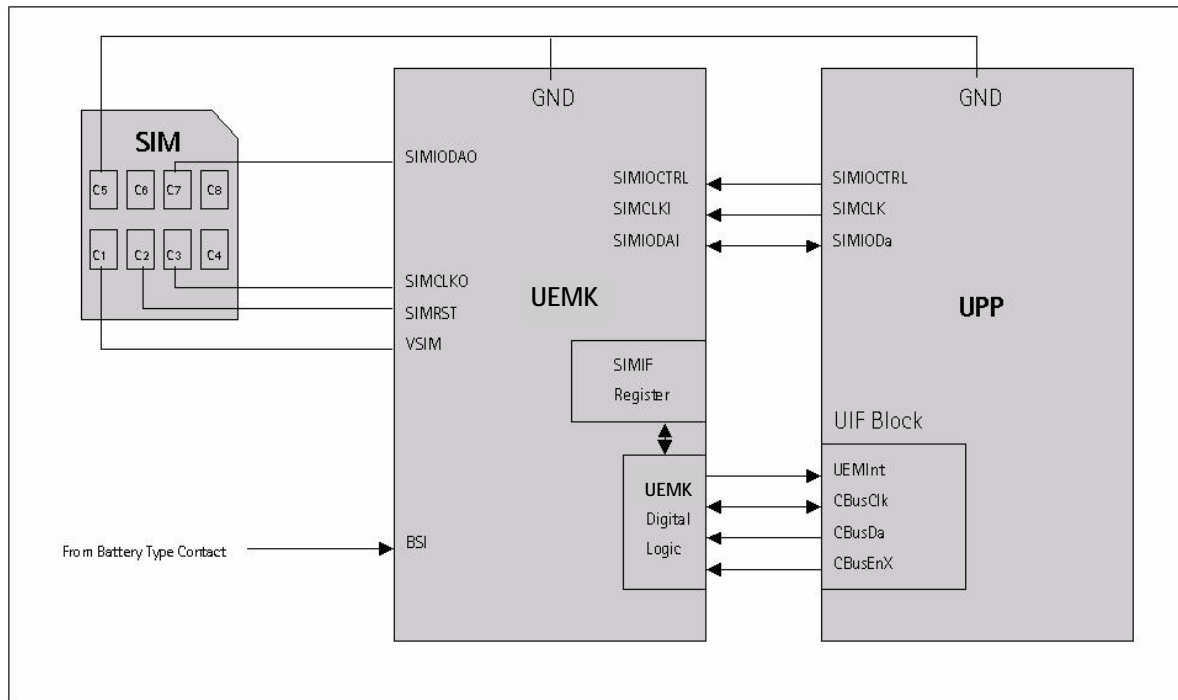
Figure 12: UPP_WD2 and UEMK SIM connections

The whole SIM interface is located in two chips, UPP_WD2 and UEMK. UEMK contains the SIM interface logic level shifting. UPP_WD2 provides SIMClk through UEMK to the SIM. The SIM interface supports both 3V and 1.8V SIMs. There is an EMIF component (3 Lines EMI filter) between the SIM card and UEMK, which isn't shown in the below picture.

The SIM power up/down sequence is generated in the UEMK. This means that the UEMK generates the RST signal to the SIM. The card detection is taken from the BSI signal, which detects the removal of the battery. Monitoring of the BSI signal is done by a comparator inside UEMK. The threshold voltage is calculated from the battery size specifications.

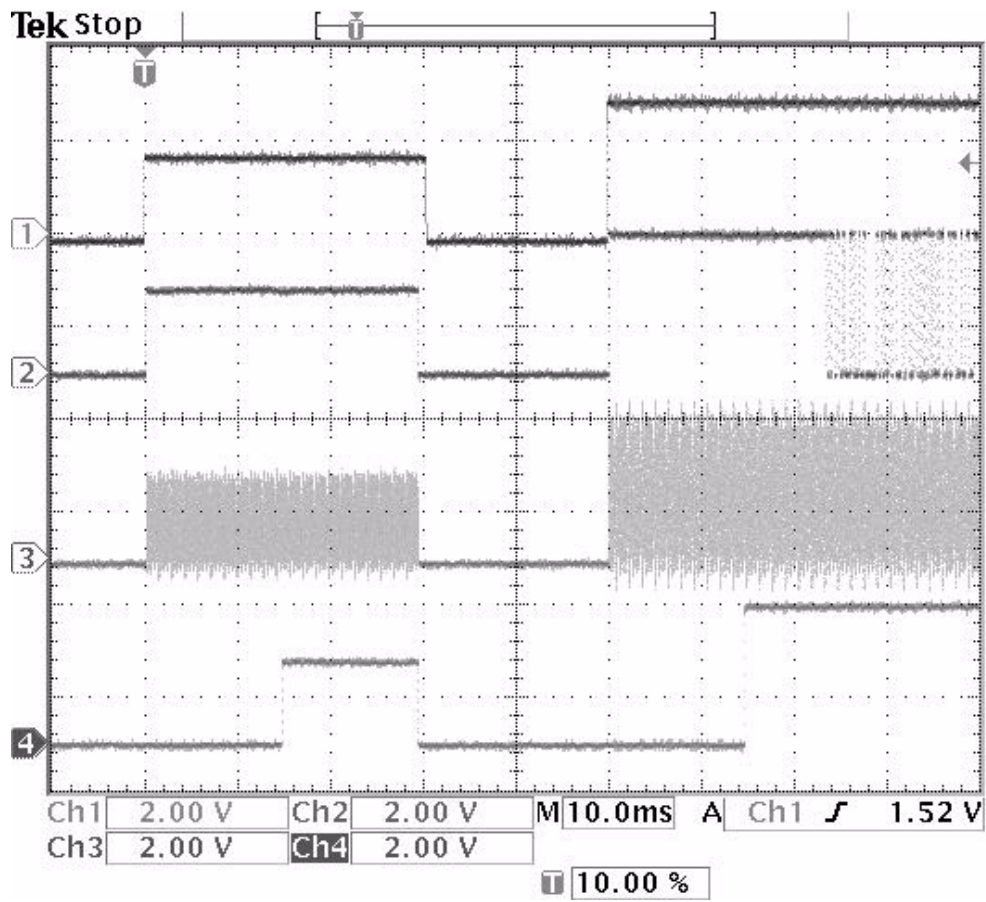
Figure 13: SIM Power up waveform

- Ch1: VSIM
- Ch2: I/O
- Ch3: Clock
- Ch4: Reset

First the SW attempts to power up the SIM with 1.8V. If this does not succeed, power up is repeated with VSIM switched to 3V.

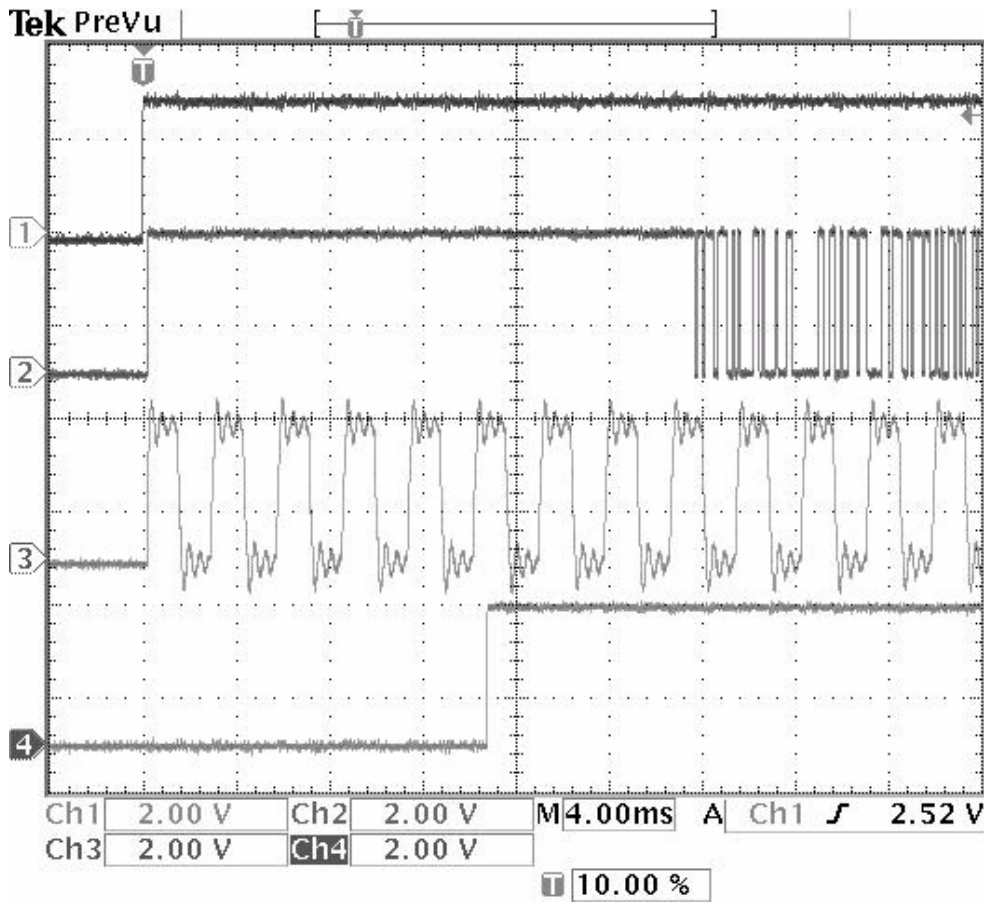
Figure 14: SIM Answer To Reset waveform

- Ch1: VSIM
- Ch2: I/O
- Ch3: Clock
- Ch4: Reset

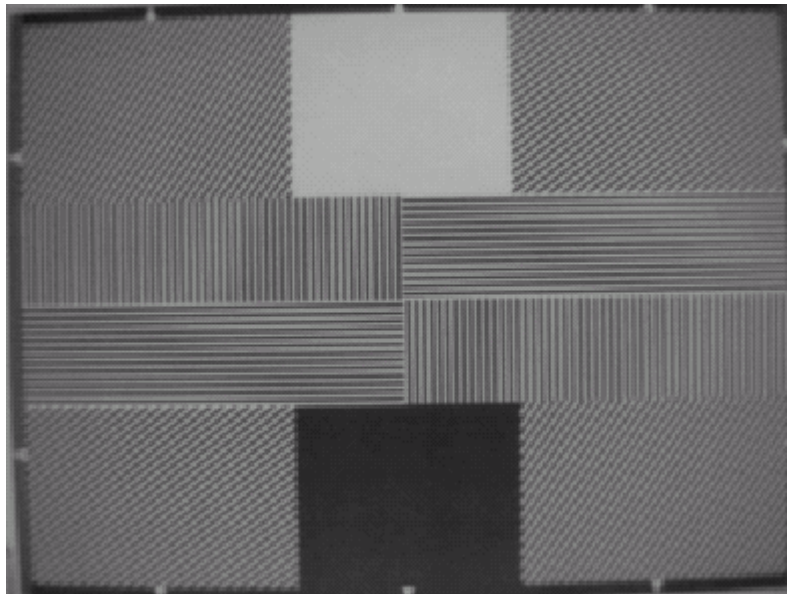
Lens performance degrades in image edges, and generally the image is sharpest in centre part. This applies particularly to distant objects (> 1 meter).

Figure 26: Sharpness of picture is worse in edge than in centre

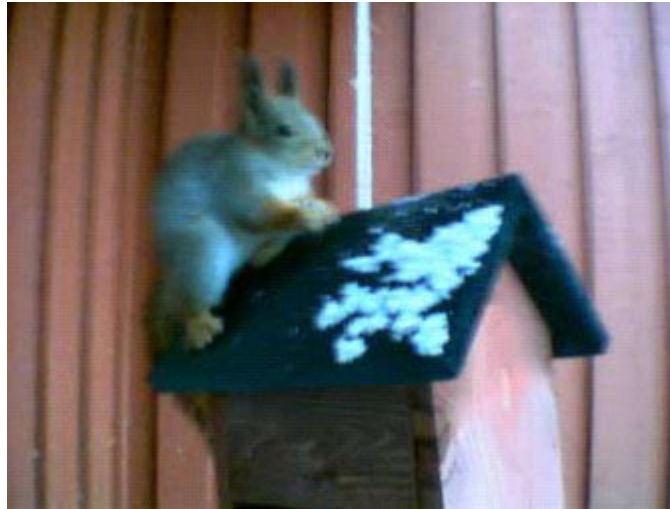
The camera lens will cause some amount of so called barrel distortion in images. In practice, this appears as bending of straight objects in edges of the image.

See the following figure. Note the geometrical barrel distortion in background, for example (wall in the background).

In dim condition camera runs out of sensitivity. Exposure time is long (especially in night mode) and the risk of getting shaken images grows. Image noise level grows. The maximum exposure time in night mode is approximately $\frac{1}{4}$ seconds, so images need to be taken with extreme care when the amount of light reflected from the target is low.

Figure 27: Shaking hands caused blurring of this image. Note the geometrical barrel distortion in background

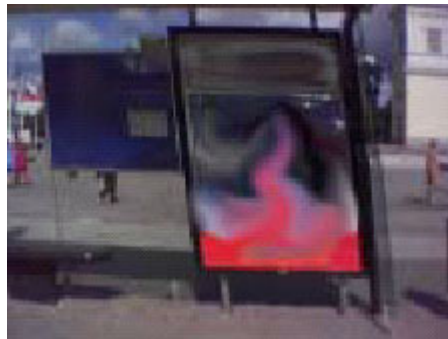
If pictures of moving objects are taken or if the device is used in a moving car, object 'skewing' or 'tilting' will occur. This phenomena is fundamental to most CMOS camera types and normal, and can not be helped. Movement of camera or object will usually cause blurring indoors or in dim lighting conditions due to long exposure time.

Figure 28: Near objects in image get skewed when shooting from a moving car

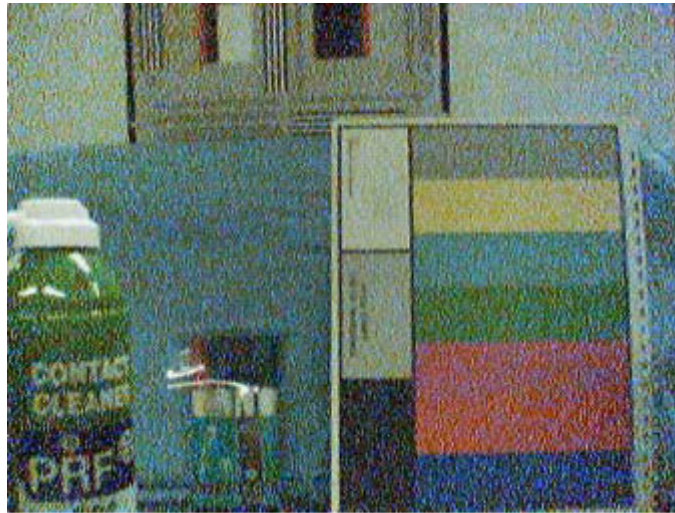
High temperatures inside the mobile phone will cause more noise to appear in images, e.g. in +70 degree of Celsius the noise level may be very high, and it further grows if the conditions are dim. This is also normal to camera operation. (See the following figure.)

Figure 29: Noisy image taken in +70deg

Noise: Variation of response between pixels with the same level of input illumination. See e.g. Figure 29: Noisy image taken in +70 deg, for an example of a noisy image.

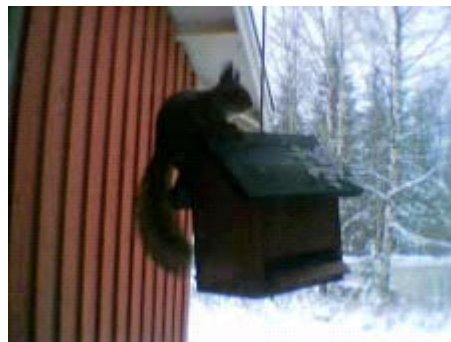
Electronic image sensors typically have much lower dynamic range than films. In practice this means that when taking a picture indoors, e.g. having a window behind object, will produce poor results.

Figure 30: Image which has been taken "against the light". The actual object (a squirrel) can't be seen well

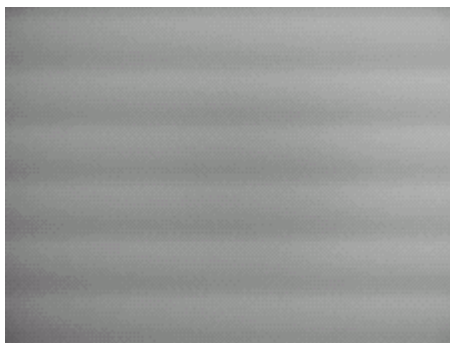
In some rare occasions a very bright fluorescent light may cause flicker to be seen in the viewfinder image.

Figure 31: Flicker in image of white uniform object illuminated by strong fluorescent light

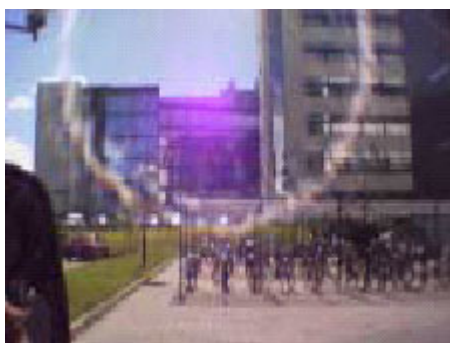
Bright light outside of image view:
Especially sun causes clearly visible 'halo' effects and poor contrast in images. This happens due to unwanted reflections inside camera optics.

Figure 32: A lens reflection effect caused by sun shining above the scene

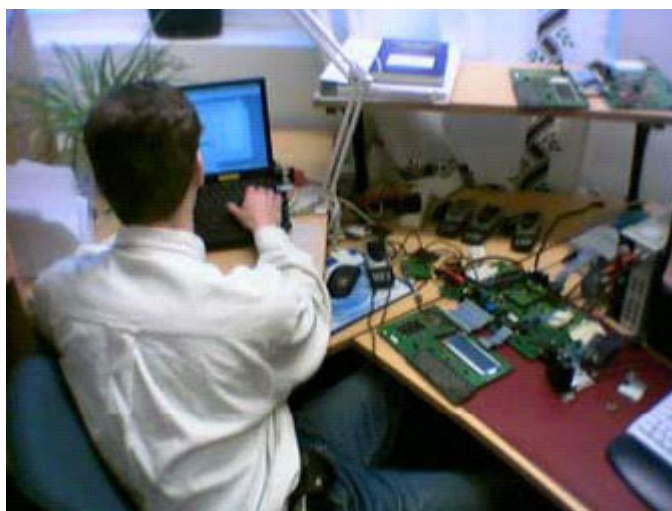
Figure 33: A good quality picture taken indoors

If no visible defects (items 2-4) can be found, a couple of test images should be taken and checked. Generally, a well illuminated typical indoor office scene, such as the one in Figure 33: A good quality picture taken indoors, can be used as a target.

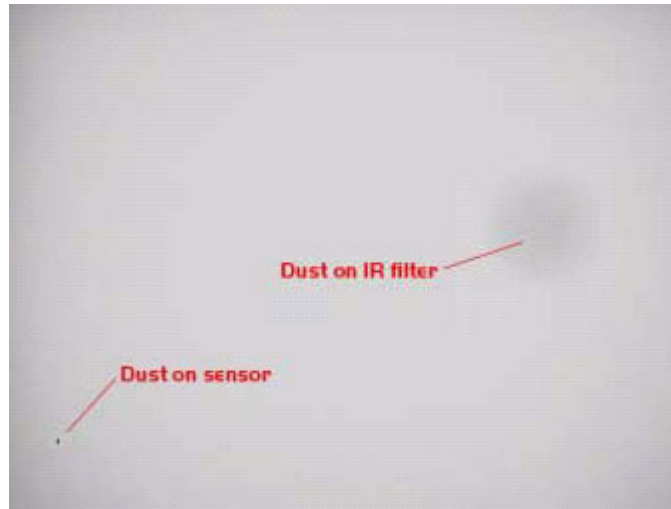
If dust particles are located on the infrared filter surface on either side, they are much harder to locate because they will be out of focus, and appear in the image as large, greyish and fading-edge 'blobs'. Sometimes they will be very hard to find, and thus the user probably will not notice them at all since they do no harm. But it is possible that a larger particle disturbs the user, causing the need for service.

Figure 34: Effects of dust in optical path

Black spots in image are caused by dirt particles trapped into the optical system: clearly visible and sharp edged black dots in the image are typically dust particles on the image sensor.

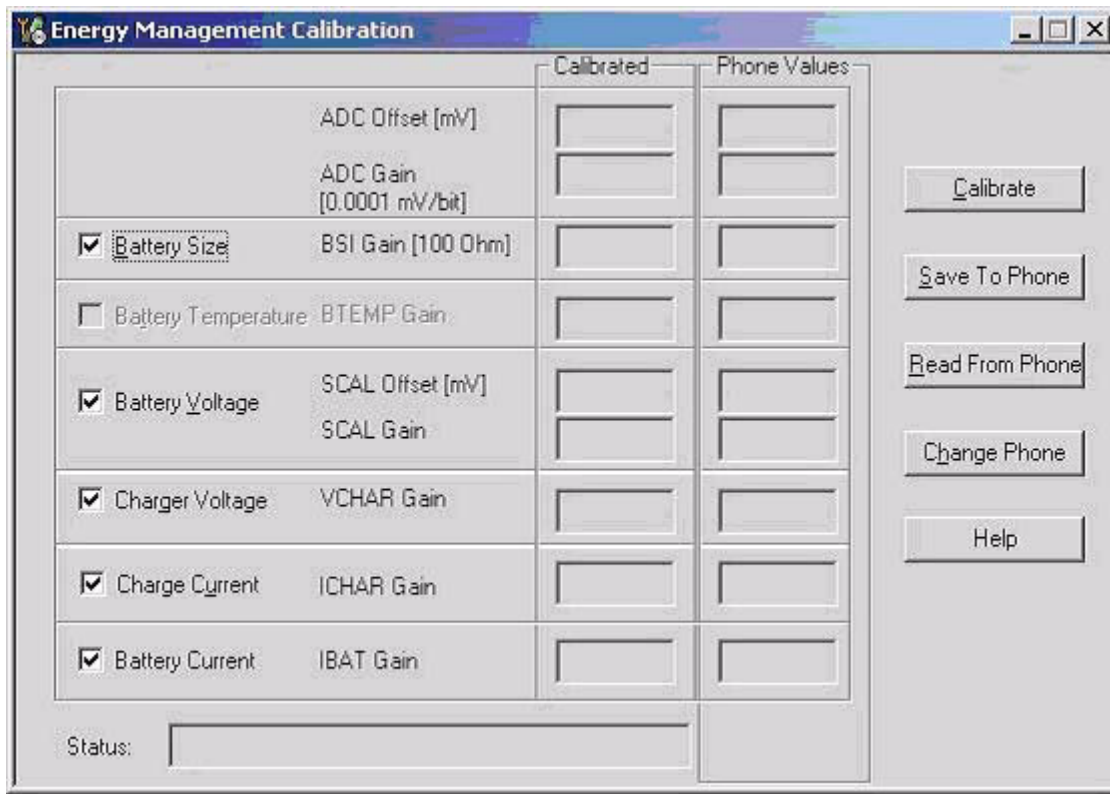
Figure 38: Energy Management Calibration window

- Start Phoenix service software.
- Select FBUS connection.
- Choose Main -> Choose product-> NHL-10.
- Choose Tuning-> Energy Management Calibration.

- 1 Select **Read from phone** to display the current calibration values that stored in the phone memory. The values are displayed in the **Phone Values** field.
- 2 Select the ADC channel(s) you intend to calibrate.
- 3 Press **Calibrate**.
- 4 Calibration is automatically done regarding the calibration channel(s) that you selected.
- 5 The candidate of the new calibration values is shown in the "calculated" field. If the new calibration values are within the limit (please refer to the calibration value limit table), Press **Save to phone** to store the new calibration value(s) into the phone.
- 6 Select **Read from phone** to confirm if the new calibration value(s) are stored into phone, correctly. If not, please try to store by selecting **Write to PM** again.
- 7 Close the Energy Management Calibration window.

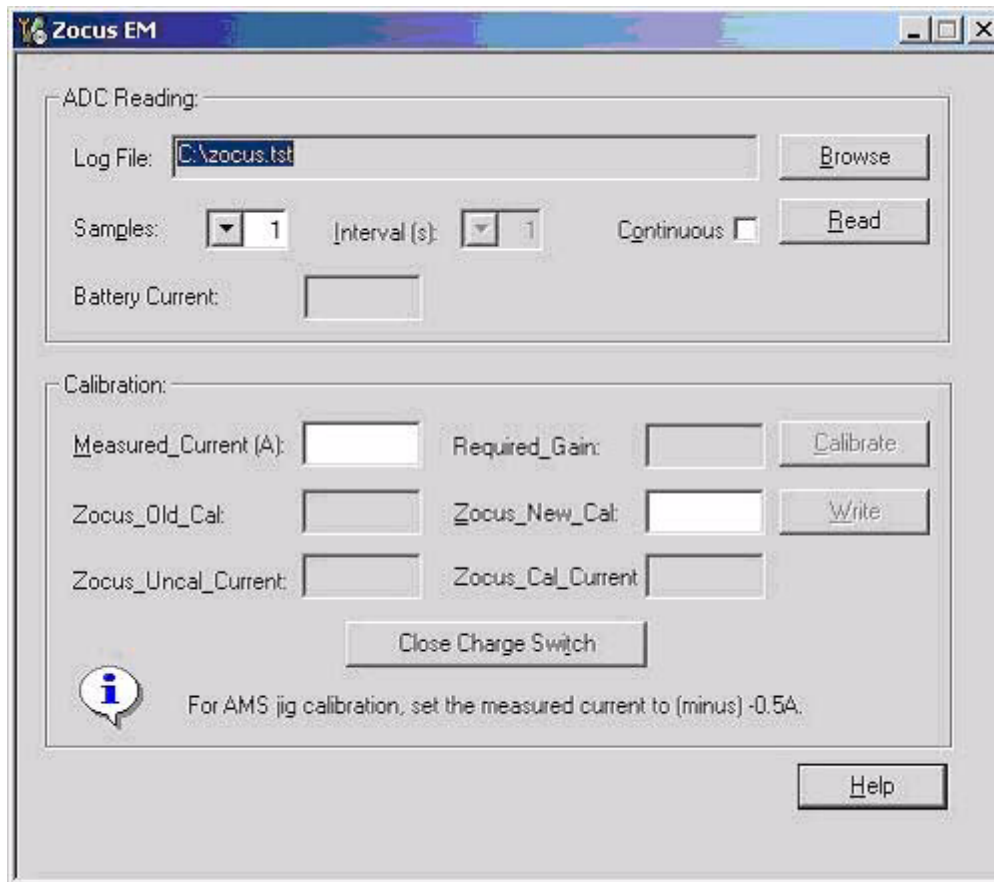
Figure 39: Zocus EM window

- Start Phoenix service software.
- Select FBUS connection.
- Choose **Main** -> Choose product-> **NHL-10**.
- Choose **Tuning** -> **Zocus EM**.

- 1 Place the PWB in the module jig.
- 2 Connect an ammeter to Ammeter sockets to check the current flowing on the line.
Be careful for the shunt resistor value of ammeter. Large shunt resistor value causes the difficulty of phone power up.
- 3 Set the S1: Passed and S2: Calibration.
- 4 Power up the module jig in local mode – the ammeter will indicate the local mode current.
- 5 Connect the charger input to a power supply set to 8.4V and current limited to 500mA.
- 6 Turn the power supply on.
- 7 Open the **Zocus EM** window in Phoenix.
