**Nokia Customer Care**  
**RH-51/52, RH-67/68 Series Cellular Phones**

**6(a) – Baseband Troubleshooting  
and Manual Tuning Guide**

This document is intended to be a guide for localising and repairing electrical faults in the RH-51/52, RH-67/68 device. The fault repairing is divided into troubleshooting paths.

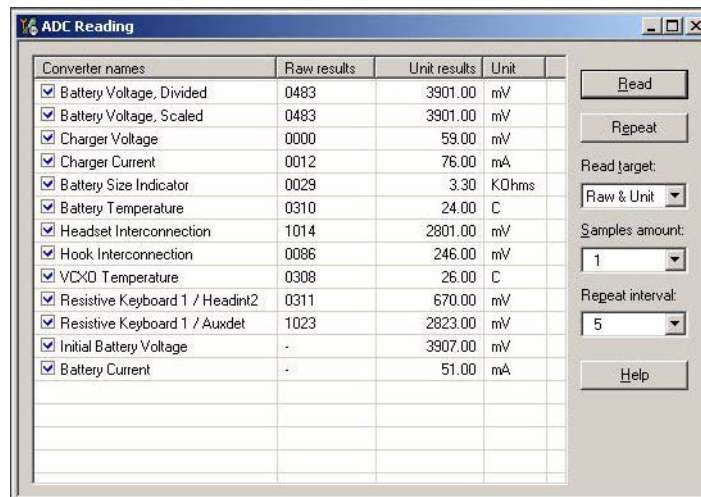
Figure 12: ADC reading view

Divided and scaled battery voltage, battery current, charger voltage, charger current and BSI values can be read by this tool. Read values a few times before you can be sure that results are accurate.

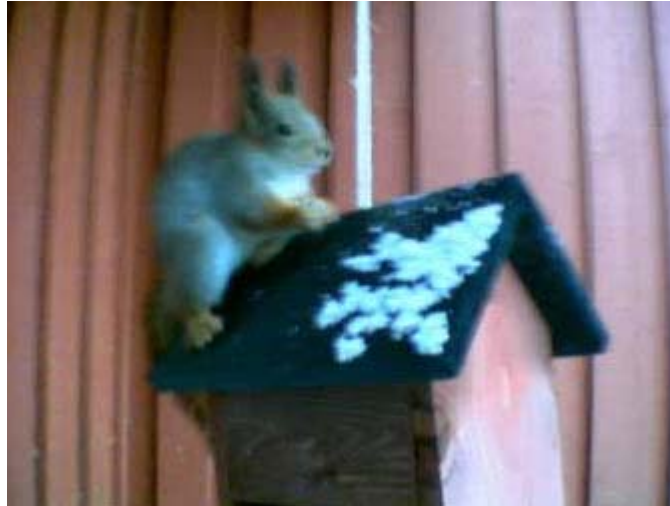
In dim conditions the camera runs out of sensitivity. Exposure time is long (especially in night mode) and the risk of getting shaken images grows. Image noise level grows. The maximum exposure time in night mode is approximately  $\frac{1}{4}$  seconds, so images need to be taken with extreme care when the amount of light reflected from the target is low.

Figure 31: Shaking hands caused blurring of this image. Note geometrical barrel disortion in background.

The camera lens will cause some amount of so called barrel distortion in images. In practice, this appears as bending of straight objects in edges of the image.
