Nokia Customer Care
RH-51/52, RH-67/68 Series Cellular Phones

**6(a) – Baseband Troubleshooting
and Manual Tuning Guide**

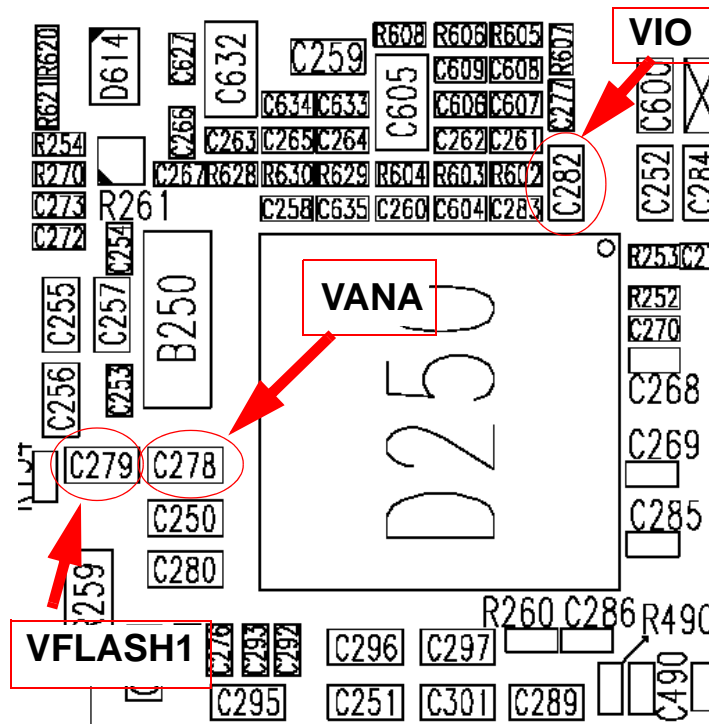
UEME internal regulators

Test points: VIO 1.8V at C282

VANA 2.78V at C278

VFLASH1 2.78V at C279

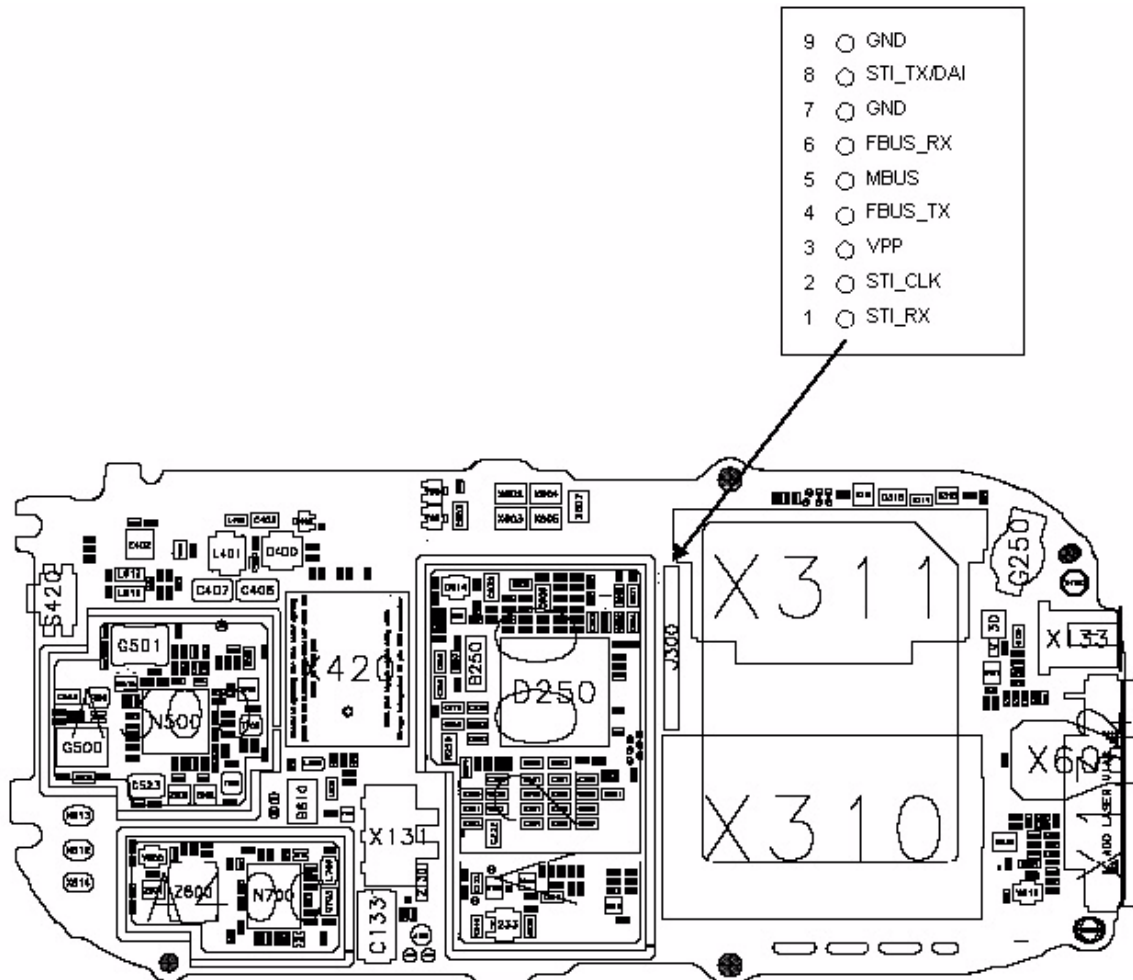
Figure 9: Flash interface layout (FBUS/MBUS test pads layout)

Fbus signals can be seen at flashing test pads and the pad layout is shown in the following figure.

The interface voltage level on the phone flash/test pad pattern is 2.78V and on the UPP_WD2 end it is 1.8V. MBUS traffic between UPP_WD2 and UEME can be tested with Phoenix (ST_MBUS_RX_TX_LOOP_TEST). Flashing is not possible if there is a problem in MBUS. The MBUS signal can also be seen at flashing test pads and the pad layout is shown in the following figure.

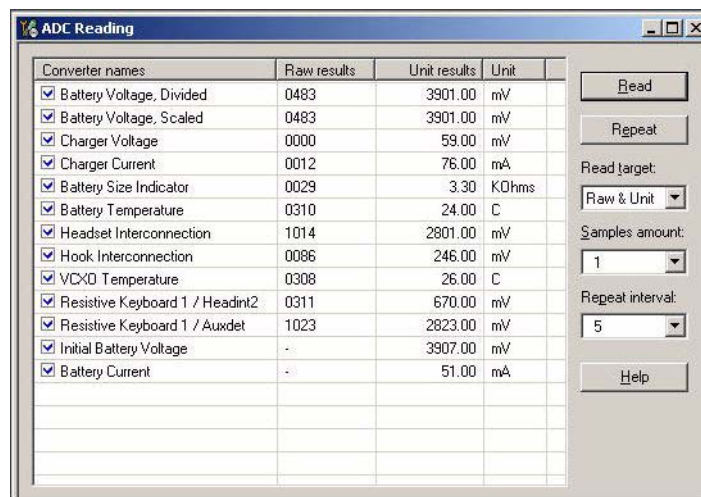
Figure 12: ADC reading view

Calibration can be checked using the ADC reading. Known voltages, currents and resistances are fed and read by the ADC reading, read values and known values can be compared.

Divided and scaled battery voltage, battery current, charger voltage, charger current and BSI values can be read by this tool. Read values a few times before you can be sure that results are accurate.

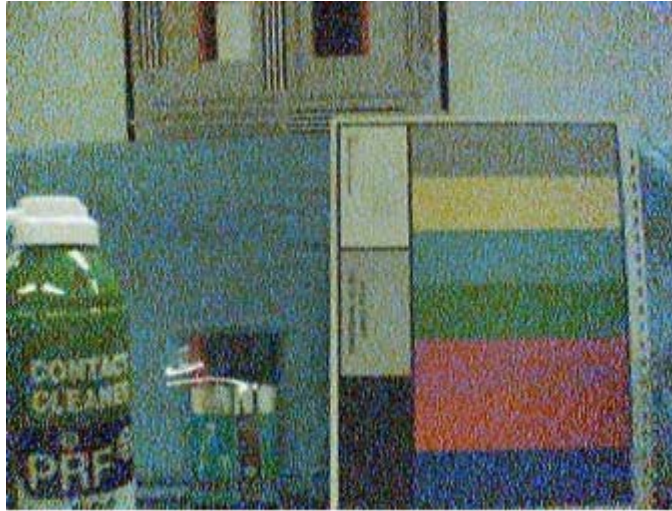
High temperatures inside the mobile phone will cause more noise to appear in images, e.g. in $+70^{\circ}\text{C}$ the noise level may be very high, and it further grows if the conditions are dim. This is also normal to camera operation. (See the following figure.)

Figure 33: Noisy image taken in +70deg

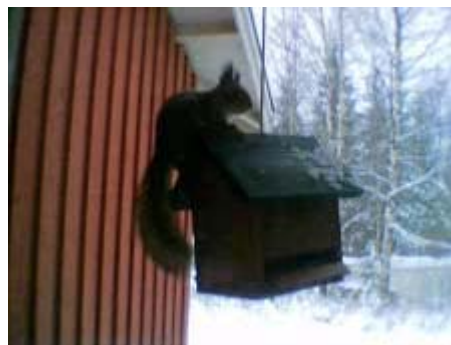
Electronic image sensors typically have a much lower dynamic range than films. In practice, this means that when taking a picture inside e.g. having a window behind the object, will produce poor results.

Figure 34: Image which has been taken "against the light". The actual object (a squirrel) can't be seen well

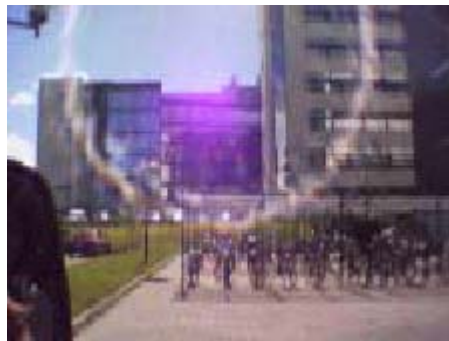
Especially sun causes clearly visible 'halo' effects and poor contrast in images. This happens due to unwanted reflections inside camera optics.

Figure 36: A lens reflection effect caused by sun shining above the scene

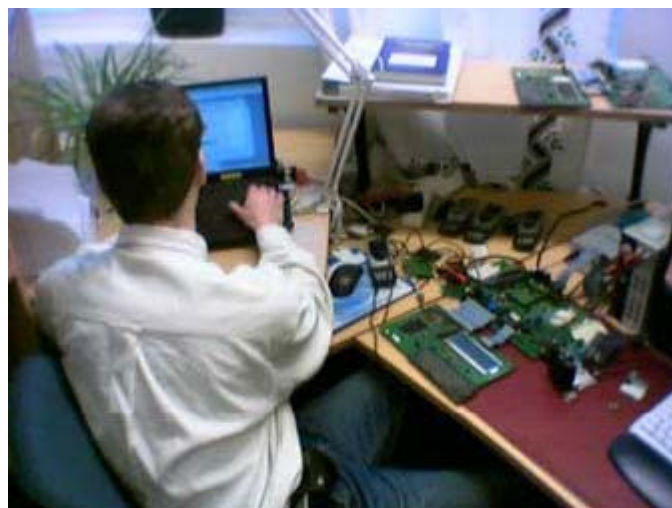
Figure 37: A good quality picture taken indoors

If no visible defects (items 2-4) can be found, a couple of test images should be taken and checked. Generally, a well illuminated typical indoor office scene, such as the one in Figure "A good quality picture taken indoors", can be used as a target.
