PAMS Technical Documentation

NSE-5 Series Transceivers

Troubleshooting

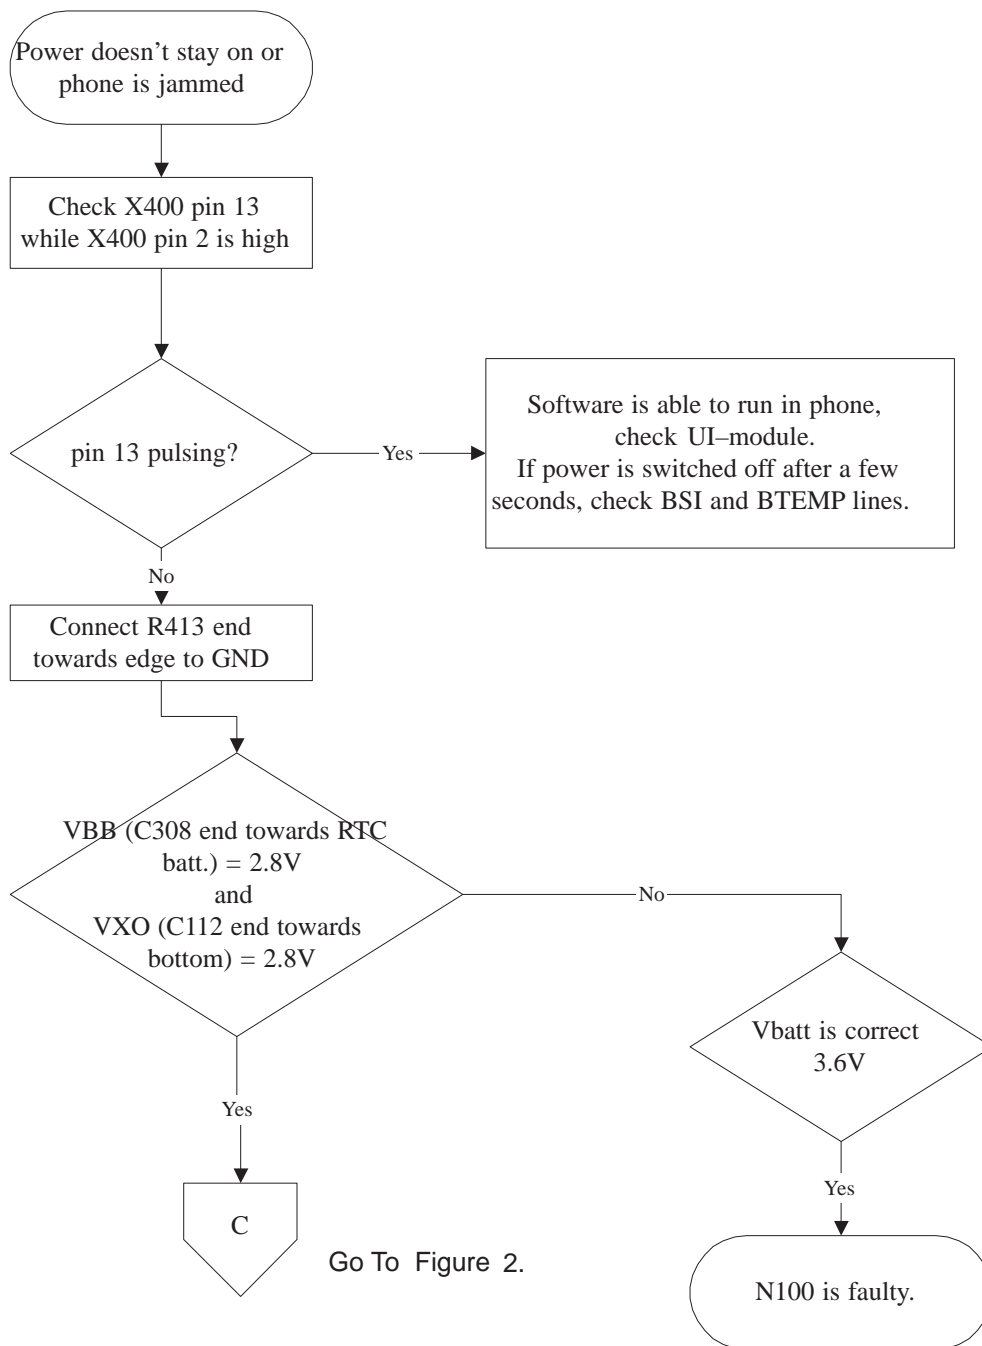
Figure 5.

3. Power doesn't stay on or phone is jammed

Normally the power will be switched off by CCONT (N100) after 30 seconds, if the watchdog of the CCONT can not be served by software.

Check watchdog is updated. X400 pin 2 is high and at the same time X400 pin 13 toggles. In the normal case there is a short burst of pulses every 8 seconds.

The power off function of CCONT can be prevented by connecting a short circuit wire from CCONT R413 (end towards edge) to ground.

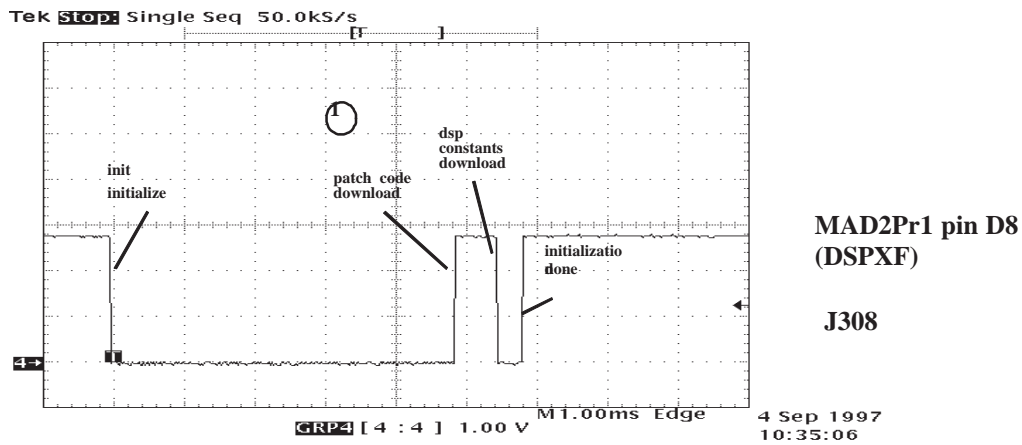
Figure 8.

The states of DSP after power on

After power up, DSP signals all completed functions by changing the state of the XF pin (see Figure 1-6, Figure 1-7, Figure 1-8 and Figure 1-9).

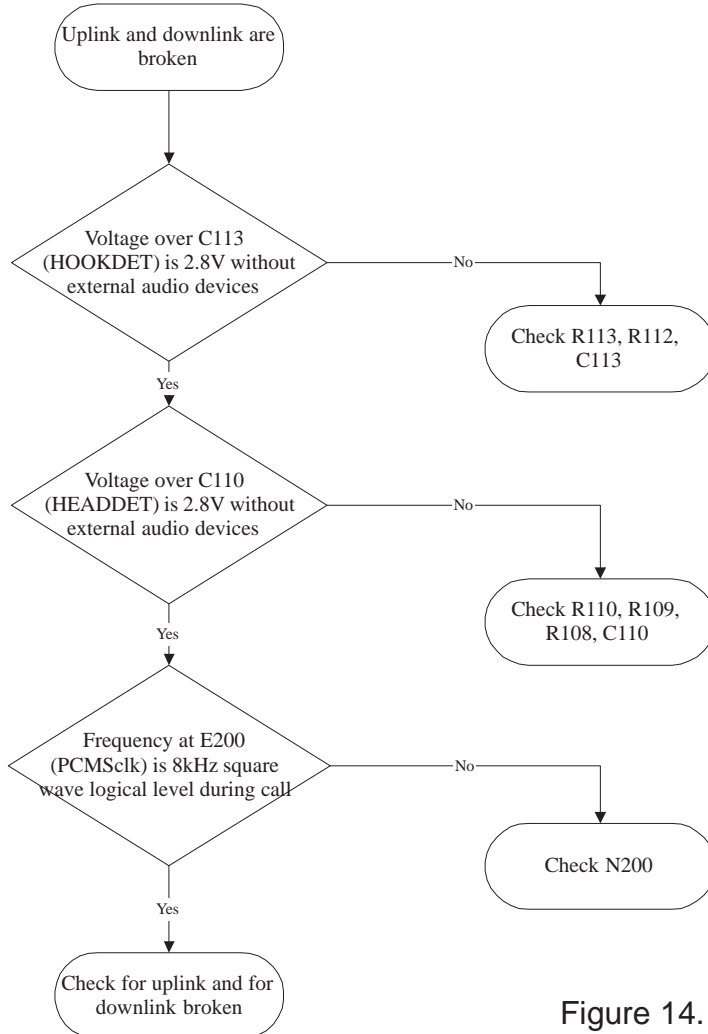
Figure 14.

7.1 Uplink/Downlink Problem

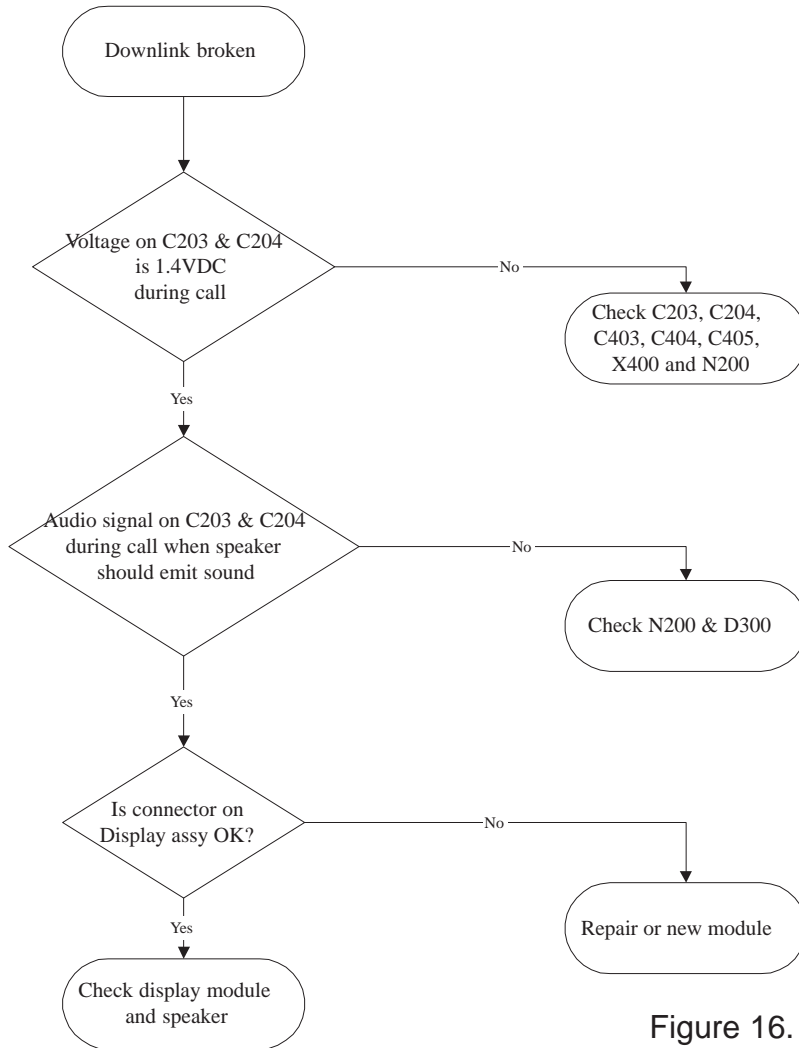
Figure 16.

7.1 Downlink Problem

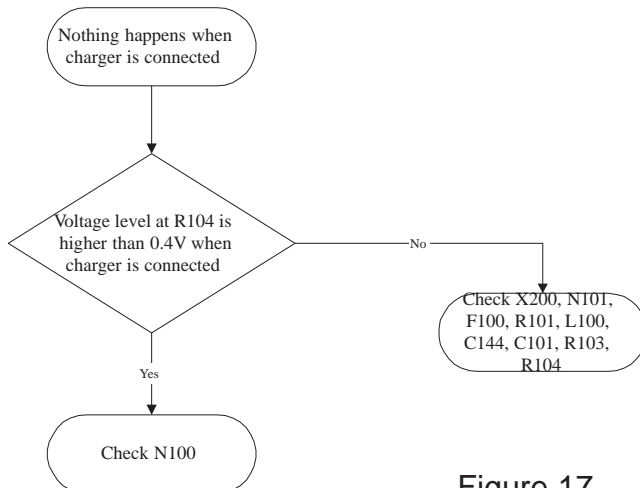
Figure 17.

8.1 Seems Dead

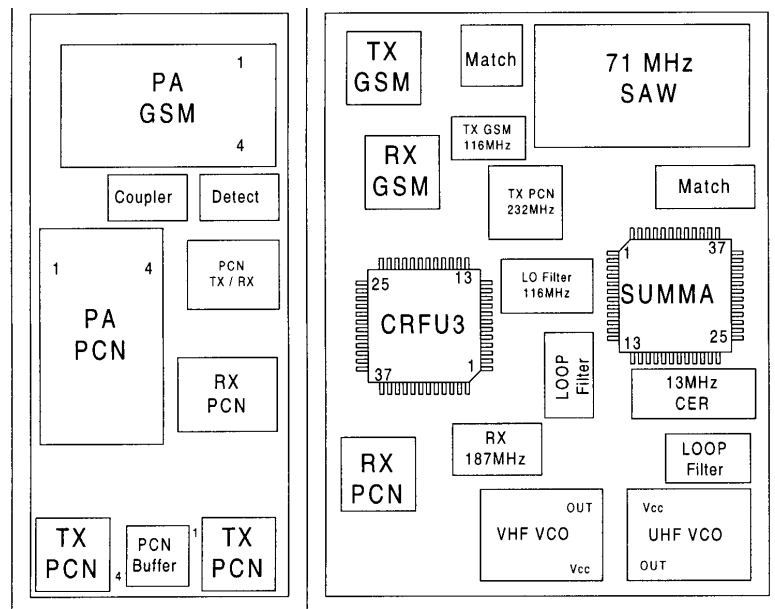
Figure 1. PCB Top View

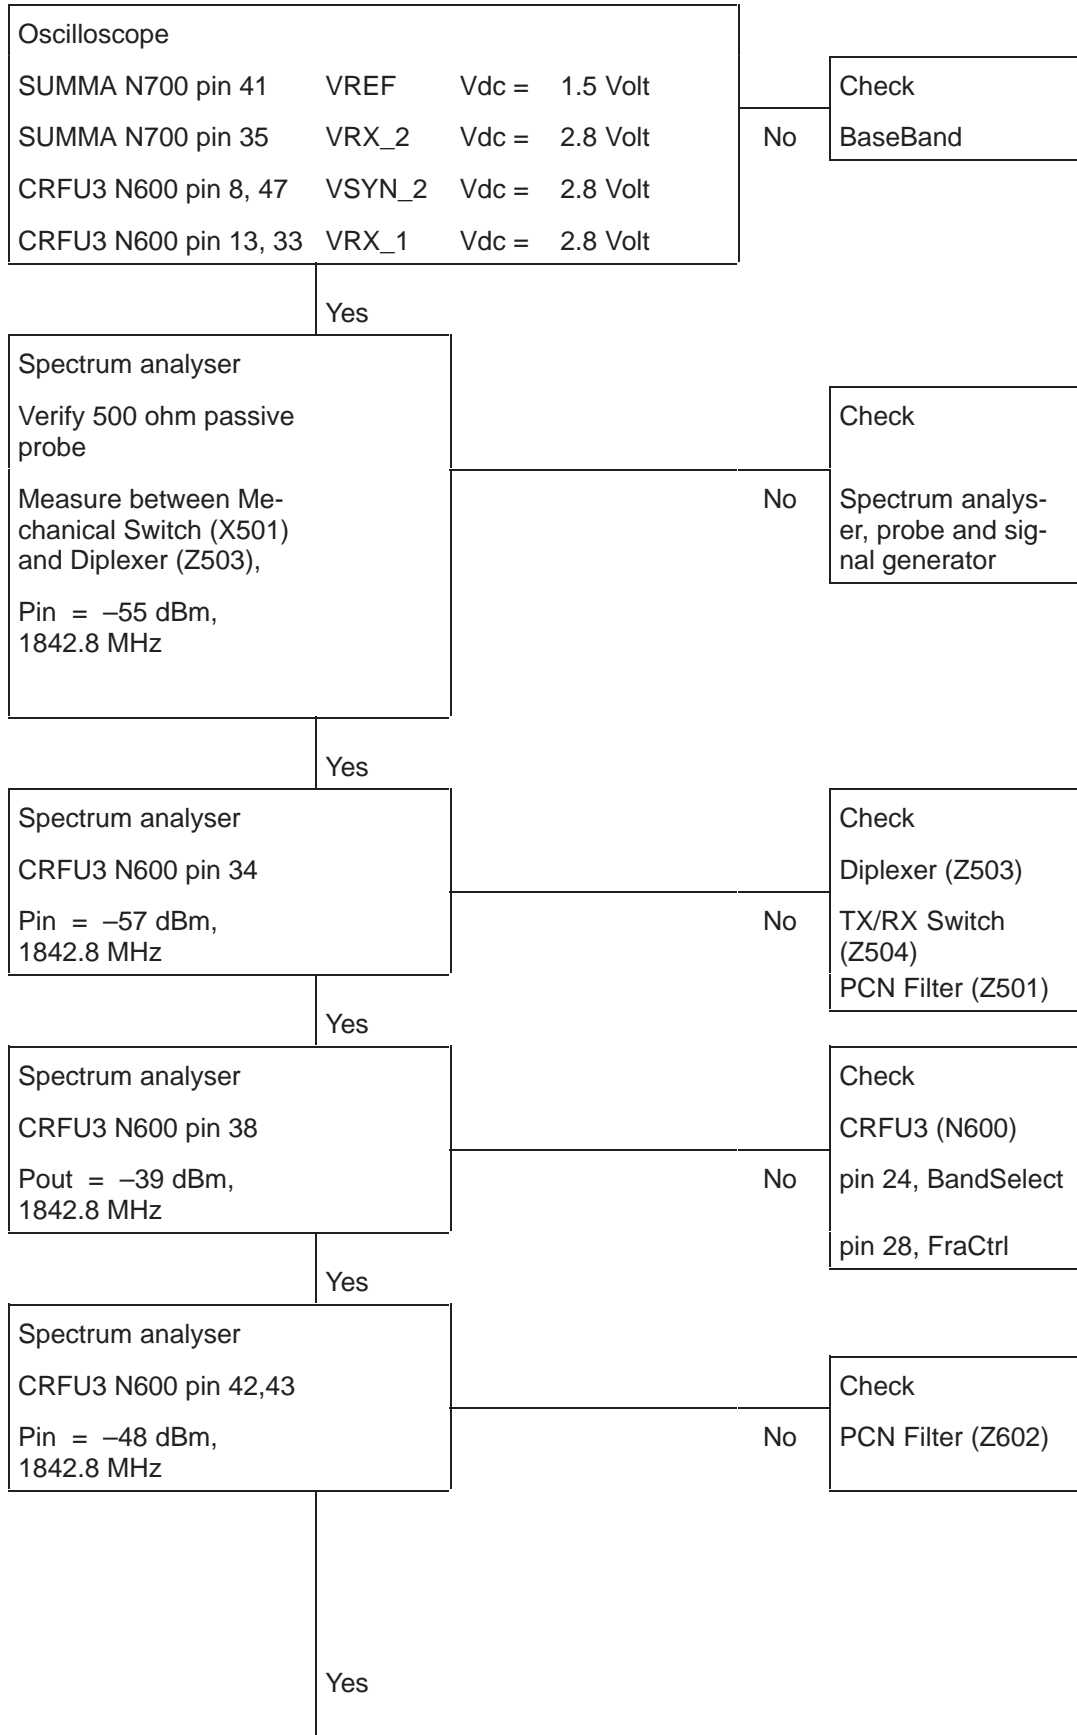
Antenna, Mechanical Switch (X501), Diplexer (Z503), TX/RX Switch (Z504), PCN Filter (Z501), CRFU3 (LNA N600), PCN Filter (Z602), CRFU3 (Mixer N600), LC 187 MHz Filter (L604), CRFU3 (Mixer N600), SAW 71MHz Filter (Z700), SUMMA (N700), 13Mhz Filter (Z701), SUMMA, COBBA_GJP (N200).

Fault finding chart for PCN receiver
