Nokia Customer Care
RH-51/RH-52 Series Cellular Phones

**6(a) – Baseband Troubleshooting
and Manual Tuning Guide**

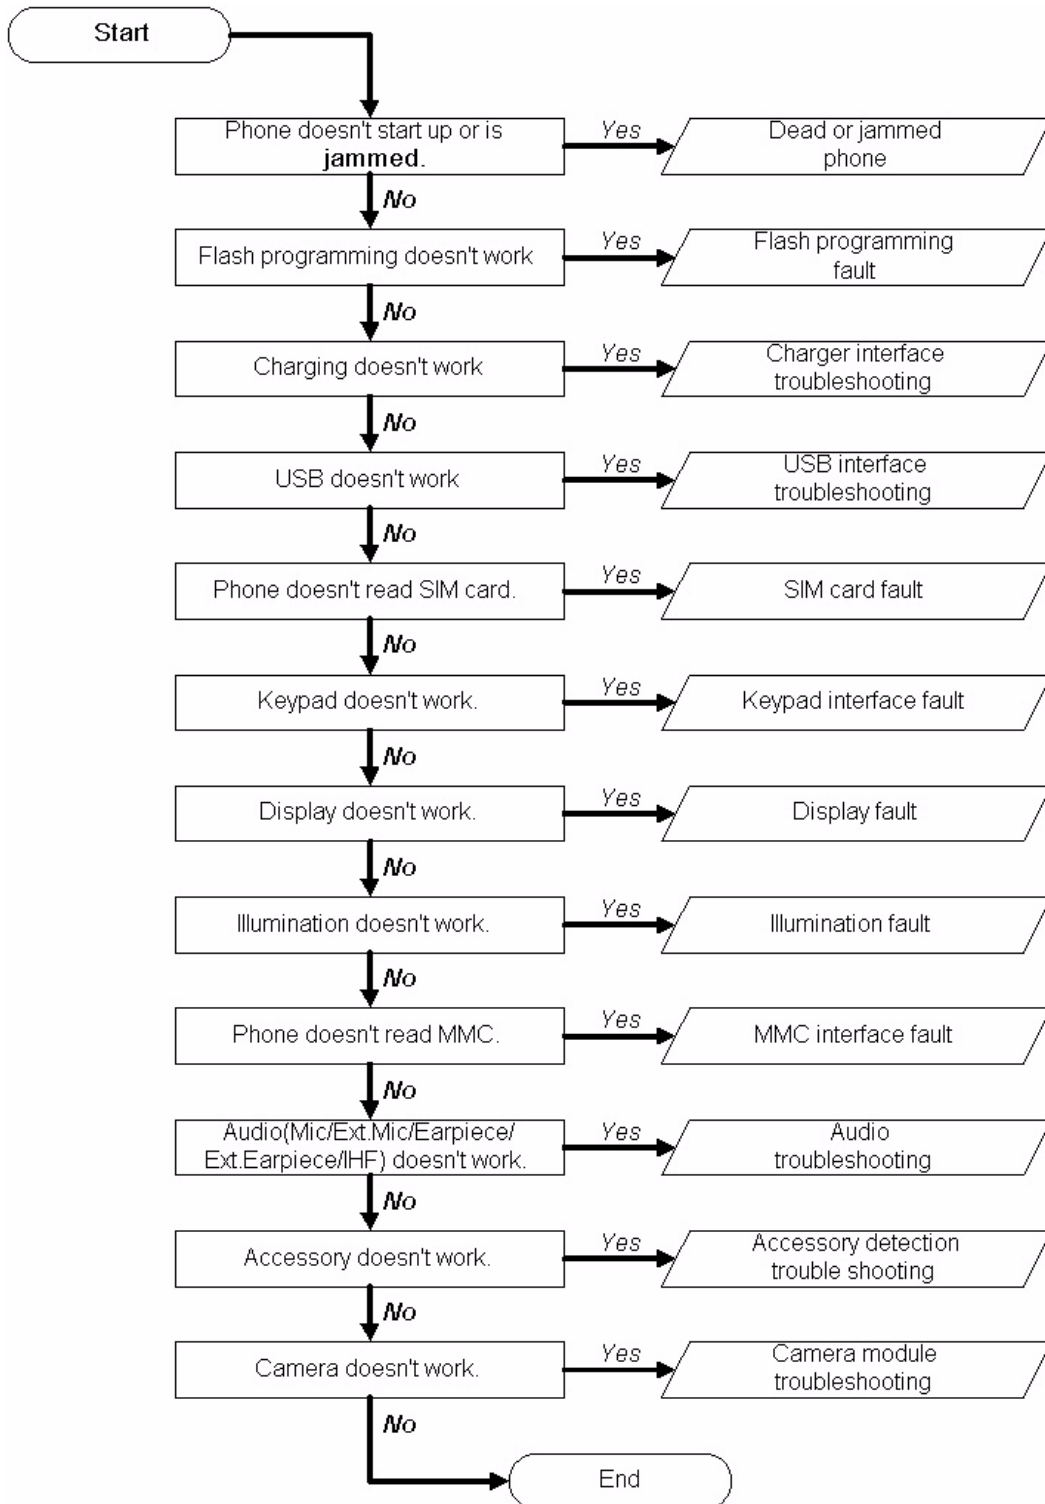
Figure 1: Main troubleshooting diagram

The following diagrams describe baseband troubleshooting.

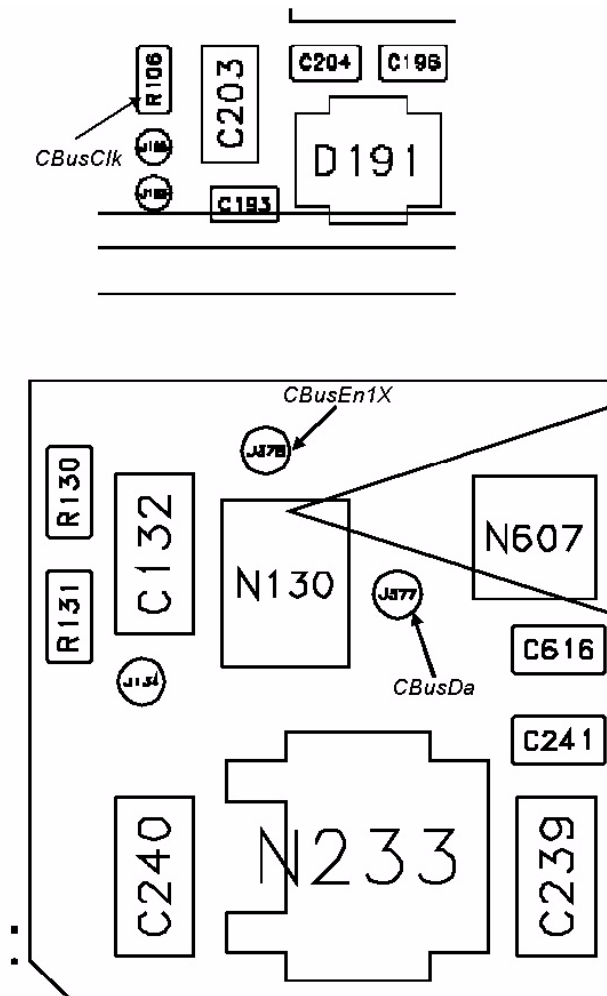
Figure 7: CBUS test points

- CBusClk UPP_WD2 side of R106 pin
- CBusEN1X J378 Pad
- CBusDA J377 Pad

The pads and pin are shown below.

If the interface is faulty from the UPP_WD2's end, the phone does not boot properly as powering configurations do not work. Traffic on the bus can be monitored at the following test point and pins.

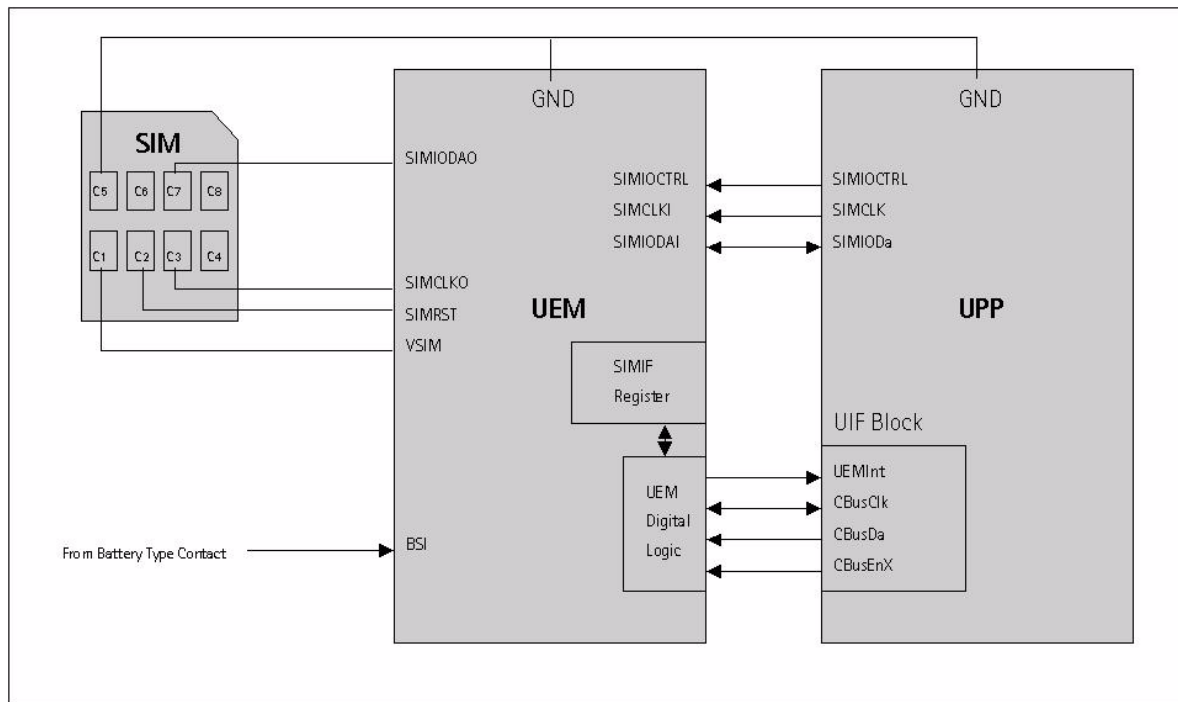
Figure 14: UPP_WD2 and UEME SIM connections

The whole SIM interface is located in two chips; UPP_WD2 and UEME. UEME contains the SIM interface logic level shifting. UPP_WD2 provides SIMClk through UEME to the SIM. The SIM interface supports both 3V and 1.8V SIMs. There is an EMIF component (3 lines EMI filter) between the SIM card and the UEME which isn't shown in the figure below.

The SIM power up/down sequence is generated in the UEME. This means that the UEME generates the RST signal to the SIM. The card detection is taken from the BSI signal, which detects the removal of the battery. A comparator inside UEME monitors the BSI signal. The threshold voltage is calculated from the battery size specifications.

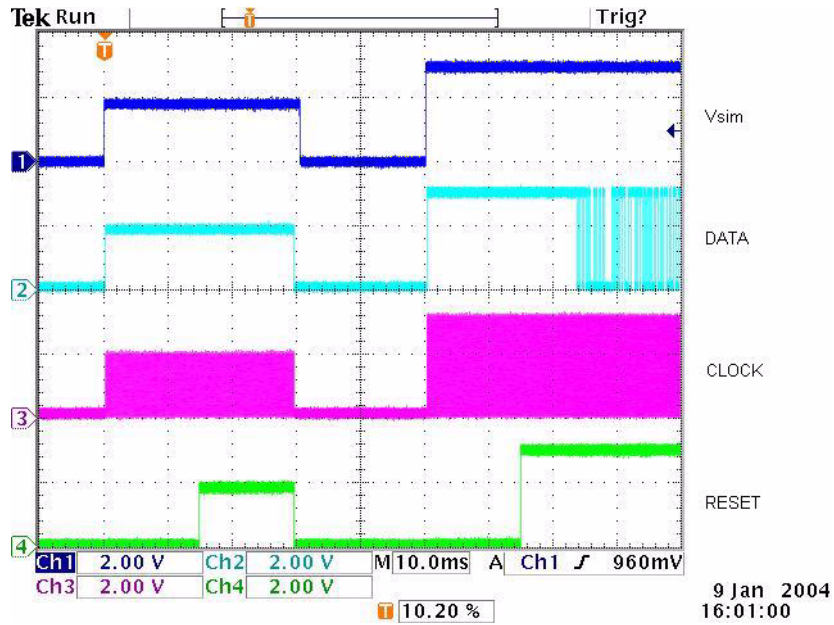
Figure 15: SIM power up waveform

First, the SW attempts to power up the SIM with 1.8V. If this does not succeed, power up is repeated with VSIM switched to 3V.

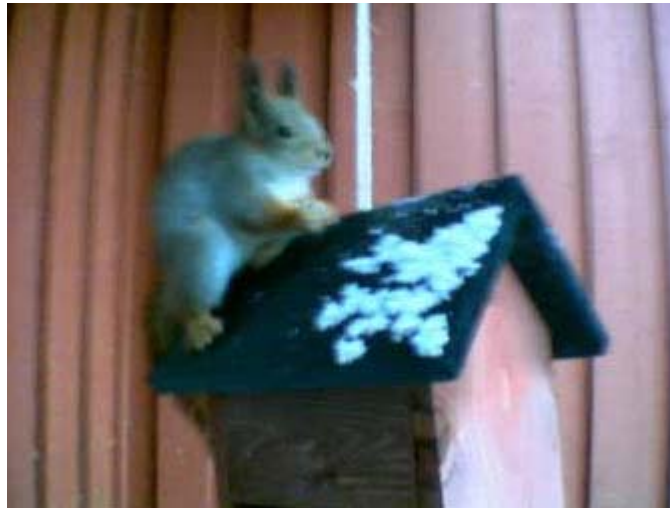
In dim conditions the camera runs out of sensitivity. Exposure time is long (especially in night mode) and the risk of getting shaken images grows. Image noise level grows. The maximum exposure time in night mode is approximately $\frac{1}{4}$ seconds, so images need to be taken with extreme care when the amount of light reflected from the target is low.

Figure 31: Shaking hands caused blurring of this image. Note geometrical barrel disortion in background.

The camera lens will cause some amount of so called barrel distortion in images. In practice, this appears as bending of straight objects in edges of the image.

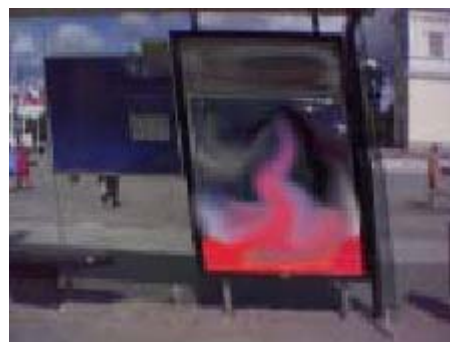
If pictures of moving objects are taken or if the device is used in a moving car, object 'skewing' or 'tilting' will occur. This phenomenon is fundamental to most CMOS cameras, and can not be helped. Movement of camera or object will usually cause blurring in inside or dim lighting conditions due to long exposure time.

Figure 32: Near objects in image get skewed when shooting from a moving car

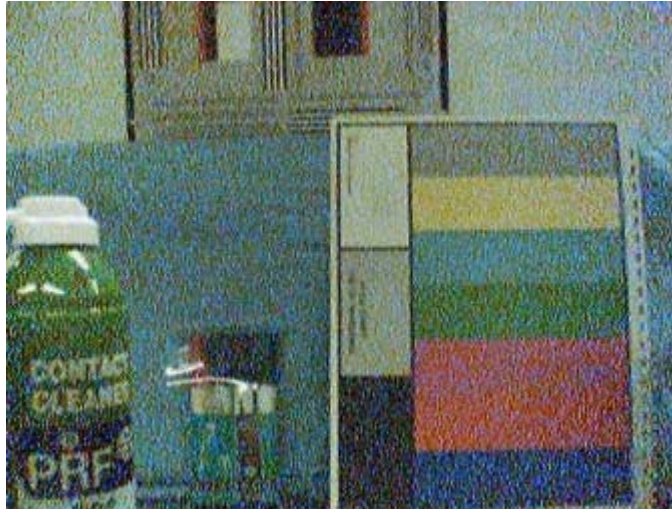
High temperatures inside the mobile phone will cause more noise to appear in images, e.g. in $+70^{\circ}\text{C}$ the noise level may be very high, and it further grows if the conditions are dim. This is also normal to camera operation. (See the following figure.)

Figure 33: Noisy image taken in +70deg

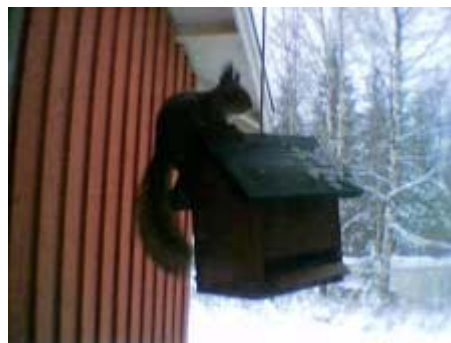
Electronic image sensors typically have a much lower dynamic range than films. In practice, this means that when taking a picture inside e.g. having a window behind the object, will produce poor results.

Figure 34: Image which has been taken "against the light". The actual object (a squirrel) can't be seen well

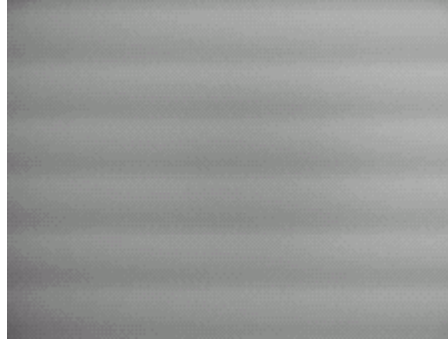
In some rare occasions a very bright fluorescent light may cause flicker to be seen in the viewfinder image.

Figure 35: Flicker in image of white uniform object illuminated by strong fluorescent light

Flicker: A phenomenon, which is caused by pulsating in scene lighting, typically appearing as wide horizontal stripes in image.

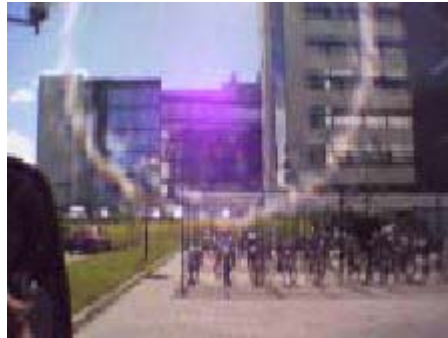
Especially sun causes clearly visible 'halo' effects and poor contrast in images. This happens due to unwanted reflections inside camera optics.

Figure 36: A lens reflection effect caused by sun shining above the scene

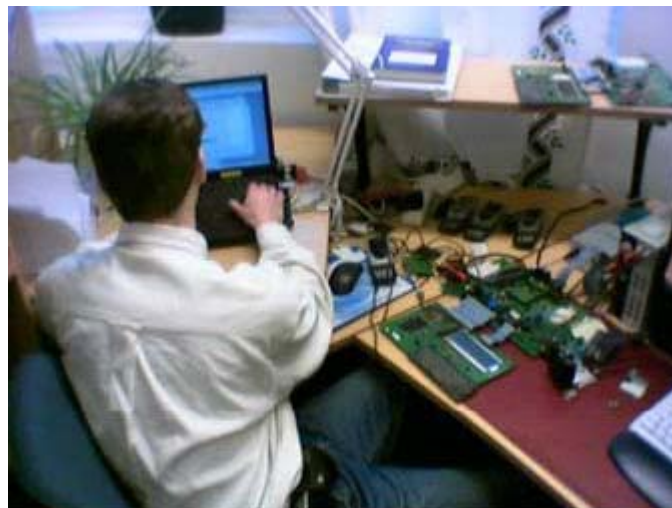
Figure 37: A good quality picture taken indoors

If no visible defects (items 2-4) can be found, a couple of test images should be taken and checked. Generally, a well illuminated typical indoor office scene, such as the one in Figure "A good quality picture taken indoors", can be used as a target.

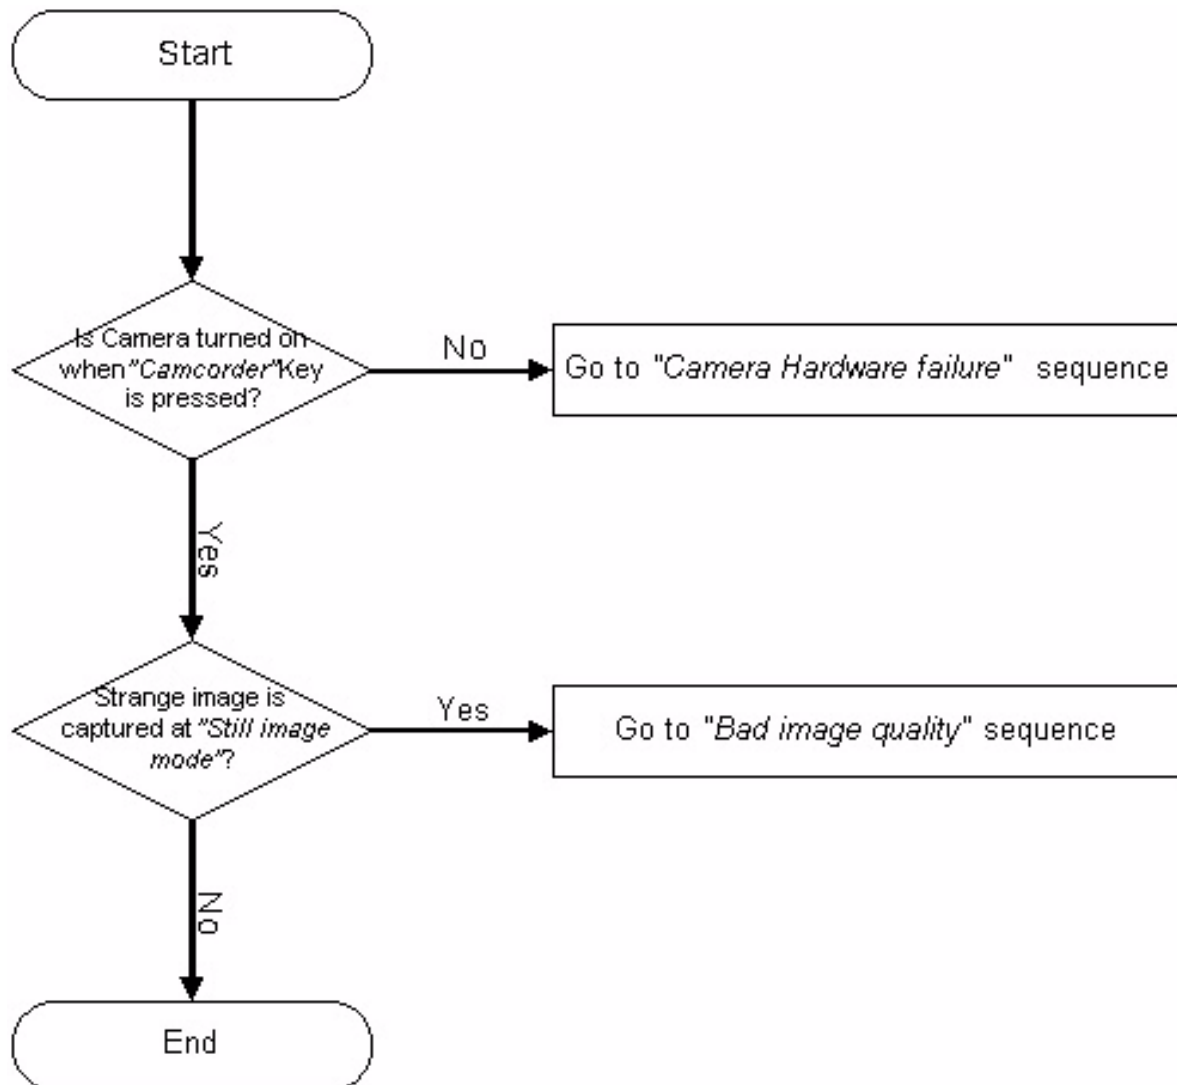
If camera related hardware is faulty, follow the troubleshooting sequence below.

Figure 39: Camera HW troubleshooting

Camera hardware failure troubleshooting flow
