**CCS Technical Documentation
NHL-2NA Series Transceiver**

Troubleshooting Instructions

Baseband Troubleshooting

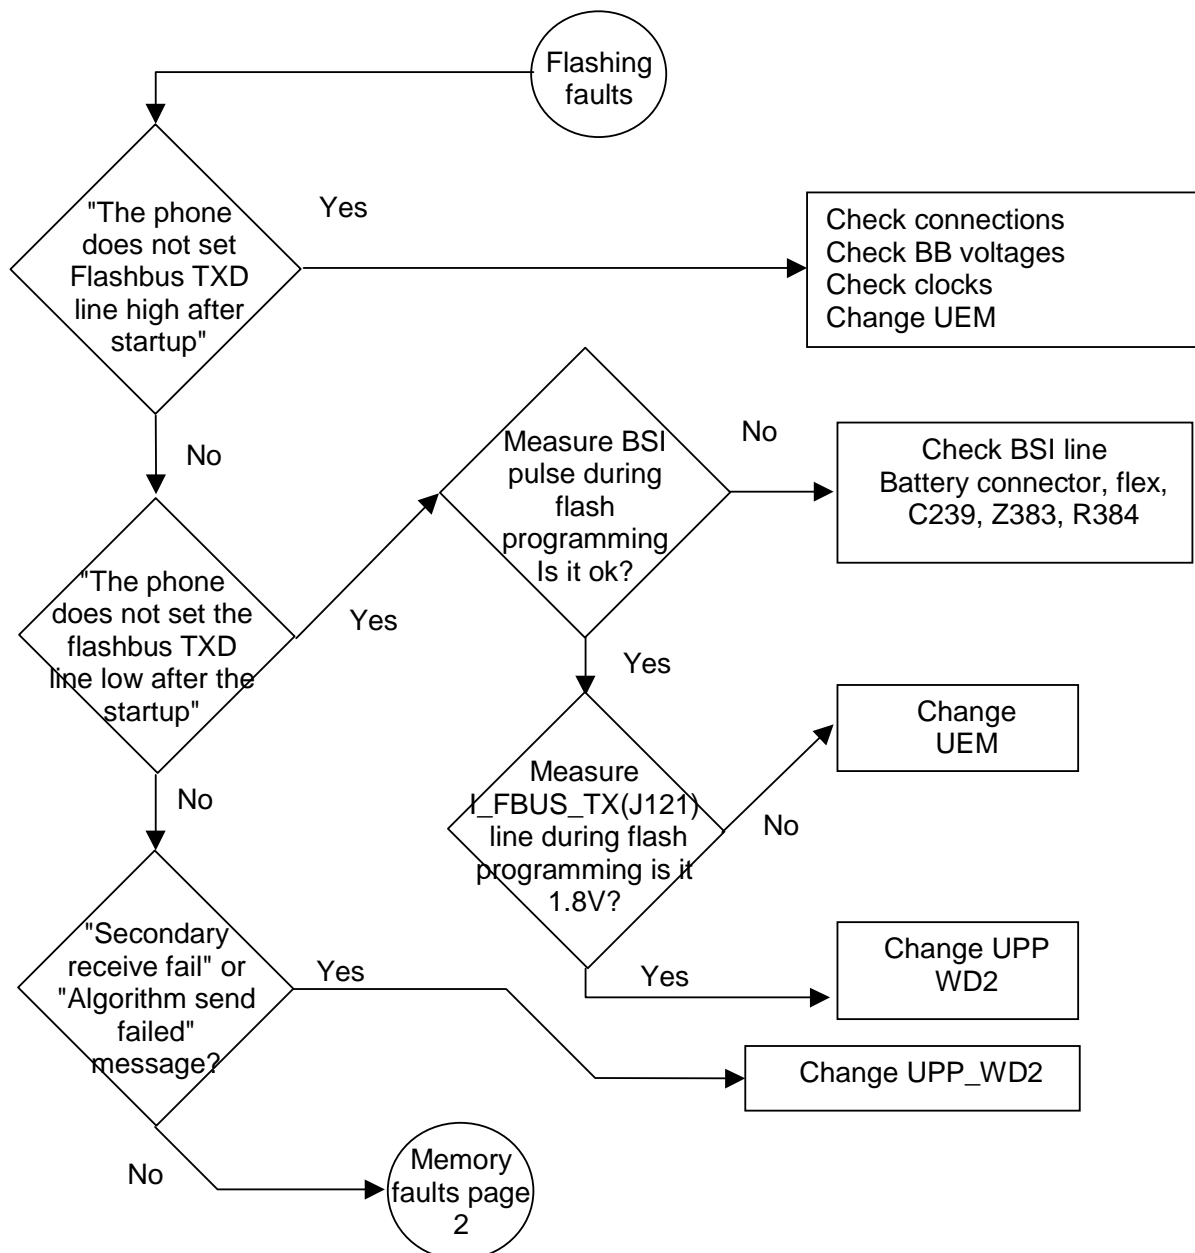
Flashing troubleshooting

NHL-2NA has three memory components installed on the main pwb. The best indication of which one is causing problems can be obtained by flashing the device. It has to be kept in mind that all three flashes are interfaced with UPP WD2 asic that might itself have some problems. The necessary steps are described below. Phoenix error messages during flashing greatly help on defining what is wrong. To be able to flash the device, most device BB area components must function properly.

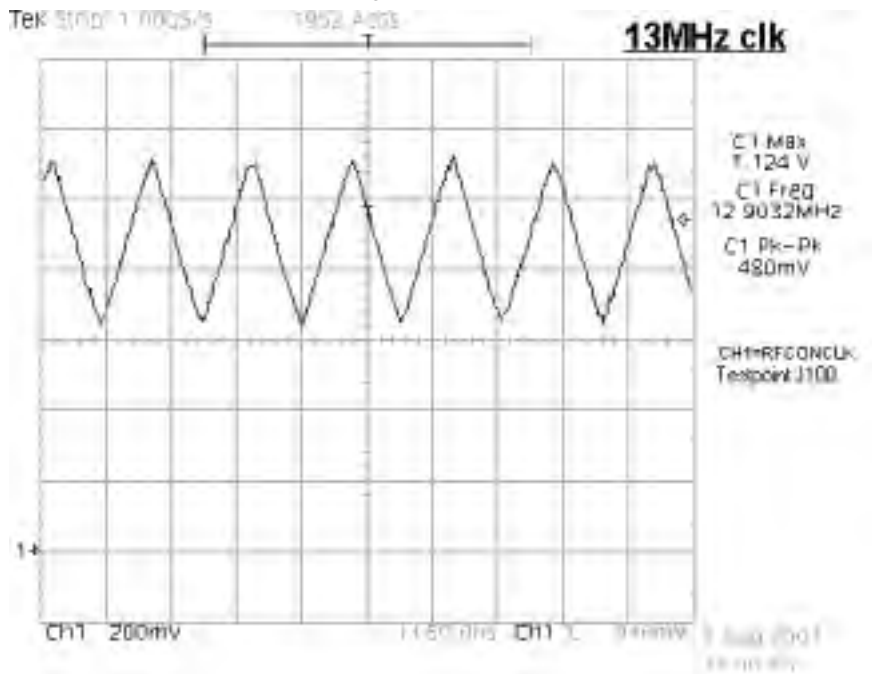
Figure 3: 13 MHz clock

- 2 Check 13Mhz Rfclk from testpoint J100. See figure below. Offset should be about 900mV. If the offset does not exist something is broken inside UPP_WD2 or DC-filtering capacitor in series on trace.

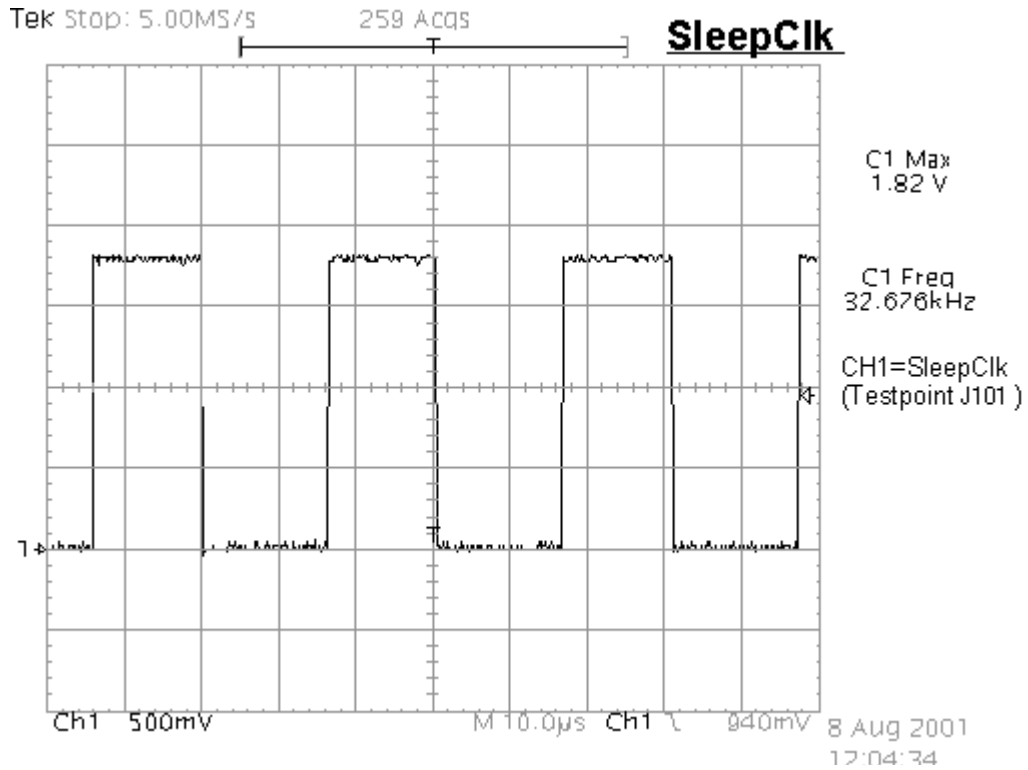
- 3 Check is the crystal oscillator (B190) oscillating at 32.768kHz frequency. If not change B190. If OK measure sleepclk from testpoint J101. Frequency should be the same 32.678kHz (see figure below.) If not change UEM.

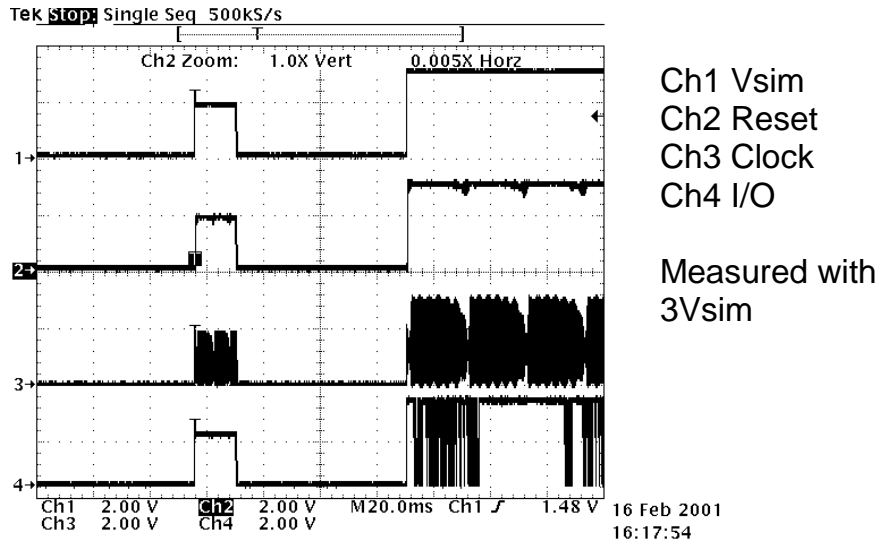
Figure 14: SIM Power Up.

First the SW attempts to power up the SIM with 1.8 V. If this does not succeed power up is repeated with VSIM switched to 3 V.

The data communication between the card and the phone is asynchronous half duplex. The clock supplied to the card is in GSM system 1.083 MHz or 3.25 MHz. The data baudrate is SIM card clock frequency divided by 372 (by default), 64, 32 or 16.

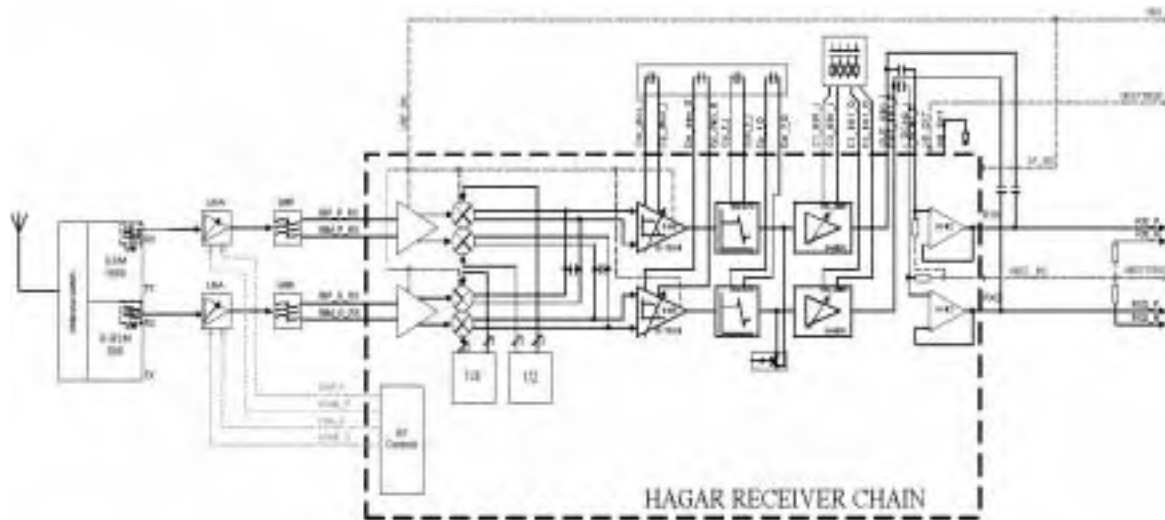
General description

The receiver is a direct-conversion, dual-band linear receiver. RF signal energy gathered by the antenna is fed via the antenna switch module to the 1st RX bandpass SAW filters and MMIC LNAs. The RF antenna switch module provides for upper- and lower-band operation. The signal having been amplified by the LNA is then fed to 2nd RX bandpass SAW filters. Both of these 2nd RX bandpass SAW filters have UNBAL/BAL configuration to achieve the balanced feed for HAGAR. The discrete LNAs have three gain levels. The first one is maximum gain, the second one is about -30dB (GSM1800) and -25dB (E-GSM900) below maximum gain and the last one is off state. The LNA gain selection is controlled directly by HAGAR.

The performance of the RX bandpass SAW filters are mainly responsible for defining the receiver's blocking characteristics against spurious signals outside passband and the protection against spurious responses.

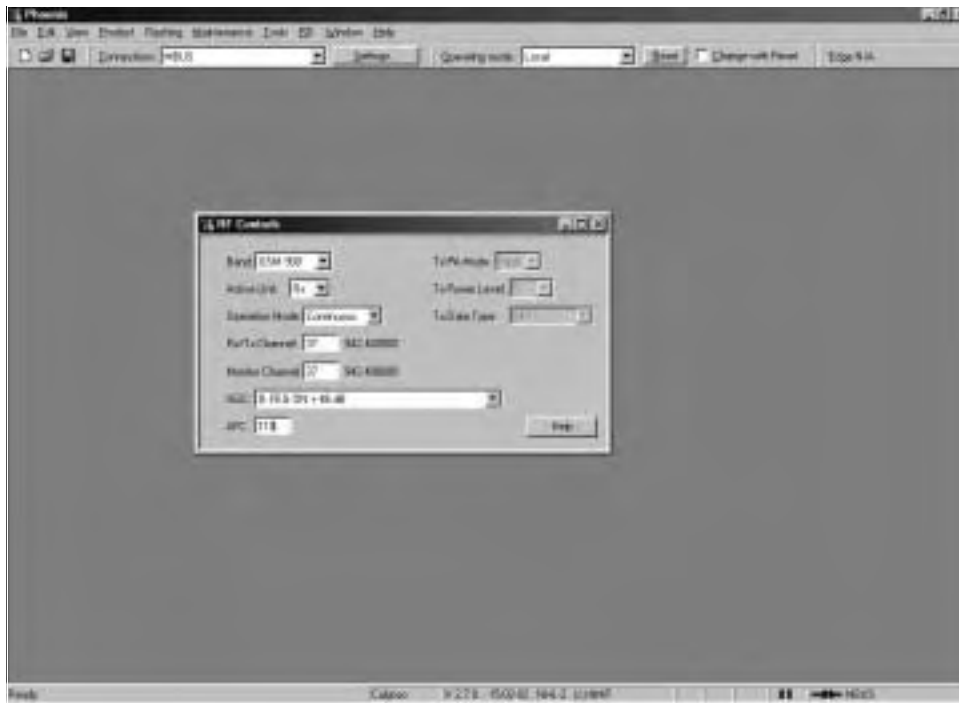
E-GSM900 RX Troubleshooting Setup steps

1	Place the phone in the test jig
2	File → Choose Product → Calypso
3	From 'Toolbar' set operating mode to Local
4	Maintenance → Testing → RF Controls
5	Select band 'GSM900'
6	Set Active unit to 'Rx'
7	Set Operation mode to 'Continuous'
8	Set AGC to '8:FEG ON +46 dB'
9	Set Rx/Tx channel to 37

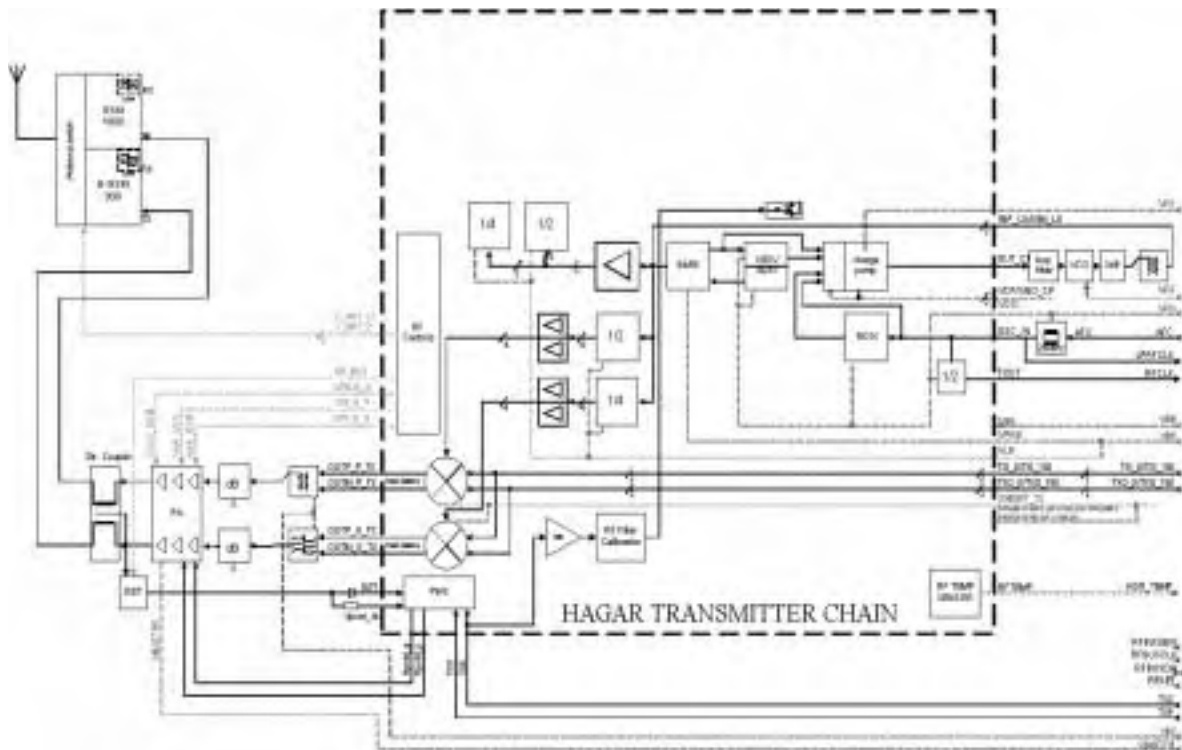
General description

The transmitter chain consists of two final frequency I/Q-modulators, one for E-GSM900 and the other for the GSM1800 band, a dual power amplifier and a power control loop. The I- and Q-signals are generated by baseband. After post filtering (RC network) they go into IQ-modulator in HAGAR. The LO signal for the modulator is generated by the external VCO and is divided by 2 or by 4 depending on the system mode. There are separate outputs one for E-GSM900 and one for GSM1800.

In the E-GSM900 branch, a SAW filter is placed before PA to attenuate unwanted signals and wide-band noise from the HAGAR IC.

The final amplification is realized with dual band power amplifier. It has two separate power chains one for E-GSM900 and one for GSM1800. The PA is capable of producing in excess of 2 W (0 dBm input level) in the E-GSM900 band and over 1 W (0 dBm input level) in the GSM1800 band assuming a 50 W output. The gain control range is over 45 dB to achieve the desired power levels and power ramp/decay performance.

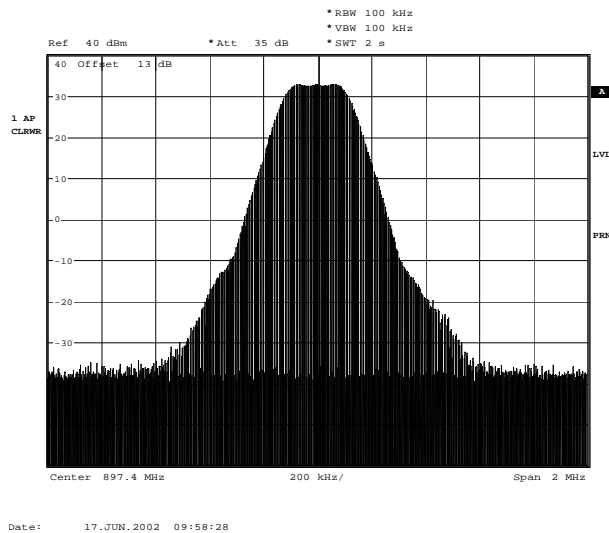
Figure 9: Example of 900 TX burst from antenna connector

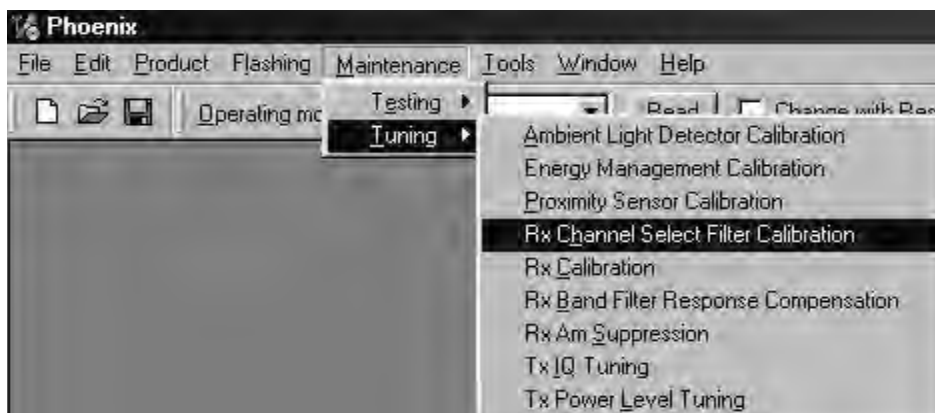
- Extra equipment / external RF signal not needed
- Must be done before other RX calibrations
- This function is used to calibrate RX channel select filter in GSM Phones.
- Rx Channel select filter is tuned only in one band = Single calibration for both bands
- Select Maintenance => Tuning => Rx Channel select filter calibration

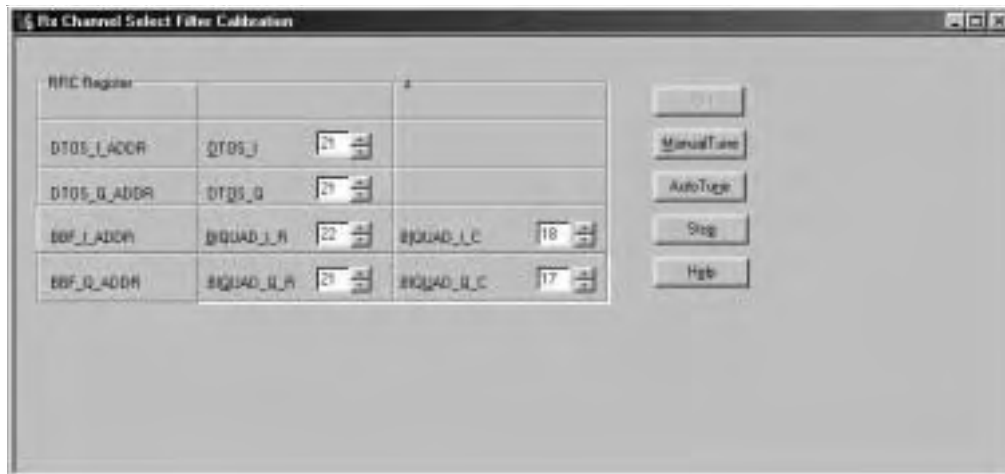
- Press "AutoTune" to start the tuning

- Tuning values should be 0...31
- Select "Stop"
- If values shown are within limits, choose "Yes" to save values to the phone save them to phone.

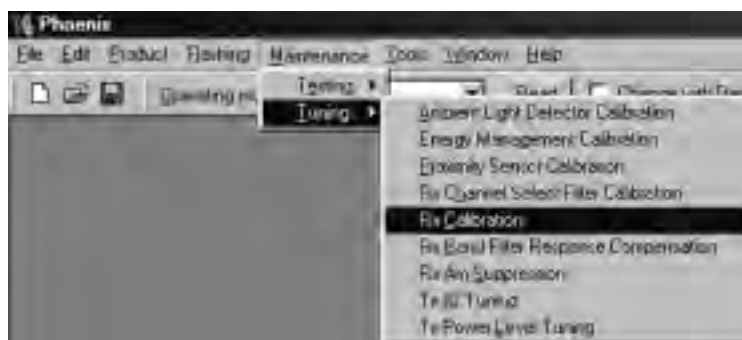
- RF generator needed
- This tuning performs RX Calibration
- Must be done separately on both bands!
- Start RX Calibration at EGSM (GSM900), then do RX Calibration at GSM1800 band.
- AFC tuning is done while EGSM (GSM900) band RX Calibration is performed.
- *Remember to take jig and cable attenuations into account!*
- Select Maintenance => Tuning => Rx calibration

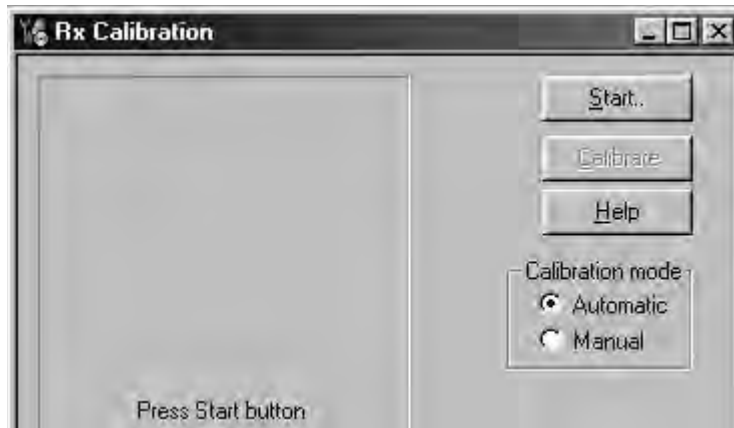
- Press "Start"

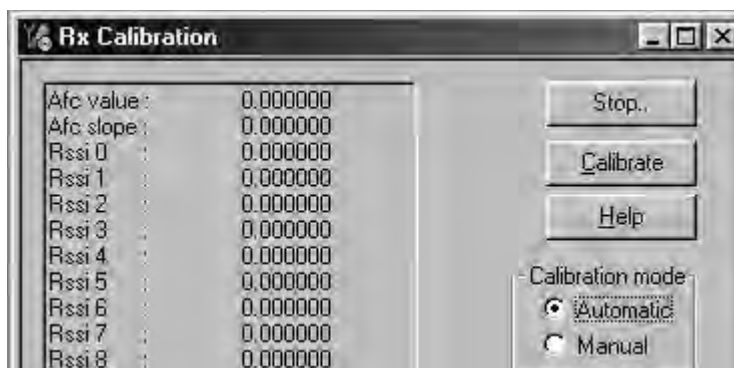
- Set the Calibration mode to "Automatic"
- Press "Calibrate"

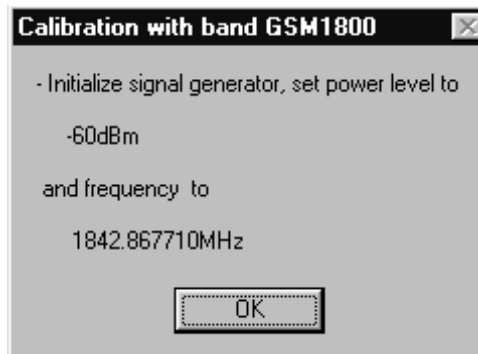
When asked, set RF generator to required frequency => OK

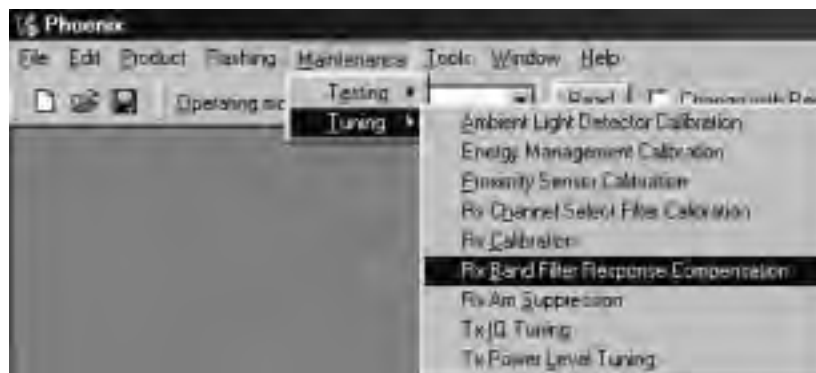
- RF generator needed
- Must be done separately on both bands!
- Start RX Band Filter Response Compensation at EGSM (GSM900), then do RX Band Filter Response Compensation at GSM1800 band.
- *Note: Remember to do RX calibration before doing Rx Band Filter Response Compensation!*
- Remember to take jig and cable attenuations into account!
- Select Maintenance => Tuning => Rx band filter response compensation

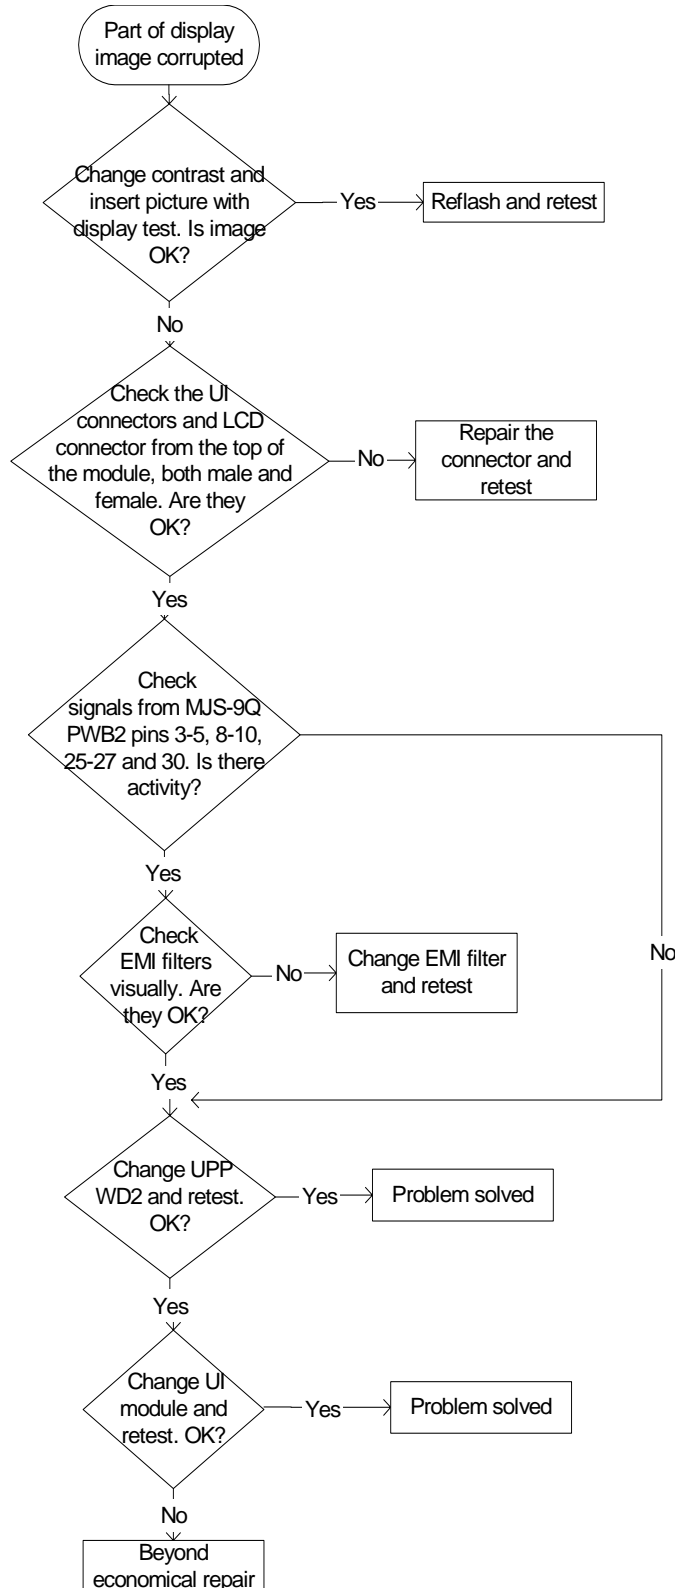
Image on display not correct

Image on the display can be corrupted or part of the image can be missing. If part of image is missing change the UI module. If the image is otherwise corrupted, follow the path below.

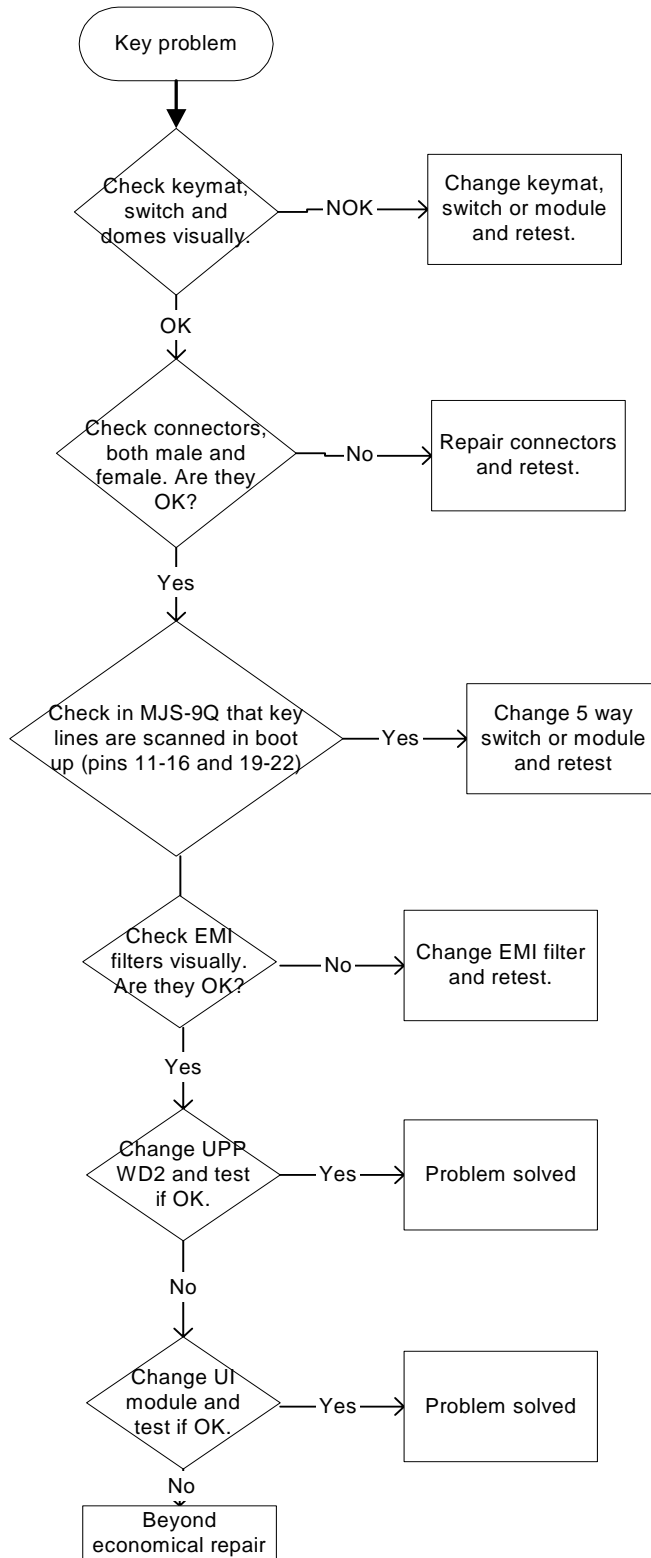
Key or 5-way switch not working

UI module includes 5-way switch, application key, voice recorder key and two softkeys.

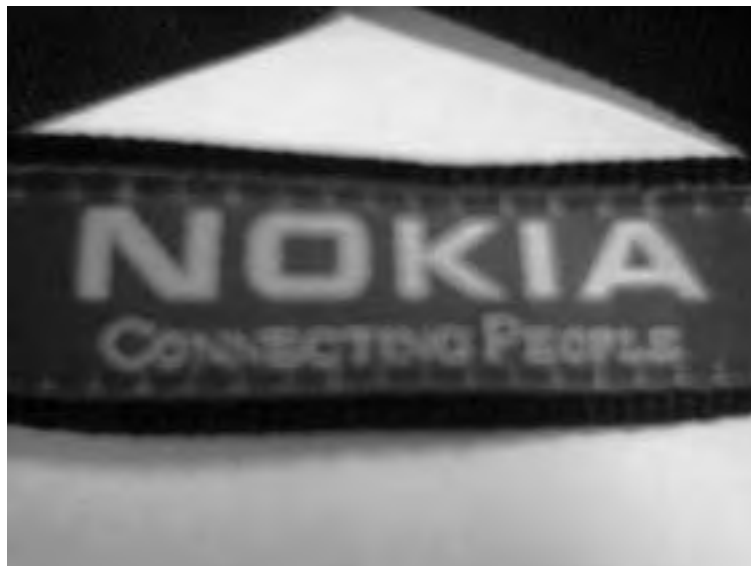
Distance to target: the lens in the module is specified to operate satisfactorily from 30cm to infinite distance of scene objects. In practice, the operation is such that close objects may be noticed to get more blurred when distance to them is shortened from 40cm. Lack of sharpness will be first visible in full resolution (VGA) images. If observing just the viewfinder, even very close objects may seem to appear sharp. *This is normal behavior, do not change the camera module.*

Figure 1: Image blurred due to too close distance to target (5 cm)

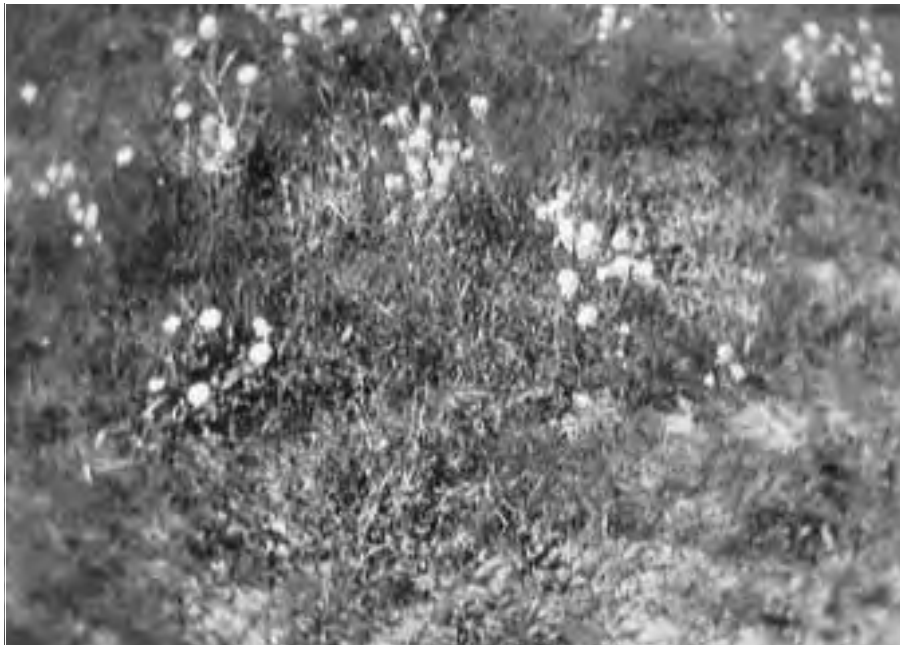
Figure 3: Especially this type of images are affected much by lack of sharpness in edges / corners

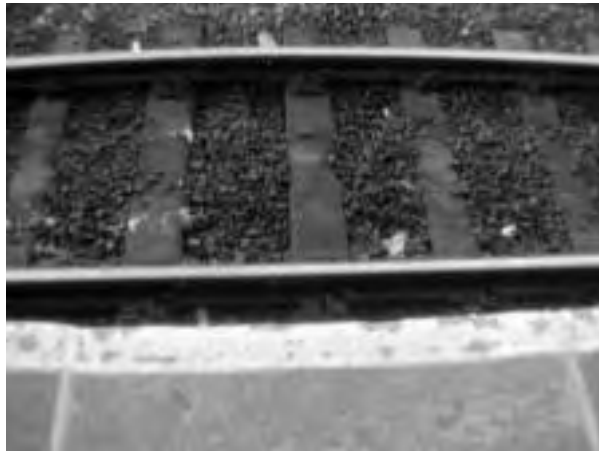
Geometrical distortion: camera lens will cause some amount of so called barrel distortion in images. In practice, this appears as bending of straight objects in edges of the image. See Geometrical distortion and Handshake has caused blurring of this image. Note geometrical barrel distortion in background for example. *This is normal behavior, do not change the camera module.*

Figure 4: Geometrical distortion

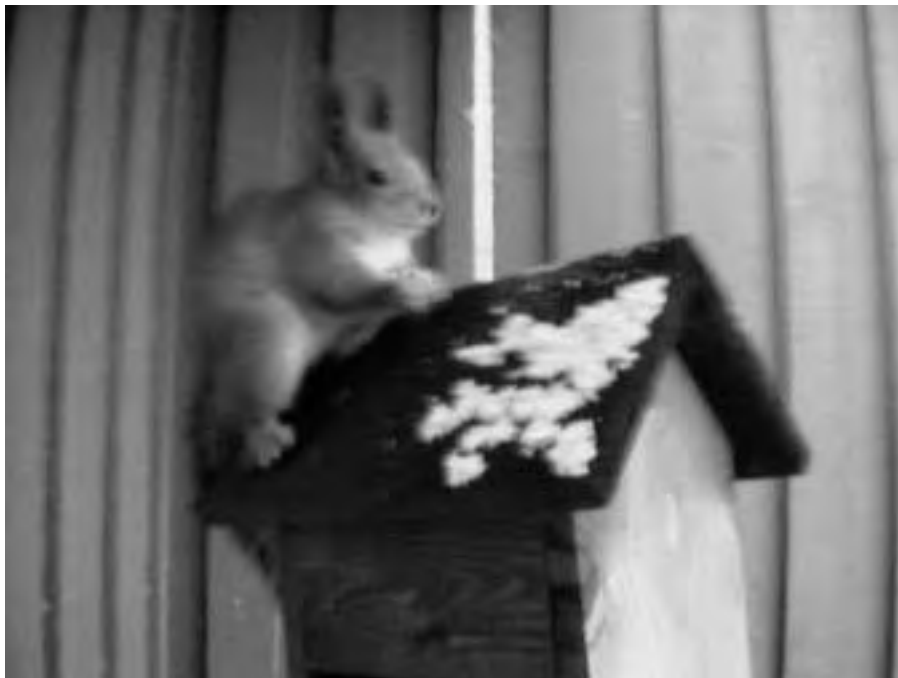
Amount of light available: in dim conditions camera runs out of sensitivity. Exposure time is long (especially in night mode) and the risk of getting shaken (= blurred) images grows. Image noise level grows. The maximum exposure time in night mode is $\frac{1}{4}$ seconds, so images need to be taken with extreme care and by supporting the phone when the amount of light reflected from the target is low. Sometimes blurring may even happen at daytime if image is taken very carelessly. See Handshake has caused blurring of this image. Note geometrical barrel distortion in background for example. *This is normal behavior, do not change the camera module.*

Figure 5: Handshake has caused blurring of this image. Note geometrical barrel distortion in background

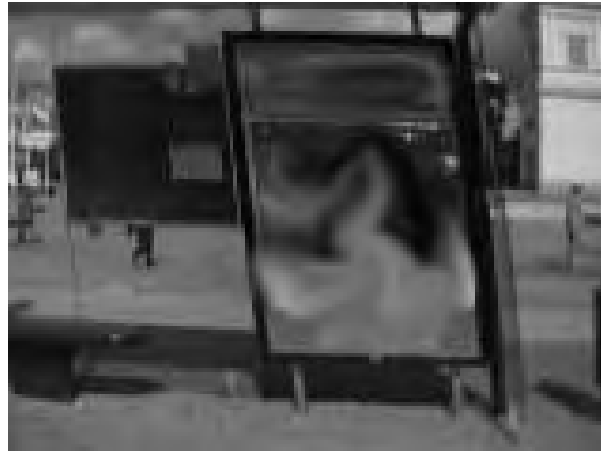
Movement in bright light: If pictures of moving objects are taken or if the device is used in a moving car, object 'skewing' or 'tilting' will occur. This phenomena is fundamental to most CMOS camera types and normal, and can not be helped. Movement of camera or object will usually cause blurring in inside or dim lighting conditions due to long exposure time. *This is normal behavior, do not change the camera module.*

Figure 6: Near objects in image get skewed when shooting from a moving car

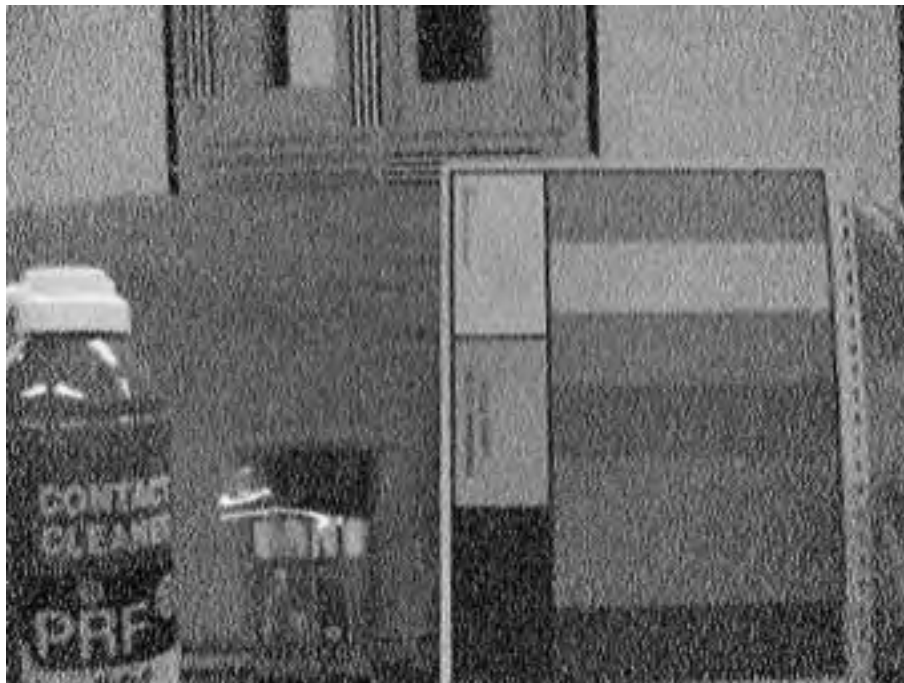
Temperature: high temperatures inside the mobile phone will cause more noise to appear in images, e.g. in +70 degrees of celsius the noise level may be very high, and it further grows if the conditions are dim. This is also normal to camera operation. *This is normal behavior, do not change the camera module.*

Figure 7: Noisy image taken in +70 degrees celsius

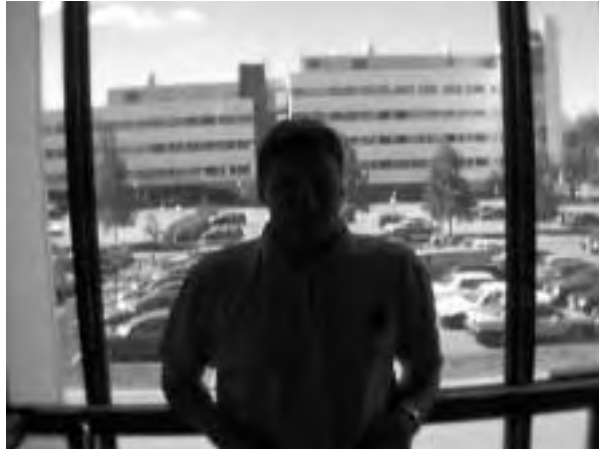
Basic rules of photography, especially shooting against light: electronic image sensors typically have much lower dynamic range than what films have. In practice this means that when taking a picture inside e.g. having a window behind object, will produce poor results. *This is normal behavior, do not change the camera module.*

Figure 8: Image which has been taken "against light". The actual object is dark.

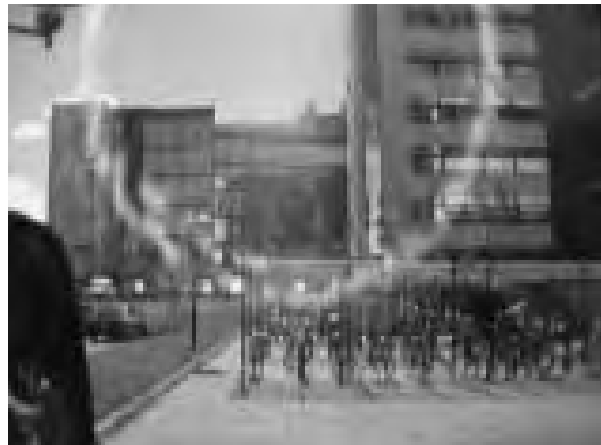
Bright light outside of image view: Especially sun can cause clearly visible 'halo' effects and poor contrast in images. This happens due to unwanted reflections inside camera optics. Generally this kind of reflections are common in all optical systems. *This is normal behavior, do not change the camera module.*

Figure 10: A lens reflection effect caused by sun shining above the scene

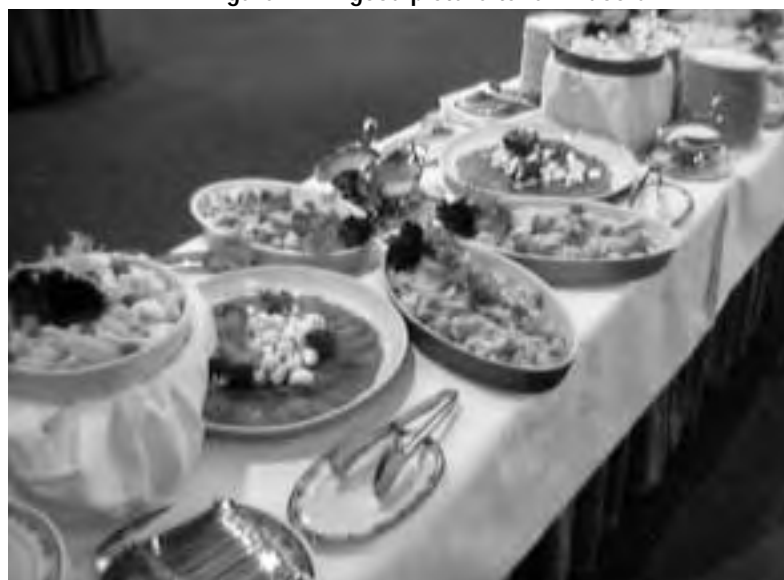
Figure 11: A good picture taken indoors

If no visible defects (items 1-4) can be found, a couple of test images should be taken and checked. Generally, a well illuminated typical indoor office scene, such as the one in A good picture taken indoors, can be used as a target. The main considerations are:

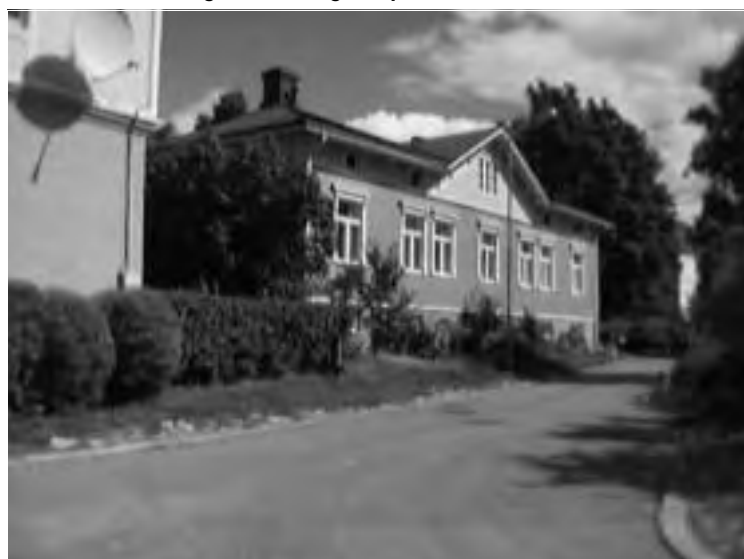
Figure 12: A good picture taken outdoors

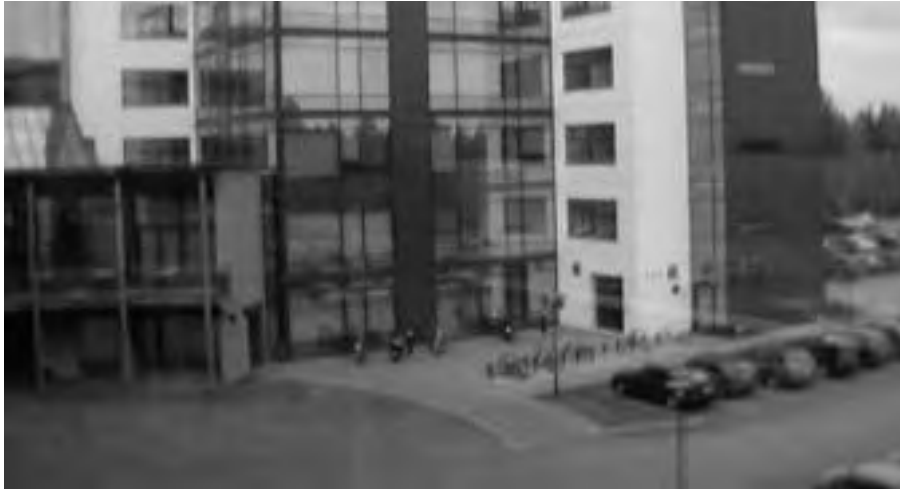
Figure 19: Natural scene, clear back window

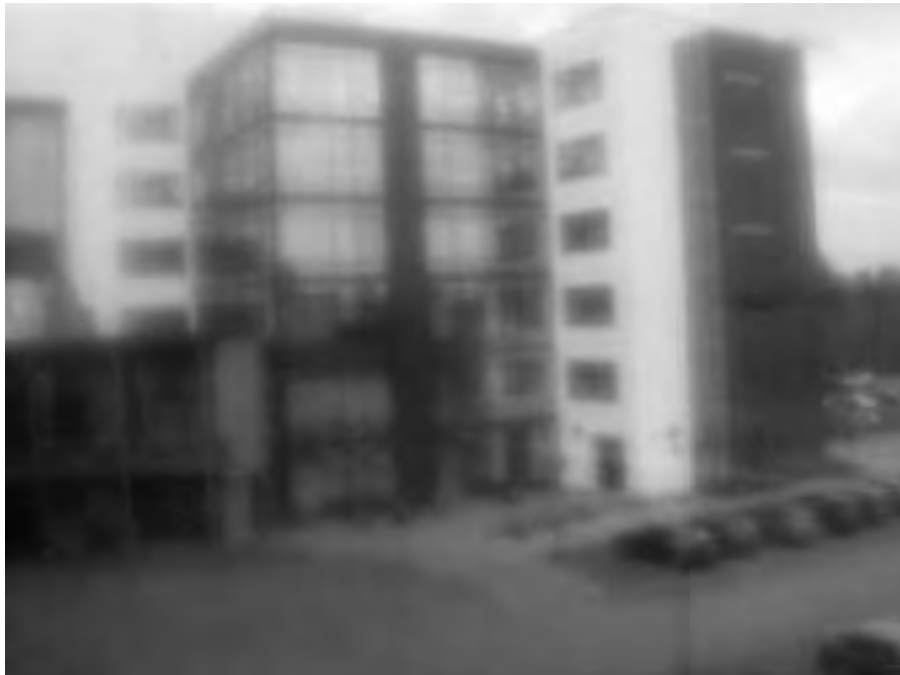
**Figure 20: Natural scene, badly soiled back window**
