Model: NAD 30S/30/40		Date: 31-May-98	No: 3
Subject: Service Manual Corrections		Prepared by: Y. Furuya	
From: Technical Service Department.			
Classification:	<input type="checkbox"/> Troubleshooting	<input type="checkbox"/> Part information	<input type="checkbox"/> Action required
	<input type="checkbox"/> Mechanical	<input type="checkbox"/> Electrical	<input checked="" type="checkbox"/> Service manual revision
	<input type="checkbox"/> Paper path	<input type="checkbox"/> Transmit/receive	<input type="checkbox"/> Retrofit information
	<input type="checkbox"/> Other (      )

This bulletin contains corrections for the Fax Option Type 450 service manual.

## Chapter 3

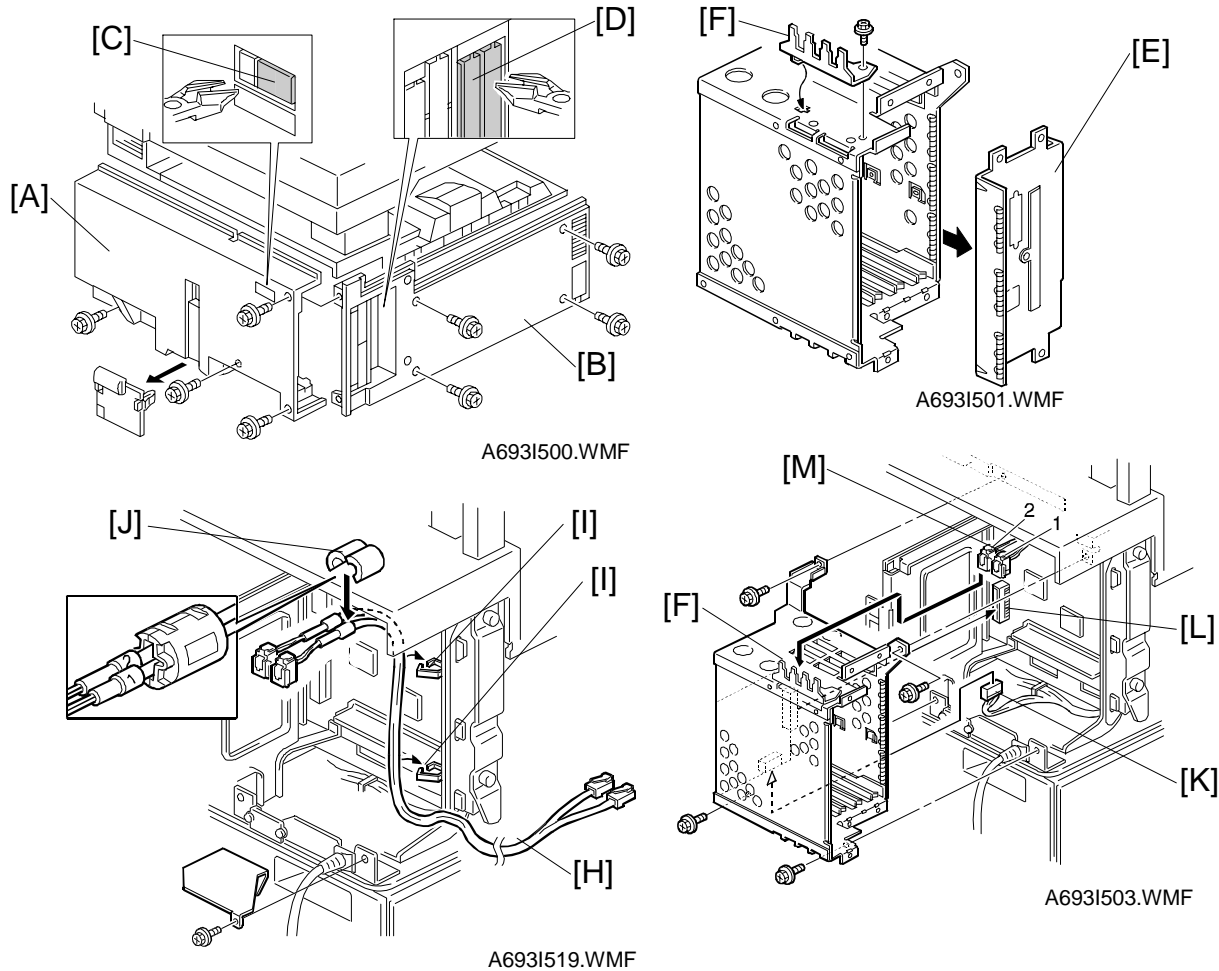
1. Remove the rear cover [A] (4 screws) and the left side cover [B] (4 screws), as shown.
2. Cut away the covers [C] and [D] (shaded parts), as shown.

**NOTE:** If installing the fax hard disk option at the same time, refer to the hard disk installation procedure before going on to the next step.
3. Remove the cover [E] from the expansion box, then install the FCU cover bracket [F] (1 screw) as shown.

**NOTE:** The bracket [F] is included in the fax unit.
4. Remove the bracket [G], and run the cable [H] through the clamps [I], then install a metal core [J] as shown.

**NOTE:** The metal core [J] is not installed the model for Taiwan.
5. Connect the harness [K] to CN355 on the expansion box, then install the expansion box (4 screws) so that the CN350 fits in CN304 [L] on the BiCU.

**NOTE:** Use a magnetic screwdriver so as not to drop any screws inside the machine.
6. Attach the modular jacks [M] to the bracket [F] as indicated on the bracket.

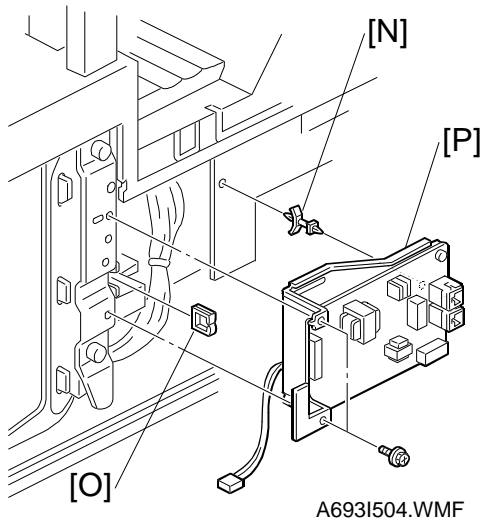
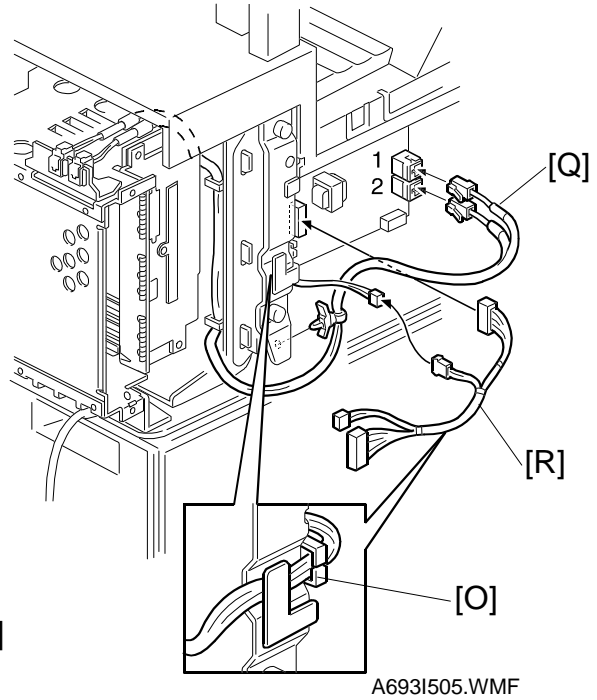
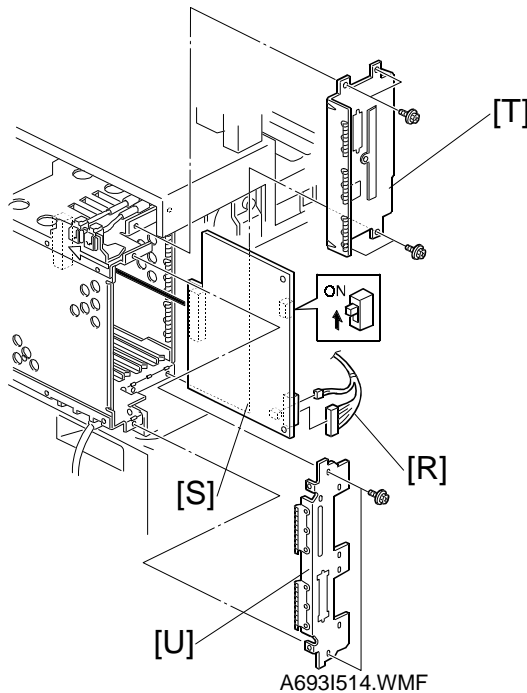
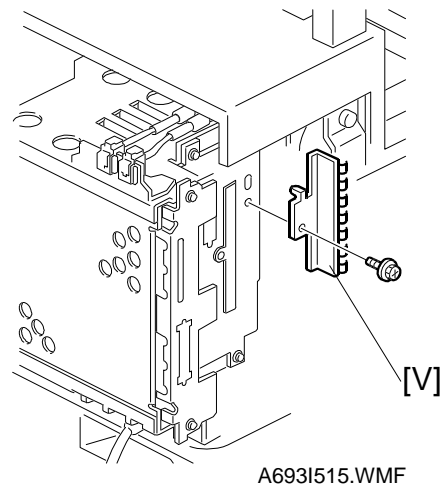
7. Set the locking support [N] and the edge saddle [O] as shown, then install the NCU/Speaker assembly [P] (2 screws).
8. Connect the cable [Q] and the harness [R] as shown. The harness [R] must run through the edge saddle [O] as shown.
9. Turn on the battery switch (SW1) on the FCU [S] then set it in the right-most slot of the expansion box as shown. Connect the harness [R] to the FCU (CN328 and CN330), then slide the FCU [S] all the way in (1 connector).
10. Install the brackets [T] (3 screws), [U] (2 screws) and [V] (1 screw) as shown.  
**NOTE:** The bracket [U] is installed only in the model for Taiwan.

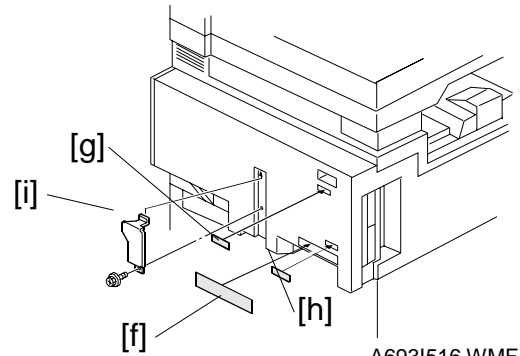
A6931516.WMF

11. Remove the operation panel [W], then remove parts [X], [Y], and [Z].
12. Install part [a], then connect the harnesses [b] and [c] to the operation panel as shown.
13. Replace the operation panel [W], then install the parts [d] and [e], as shown.
14. Replace the left side cover (4 screws) and the rear cover (4 screws).
15. Affix the serial number label [f], the LINE/TEL label [g] and the appropriate approval label [h] onto the rear cover. Then install the bracket [i] (1 screw).
16. Attach the "Super G3" label [j] to the front cover.

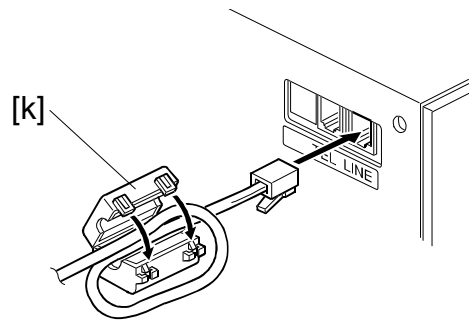
A693I517.WMF

17. Wrap the phone line around the core [k] as shown, and connect it to the “LINE” jack at the rear of the machine.
18. Plug in the machine and turn on the main power switch.
19. Press the ‘Facsimile’ key and check the facsimile LED lights.  
At this time, the display reads: SC1201 - Functional problem with the fax. Data should be initialized.  
**NOTE:** This is not a functional problem. The machine shows this message only when the fax unit is first installed. If the same message appears at the next power-on, check whether the battery switch (SW1) on the FCU has been turned on.
20. Press “Yes” to initialize the fax unit.
21. Set up and program the items required for fax communications as shown below. If the user function keys (F1, F2, F3, F4, and F5) need to be programmed, attach the label.
