Novell[®] NEST Autoroute[™]

**Function Upgrade Card Type 140
Plus Novell[®] NEST[™]**

**Feature Expander Type 100 2M
Plus Novell[®] NEST[™]**

SERVICE MANUAL

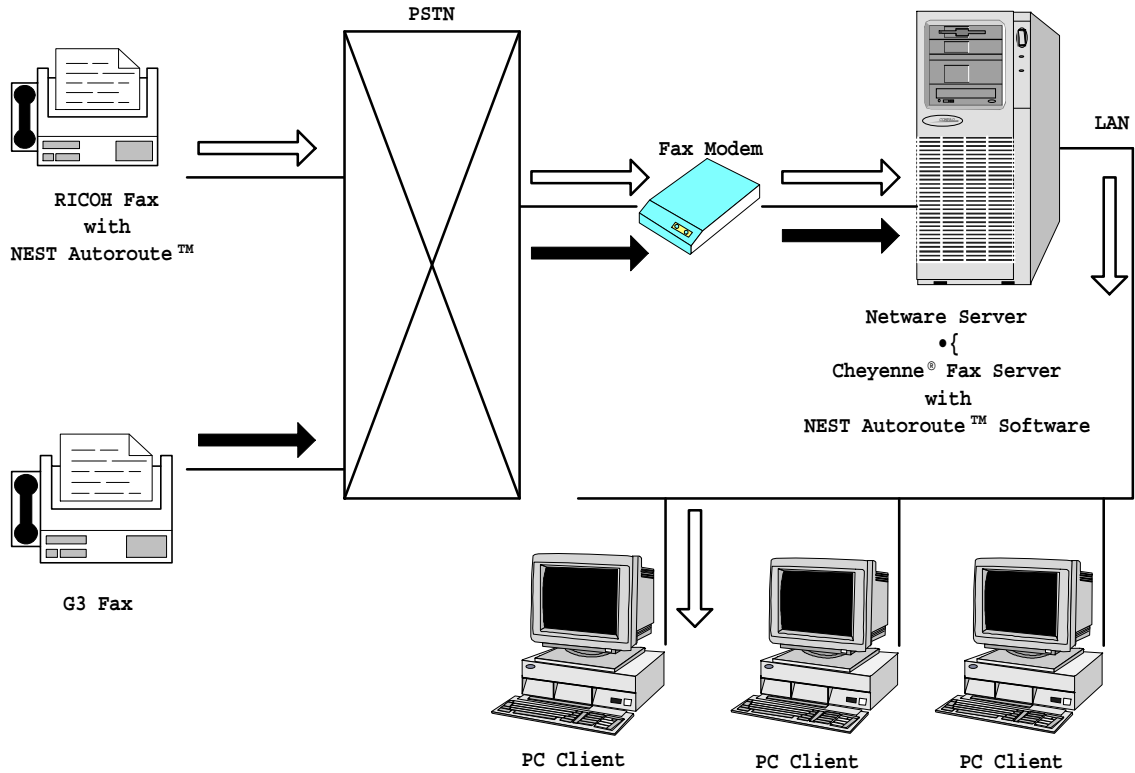
H130V500.wmf

Novell® Embedded System Technology (NEST) Autoroute™ is an alternative routing methodology, patented by Novell®. It allows a user to send a fax to a NetWare network and have the fax routed directly to the recipient's PC clients.

Using the standard Group 3 T.30 protocol for routing information, NEST Autoroute™ works by including an Autoroute ID code with each fax transmission. The code, which is sent in the TSI frame, provides the information required to deliver a fax to its destination.
