Model: Russian-P		Date: 29-Mar-00	No.: RG038001
Subject: Hard Disk Compatibility		Prepared by: K. Misugi	
From: Technical Services Dept., GTS Division			
Classification:	<input checked="" type="checkbox"/> Troubleshooting	<input type="checkbox"/> Part information	<input type="checkbox"/> Action required
	<input type="checkbox"/> Mechanical	<input type="checkbox"/> Electrical	<input type="checkbox"/> Service manual revision
	<input type="checkbox"/> Paper path	<input type="checkbox"/> Transmit/receive	<input type="checkbox"/> Retrofit information
	<input type="checkbox"/> Other (      )

This RTB informs possible compatibility problems with the Printer Hard Disk Type 185 (model code: G690-06).

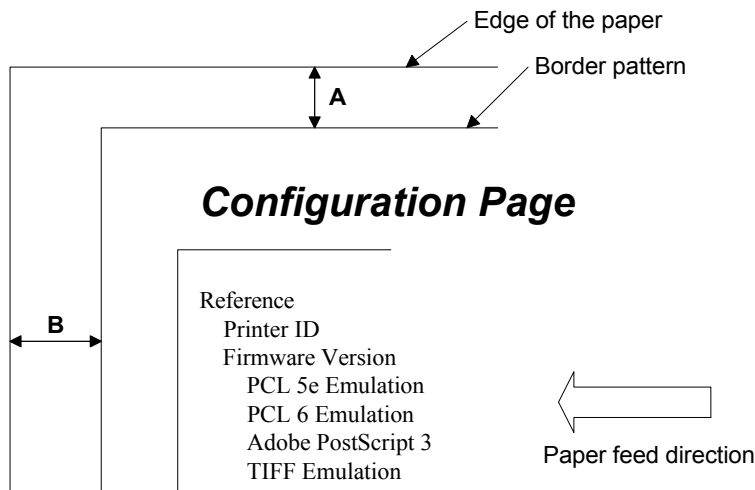
4. Press "Enter" to save the change and exit the service mode.
5. Print the Configuration Sheet and notice that the border pattern is printed.  
**Note:** The machine prints the border pattern only for A4 or Letter size paper LEF.

6. Adjust the leading edge and the side-to-side registration using the registration adjustment mode (Service Menu 2: Service regist).

**Adjustment parameters**

<b>Leading Edge (A)</b>	<b>Side-to-Side (B)</b>
A4 (LEF)	4.2 mm	6.0 mm
Letter (LEF)	4.2 mm	6.4 mm
