TELEVISION TECHNICAL BULLETIN

MODELS 56FW53H 66FW53H 66FW54H 76FW53H

Faults experienced on the DA100 (50Hz) Chassis

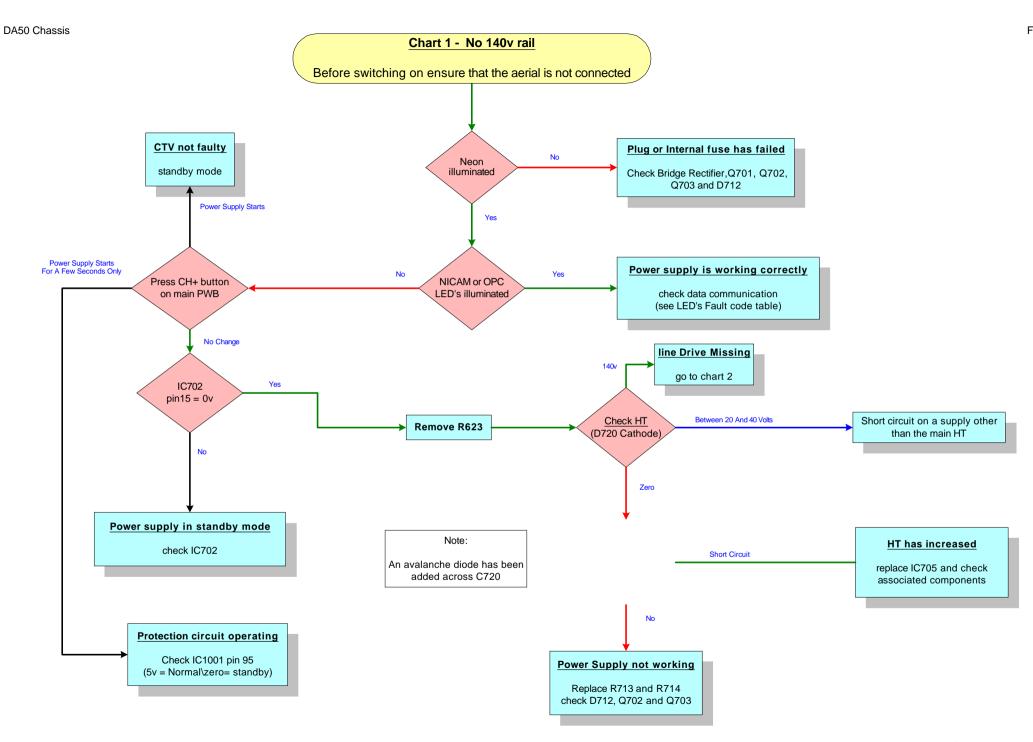
- 1. Fault finding flow chart. (See page 2)
- 2. <u>LED fault code table</u> (See page 4)
- 3. NVM associate problems. (See page 5)
