BOB, WØYVA/4

MAY-75

MODIFICATIONS AND REPAIR INFORMATION

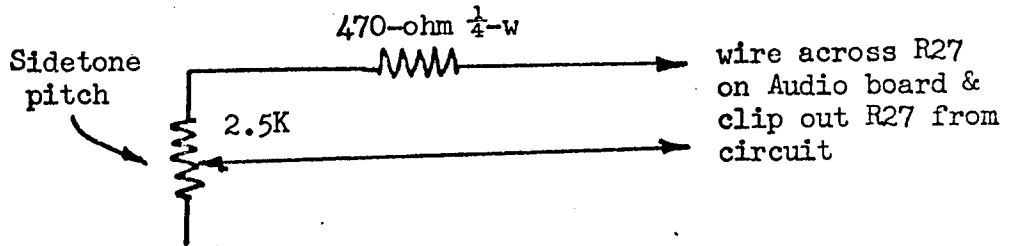
Johnson (Johnson and Associates) forwarded the following suggestion for those who tire of a monotonous side tone when operating CW. The new potentiometer can be installed as a dual concentric unit with the CW speed control. See diagram below:
