VOL. II
NO'S 1-6
ORIGINALS

S/1 NEWS

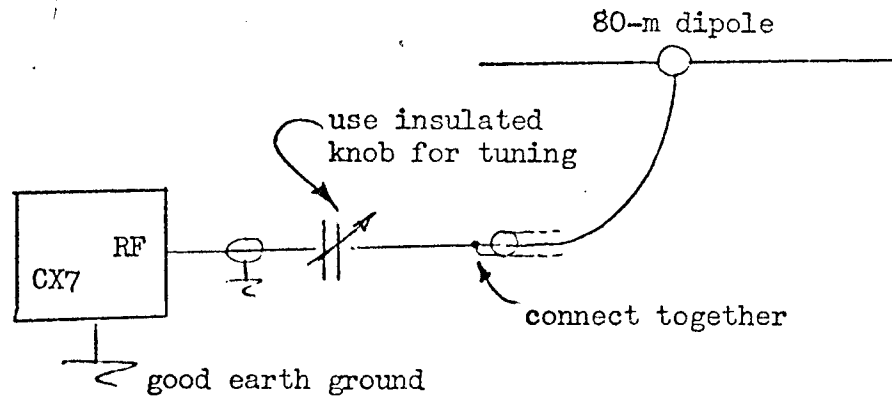
Jan, W3SWN, writes with a neat idea for getting on 160 using a 80-meter dipole. Here is how he does it;

1. Tie feeders to dipole together
2. Connect feeders to a 3-gang BC variable - all sections in parallel
3. Connect CX7 coax center output to other side of variable
4. Ensure a GOOD ground to CX7
5. Set the BC capacitor to $\frac{1}{2}$ -capacity
6. Tune CX7 is MANUAL to get indication on FWD PWR
7. Retune the BC variable for min REV PWR
8. Recheck tuning in FWD

Jan reports that he can cover 1800-1850 with one setting of the BC capacitor with zero reverse power and can cover 1970-2000 by simply moving the capacitor 10-15° for zero reverse power. (Do your tuning at as low a power as possible and do it quickly!...ed).
