Car Stereo  
Service Bulletin

**Model:** XM-701/1000

**No.** 125

**Subject:** Speed-Dependent Noise

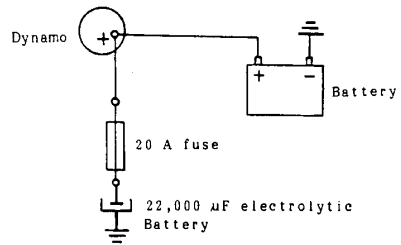
- o Connect the car radio's ground wire (in dashboard) together with the amplifier's ground wire (either beneath dashboard or in rear trunk) to a common ground on the car chassis. Pay attention to the cross section of the ground wires (surface: > 6mm<sup>2</sup>).
- o Reposition the amplifier LF wires (cinch) away from the PLUS/MINUS wires of the amplifiers and the car radio, respectively. If the car battery is situated underneath the car's rear seat or in the rear trunk, take care not to position the LF wires parallel to the PLUS/MINUS battery wire.
- o If you intend to use the XM-1000 amplifier in the four-speaker mode, the LF wires should be twisted together.
- o Add the interference filter XA-50 to the car radio's PLUS wire.
- o Should noise still occur, add a 22,000 uF/40V capacitor (-40° to +85°) directly to the dynamo's PLUS power connector over a 20 A fuse.
