Car Stereo Service Bulletin

Model: XR-3310/4410

Subject: Clock Runs Slow.

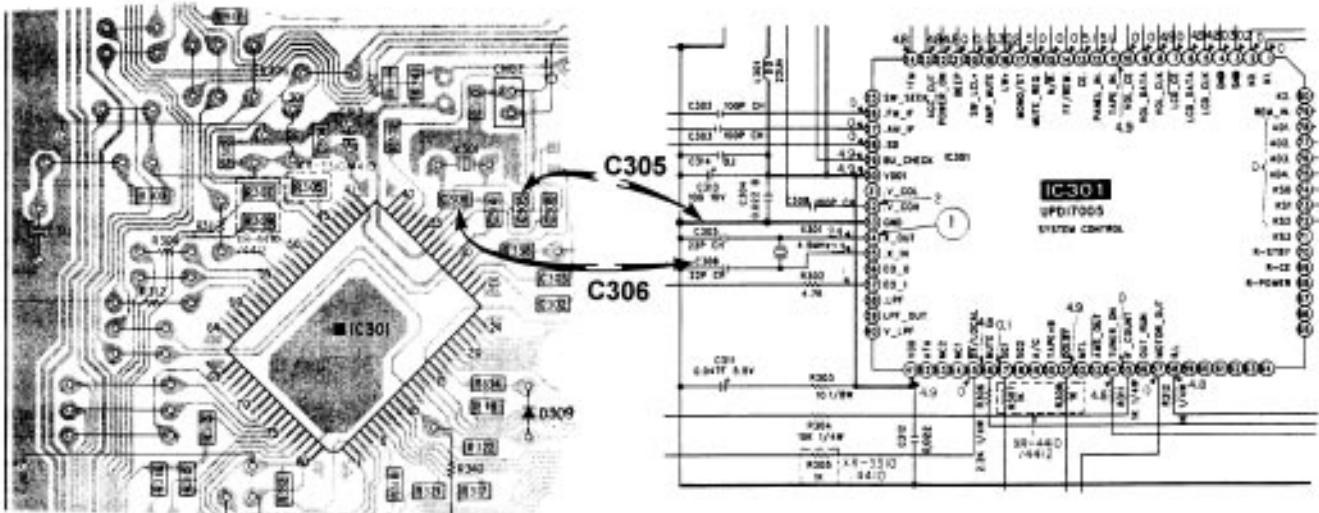
If the customer complains of this problem, change C305 and C306 on the Main board as shown below.
