# Retrofit Premium Headlights

Classification	Repair Bulletin	Section/Group	17 - Electrical	Country/Region	All
Year	2017	Model	Model S Model X	Version	All

Certain Model S and Model X vehicles were incorrectly manufactured with base headlights instead of premium headlights. While the current headlights are adequate, they are not what should have been installed.

Retrofit LH and RH premium headlights and update the vehicle configuration.

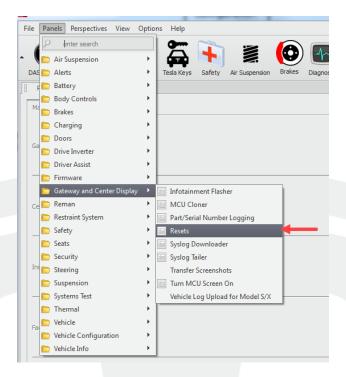
Figure 3 (Select the Resets page)

b. From the Panels menu, select Gateway and Center Display > Resets (Figure 3).

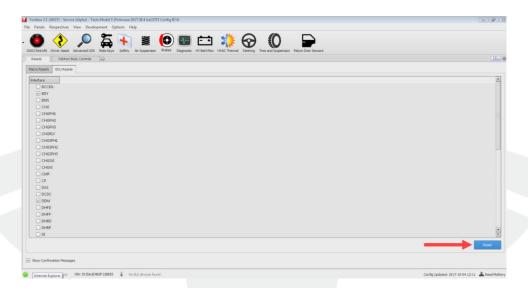
Figure 5 (Reset the selected controllers)

e. Click Reset (Figure 5).

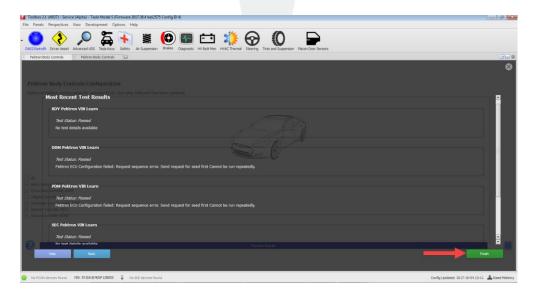
Figure 6 (Finish resetting the selected controllers)

- f. From the Panels menu, select Body Controls > Pektron Body Control configuration.
- g. Select BDY and all other equipped Pektron control units in the vehicle.
- h. Click Play.
- i. Check the results of the configuration sequence:
  - If the configuration process results indicate a success, click **Finish** (Figure 6).
  - If the configuration process results indicate a failure, reset all the Pektron control units in the vehicle and repeat steps f through i.
