3. IMAGE QUALITY

TITLE	PAGE	TITLE	PAGE	TITLE	PAGE
IQ1 IMAGE QUALITY DEFECT ENTRY.....	3-2	25. MISREGISTRATION (BLACK).....	3-13	ESS GENERATED TEST PATTERNS.....	3-19
1. BACKGROUND (OVERALL)	3-3	26. MISREGISTRATION (YELLOW)	3-13	PQ SET	3-19

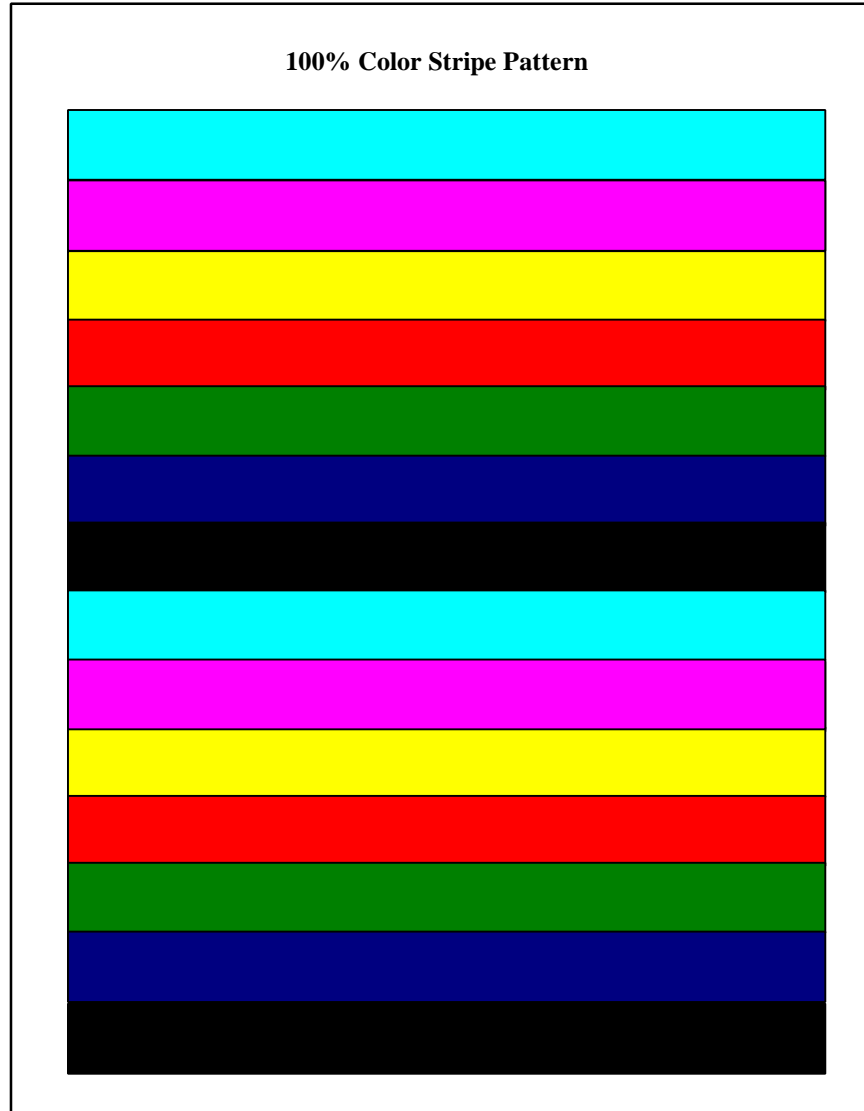
100% Stripe Test Pattern.

This test pattern consists of a series of horizontal stripes. The pattern includes the basic colors (Cyan, Magenta, Yellow, and Black) and the process colors (Red, Blue, and Green). This test pattern is useful to isolate a problem to one of the basic colors.

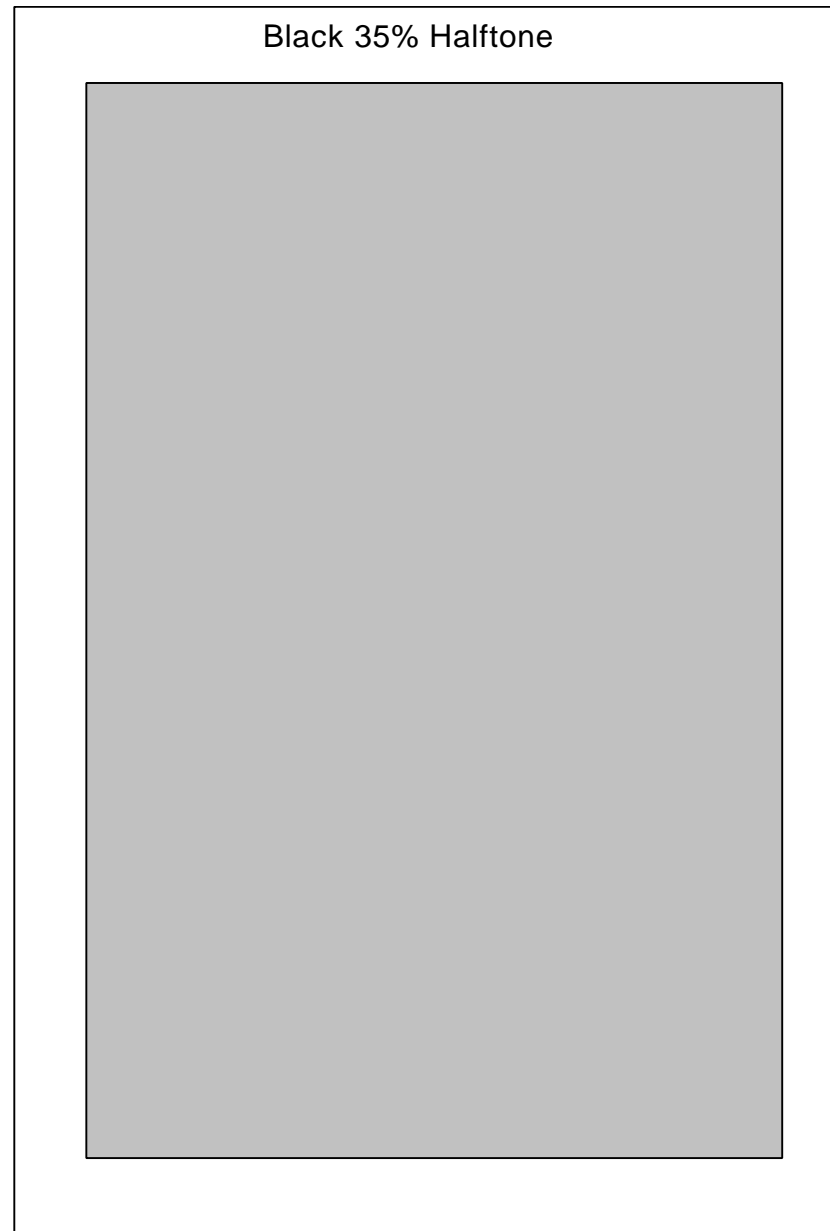
35% Halftone

This test pattern consists of a full page, 35% area coverage, halftone pattern. This pattern are useful in troubleshooting problems in the black developer subsystem.
