Compression Behavior of $\pm 45^\circ$ -Dominated Laminates with a Circular Hole or Impact Damage

Mark J. Shuart* and Jerry G. Williams*

NASA Langley Research Center, Hampton, Virginia

An investigation of the compression failure characteristics of $\pm 45^\circ$ -dominated laminates with a circular hole or impact damage was conducted. Graphite-epoxy laminates consisting of all $\pm 45^\circ$ plies and of $\pm 45^\circ$ and 90° plies were evaluated. In-plane shearing between the fibers and matrix (i.e., matrix shearing) was found to be the primary compression failure mechanism for an all $\pm 45^\circ$ laminate with a hole. The failure mechanism for the $\pm 45^\circ$ -dominated laminates with a hole appeared to be a combination of delamination and matrix shearing. The compression failure stresses and strains for both the all $\pm 45^\circ$ laminate and the $\pm 45^\circ$ -dominated laminates were unaffected by impact damage at an energy level of 5.5 J when compared to results for undamaged control specimens. The failure stresses and strains for all laminates with impact damage at energy levels of 17.0 or 34.3 J were significantly lower than the corresponding data for the undamag

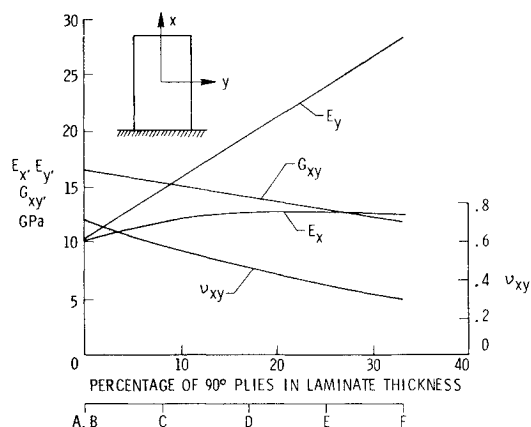
Fig. 3 Elastic properties for $\pm 45^\circ$ -dominated laminates.

are added to an all $\pm 45^\circ$ laminate. For a $[\pm 45/90]_s$ class laminate under longitudinal load, the 90° plies restrain in-plane shearing in the $\pm 45^\circ$ plies. The effects on the linear elastic material properties of adding 90° plies to an all $\pm 45^\circ$ laminate are shown in Fig. 3. Results were obtained using laminate theory and the test laminates designated A-F are indicated on a separate scale. As illustrated in the figure, the longitudinal Young's modulus E_x for a $[\pm 45/90]_s$ class laminate is greater than the corresponding property for an all $\pm 45^\circ$ laminate because of the in-plane lateral restraint. Also, the shear modulus G_{xy} for a $[\pm 45/90]_s$ class laminate is less than the corresponding property for an all $\pm 45^\circ$ laminate. The in-plane lateral restraint significantly affects the transverse Young's modulus E_y and Poisson's ratio ν_{xy} as shown in Fig. 3. The transverse Young's modulus for laminate F is almost three times the same property for laminate A and the Poisson's ratio for laminate F is approximately half the corresponding laminate A property.
