Repair Concepts for Advanced Composite Structures

Single scarf joints of a vacuum cocured graphite/epoxy laminate bonded to an autoclave precured laminate have been fabricated and subjected to an extensive series of structural tests under the following conditions: dry and wet, tension and compression, cold and hot, static and post-fatigue. Several adaptations of this joint to other situations were fabricated and tested under selected conditions. An external patch repair was also developed and tested extensively. Both the scarf joint and the external patch were later used to repair 4-in. diam holes in flat panels. The size of the damaged area to which either approach is applicable appears to be unlimited. All results are very encouraging as to the feasibility of successful repairs in graphite/epoxy laminates.

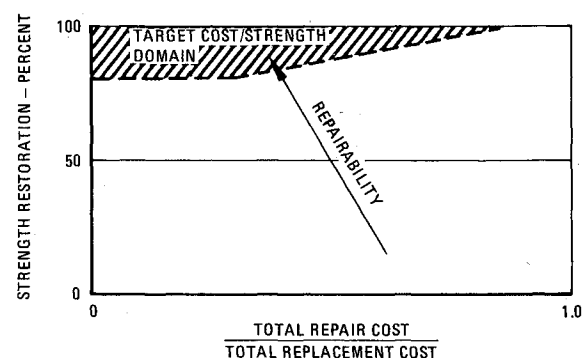
Fig. 1 Repairability.

Figure 1 expresses the two aspects of reparability which drive toward high-strength restoration and low cost. Of course, aircraft downtime and performance degradation should be evaluated and included in cost considerations. Strength restoration of 80% of the tension ultimate allowable (F_{tu}) is generally considered sufficient to cover all but the most unusual cases. The compression ultimate allowable (F_{cu}) may be higher than tension but it is rarely used as the critical design allowable except where F_{cu} is degraded, as in the case of the hot-wet environment.

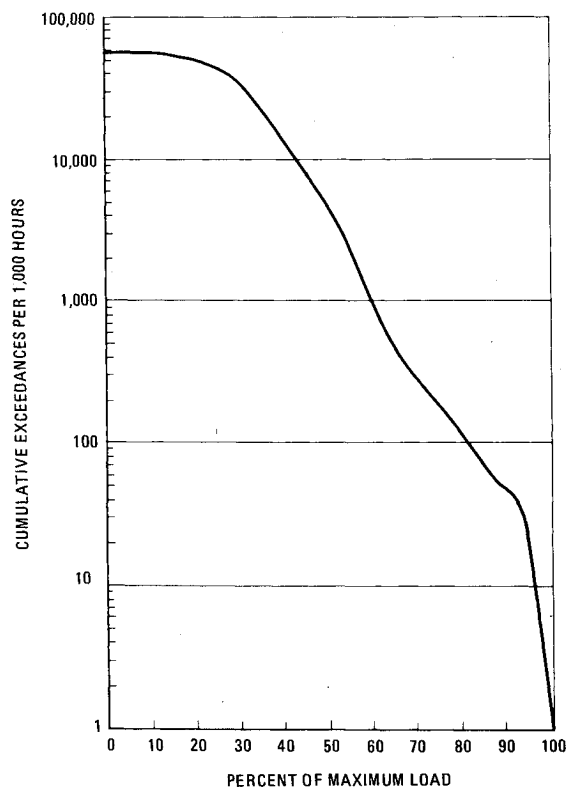
Fig. 2 F-5E load spectrum for wing lower skin at BP 29.5.

fatigue test is a determination of residual strength after a two-lifetime history of fatigue loading using the load spectrum developed for the F-5F lower inboard wing skin. The exceedance curve, shown in Fig. 2, represents 1000 hours of flying with compressive loads deleted. Three specimens of a given repair were run with the maximum fatigue load at 41.5% of parent laminate allowable and another three at a maximum fatigue load of 22.9% of parent allowable. The residual strength reported here is the minimum of these two results.

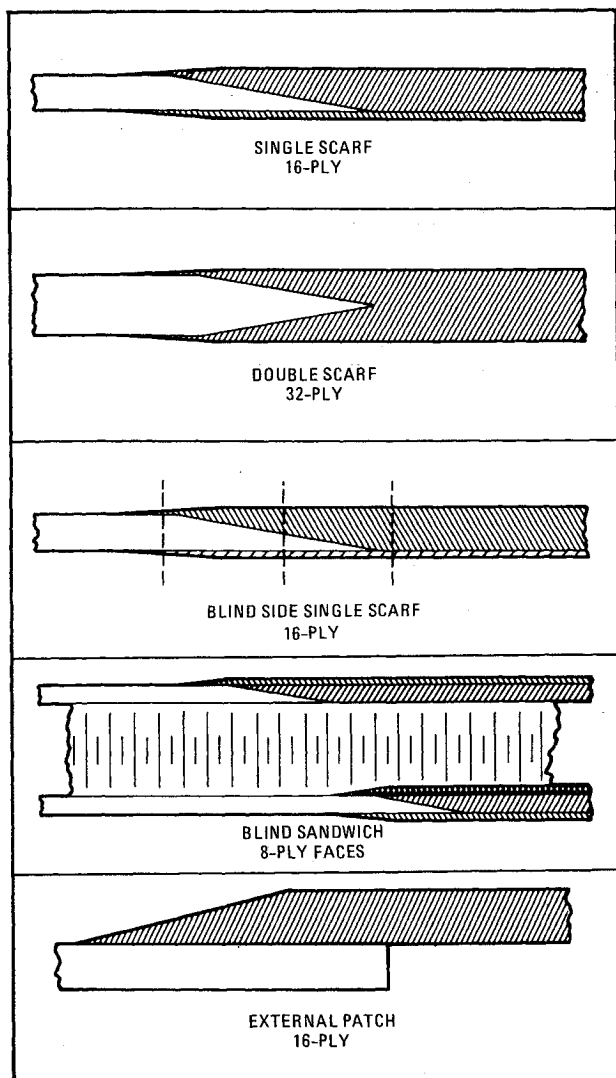
Fig. 4 Repair-joint concepts.

The five repair-joint concepts shown in Fig. 4 were developed for the generic laminate repair. Each of these will be discussed in detail.

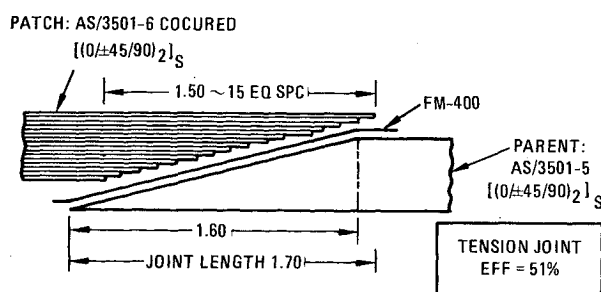
Fig. 5 Basic cocured 16-ply scarf-joint design.

$[(0/\pm 45/90)_2]_s$ stacking order as shown in Fig. 5 resulted in shear failure in the joint at 51% joint efficiency.

The difficulties involved in repairing a panel with access from one side only are obvious; the solutions are not. The substantial improvement (37%) achieved by even a small patch bonded to the inside surface (Fig. 7 cf. Fig. 5) could not be ignored. The design presented here evolved out of numerous considerations, not the least of which were: 1) how to locate the inside patch, and 2) how to effect a good bond.

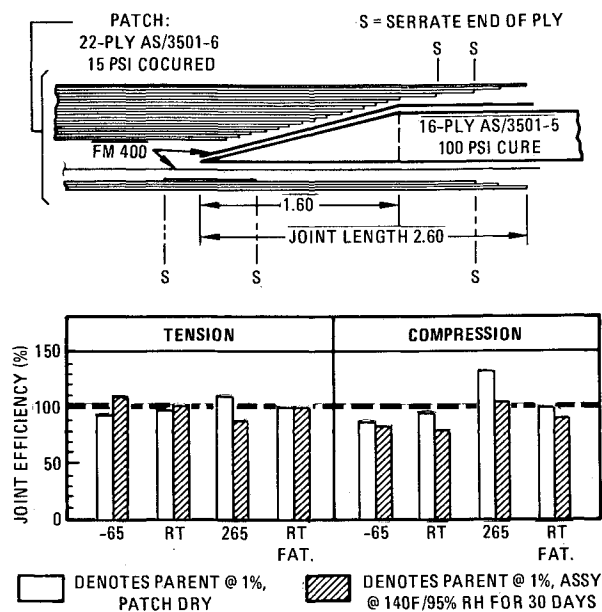
Fig. 8 Final single-scarf flush repair.

assumed to be loaded in shear as well as longitudinal tension and compression. Therefore, one ply was added in each of three directions (0, +45 and -45) on both sides of the laminate as shown in Fig. 8. This joint developed 97% joint efficiency (RT dry tension) and consistently failed in parent-laminate tension. This is a very satisfactory repair concept.

order, but otherwise the repair remained essentially unchanged from the design of Fig. 8. The test results, completed with this stacking order, are shown in Fig. 8 for tension and compression, dry and wet, -65°F, RT and 265°F, static and post-fatigue residual strength testing. Apparently, neither moisture, cold and hot temperatures, nor prior fatigue history significantly degrade the structural efficiency of the single scarf joint.

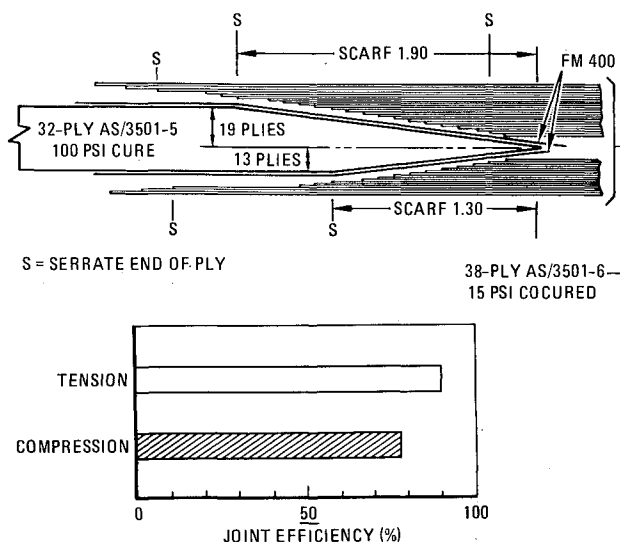
Fig. 9 Double-scarf flush repair.

The double scarf joint permits a shorter joint length and less parent material removed than a single scarf. Using the same 18/1 taper ratio, the design for a 32-ply generic laminate repair was patterned after the single scarf joint. Three plies ($\pm 45/0$) were added on both surfaces and the two longest 0-deg plies on either side were serrated. Tension and compression specimens and the results of room temperature dry tests are shown in Fig. 9. The results are satisfactory to demonstrate the validity of this approach though additional patch material appears required for full strength restoration.

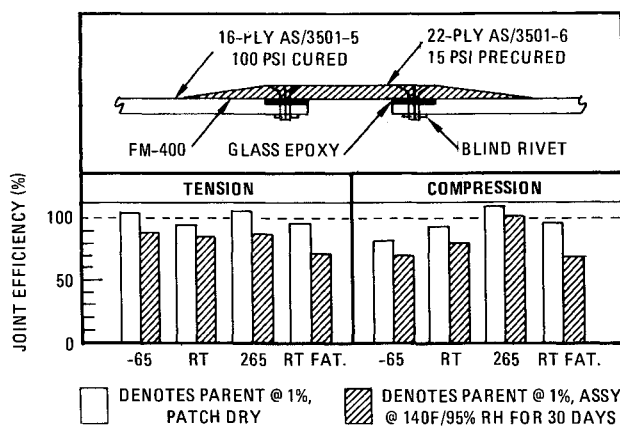
Fig. 13 External patch joint.

To stabilize the specimen for compression loading, the repaired laminate was assembled into a honeycomb sandwich beam. This specimen form was then used for all subsequent tests in tension as well as compression. The beam assembly prevents local rotation of the laminate and the resulting peeling. This raised the joint efficiency from 78% to 93% for room temperature dry tension. Complete results of these four-point beam tests of the external patch repair are shown in Fig. 13. With the change in specimen form, the mode and location

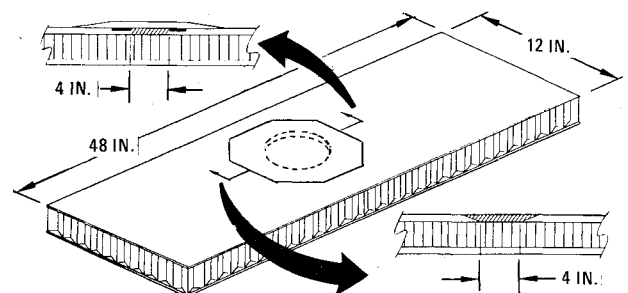
Fig. 14 Holed panel repairs.

With the validation of several repair-joint concepts via the uniaxial testing just discussed, it remains to substantiate the extension of these concepts, to three-dimensional, real world applications. To some extent, this was accomplished for the scarf-joint flush repair and the external patch repair using the 16-ply 12-in. \times 48-in. panels of Fig. 14. Each panel was loaded as a four-point beam. Both repairs are direct applications of the joints previously evaluated.

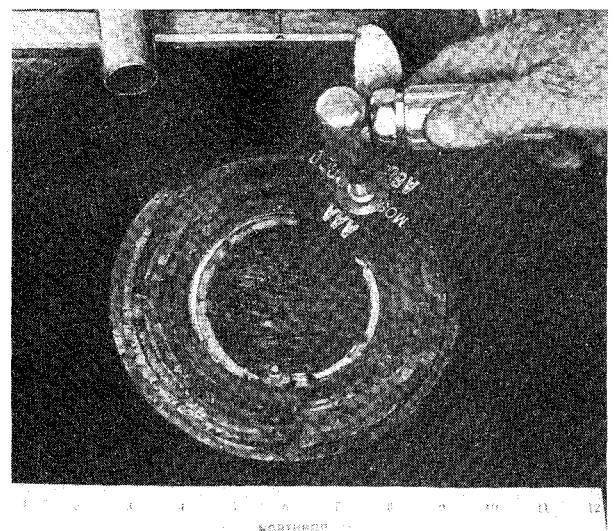
Fig. 15 Scarfing the 4-in. diam hole.

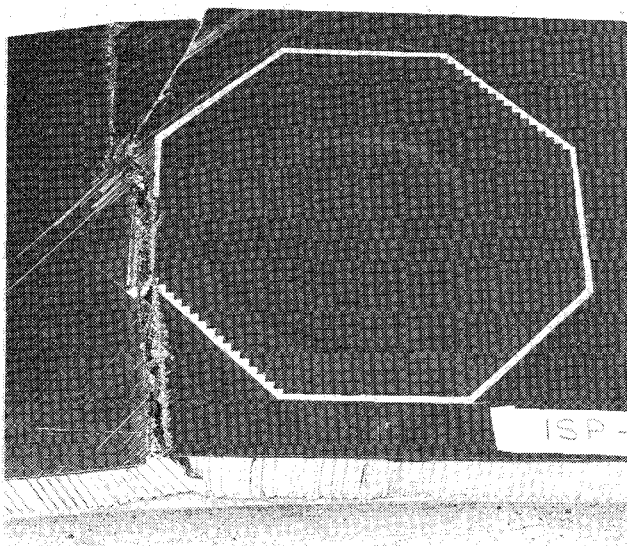
Fig. 16 Typical tension failure of scarf-joint repair panel.

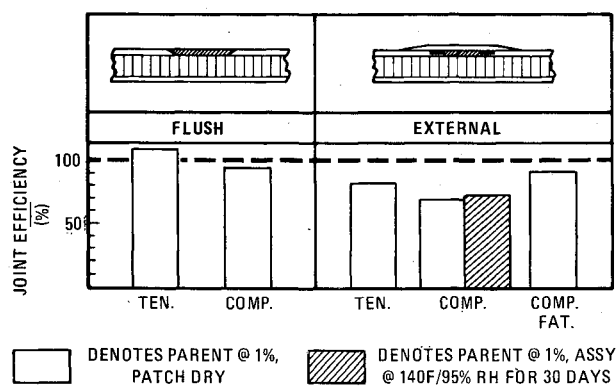
Fig. 17 Holed panel results.

Ten panels, each with a 4-in. diam hole were repaired with an external patch designed for longitudinal loading only. The results shown in Fig. 17 are seen to be lower than the corresponding results on the scarf-joint flush repair and are also considerably lower than the corresponding results on 1-in. wide beams. No sign of incipient failure was evident in any of the tension panels. However, those panels with the repair in compression showed considerable incipient failure beginning at 25% of the parent ultimate compression allowable. Figure 18 shows incipient failure at 35% of the parent allowable. Failure begins where the surface ply (0-deg) joggles over the next longest ply. While this joggle is only a 0.0055-in. step, it is nevertheless seen to have had a significant effect on the ability of the ply to resist failure. Once a local failure occurs, it grows and is joined by others as load is increased, until the entire patch is peeled off. Concern over fatigue loading would appear justified where the maximum compression loads would be high enough to cause such incipient failure. However, spectrum compression fatigue loading to a maximum of 37% of the parent compression allowable resulted in no incipient failure. After fatigue loading, incipient failure began during residual strength testing at 45% of the parent compression allowable. It appears that a stress-relieving mechanism takes place under fatigue loads which suppresses the incipient failure.

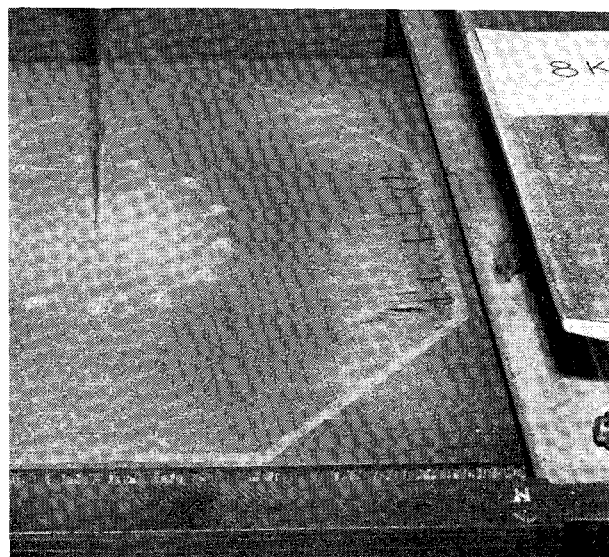
Fig. 18 Incipient failure developing at 35% of parent allowable compression.

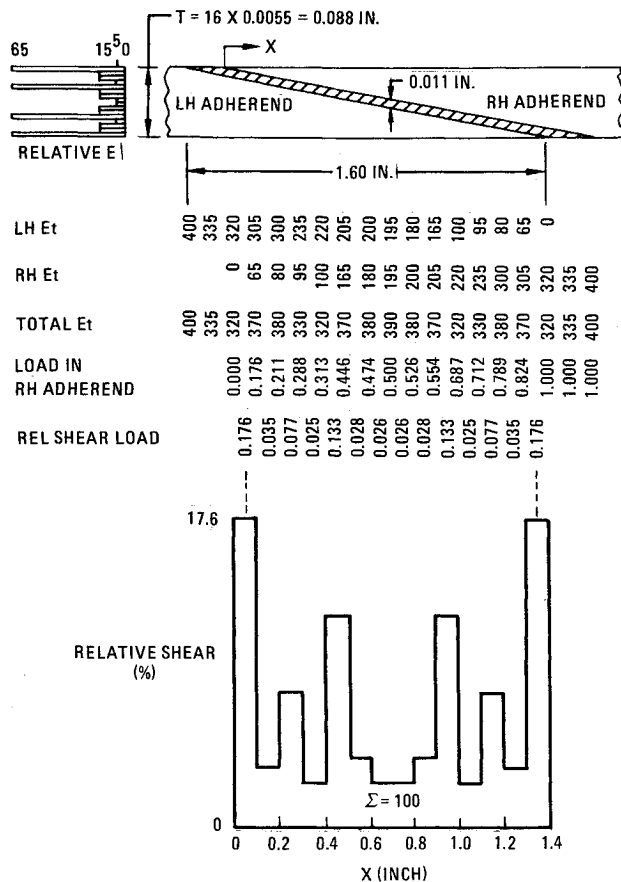
Fig. A1 Shear distribution analysis for scarf-joint with identical $[0/\pm 45/90]_2$ adherends.

The relative shear diagram (Fig. A1) gives some insight into the load-transfer mechanics. No claim is made for precision since shear lag is neglected, but the general nonuniformity is rationally determined. The higher shears exist on those steps where the 0-deg ply of the thinner adherend is bonded.

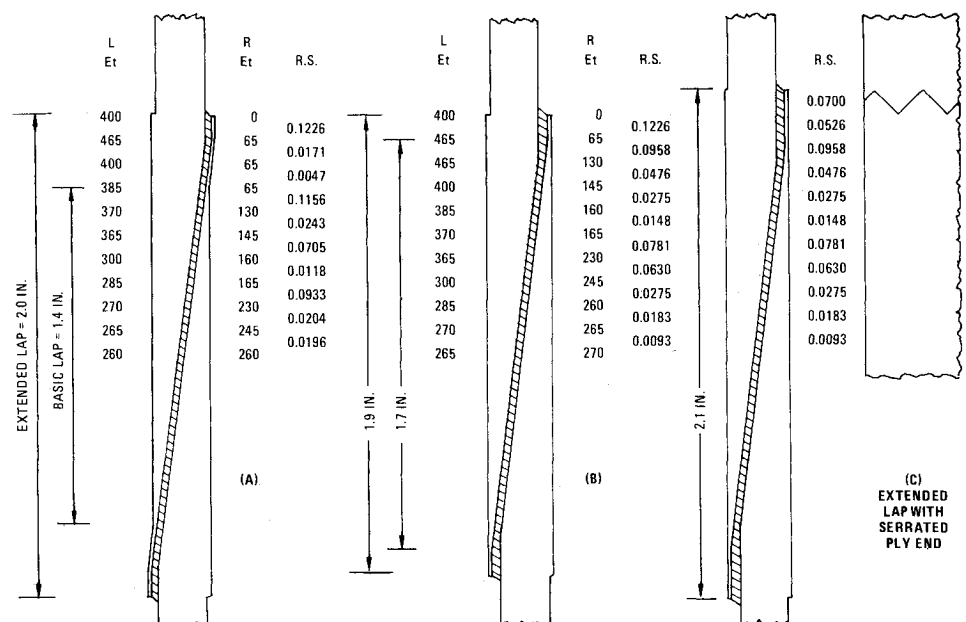
Fig. A3 Shear distribution analysis with added 0-deg plies.

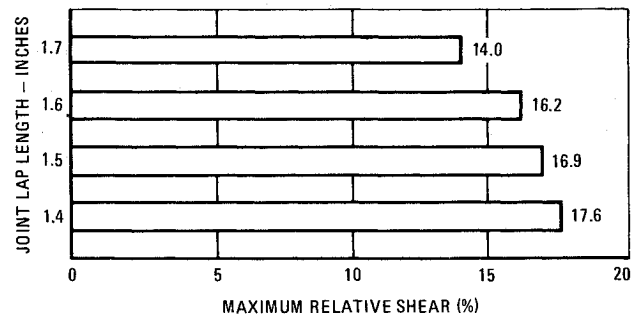
Fig. A2 Effect of lap length on MRS.
