Sonic Fatigue Testing of an Advanced Composite Aileron

The sonic fatigue test program to verify the design of the composite inboard aileron for the L-1011 airplane is described. The composite aileron is fabricated from graphite/epoxy minisandwich covers which are attached to graphite/epoxy front spar and ribs, and to an aluminum rear spar with fasteners. The program covers the development of random fatigue data by means of coupon testing and modal studies on a representative section of the composite aileron, culminating in the accelerated sonic fatigue proof test. The composite aileron sustained nonlinear panel vibration during the proof test without failure. Viscous damping coefficients as low as 0.4% were measured on the panels. The effects of moisture conditioning and elevated temperature on the random fatigue life of both undamaged and impact damaged coupons were investigated. The combination of impact damage, moisture, and a 180°F temperature could reduce the random fatigue life by 50%.

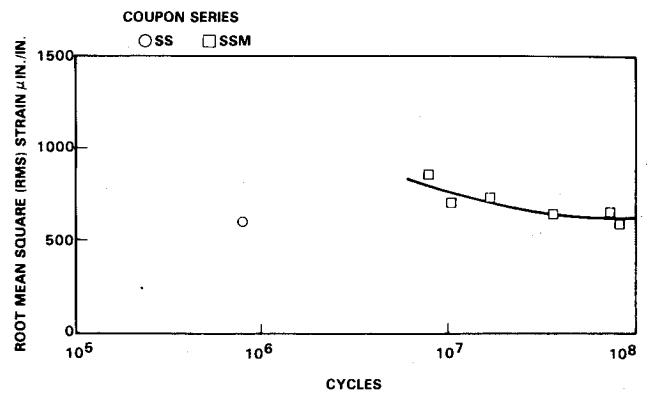
Fig. 4 Random fatigue data for the cover/spar interface.

The random fatigue data in Fig. 4 for the cover/spar coupons did indicate an improvement in the fatigue life. Only one series SS coupon was tested on account of the design change occurring in the middle of the coupon test program. However, the three SRM series of coupons, tested at room temperature, indicated a much lower sonic fatigue life than obtained with the SR series coupons (Fig. 5). On close inspection of the photomicrographs of sectioned SR series coupons, it was discovered that the center ply in the lower face sheet had a 90-deg fiber orientation instead of a 0-deg orientation (Table 1). Calculations indicated that, for bending at the fastener location, the combined doubler and lower face sheet stiffness is comparable to the three-ply upper face sheet stiffness. The strain levels are also comparable in the upper and lower face sheets. The more critical strain distribution around the head of the countersunk fastener is thought to be responsible for the occurrence of the failures in the upper face sheet, adjacent to the fasteners, in the SR series coupons.² The failure in the SSM, SRI, and the SRM series coupons were, generally, initiated in the inner skin, adjacent to the doubler edge, as illustrated in Fig. 3.

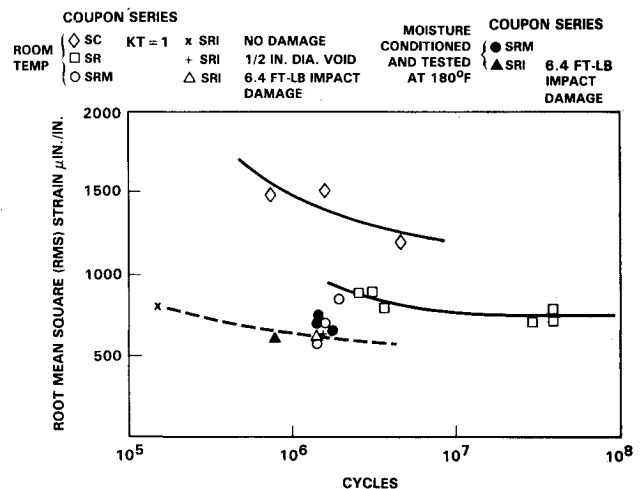
Fig. 5 Random fatigue data for the covers and the cover/rib interface.

Photomicrographs of a sectioned coupon (Fig. 3) indicate that compression of the syntactic core occurred at the edges of the doublers. The reduction in the cover thickness, at the outermost doubler edge, produced a local increase in strain level which initiated the failures at that location. In the absence of syntactic core compression, there is a very strong possibility that the failures will again be initiated at the fastener locations in the upper skin. The random fatigue life will then be defined by the SR series coupon data (Fig. 5). The

An undamaged coupon was random fatigue tested at room temperature at a rms strain level (Fig. 5) selected from the SR series coupon fatigue test data. A very short fatigue life was obtained. Thereafter, all of the remaining three SRI series coupons were tested at a more manageable excitation level.

The random fatigue data for the above coupons are summarized in Fig. 5. On the basis of the limited test data, it appears that the fatigue life is not affected by a single impact damage or the presence of a simulated void. However, the combination of a single impact damage, moisture conditioning, and a test temperature of 180°F appears to have reduced the random fatigue life by 50%. In the moisture conditioned coupon, tested at 180°F, changes in the resonant frequency, the damping, and the frequency response peak ratios were observed even at low excitation levels (Fig. 13) prior to reaching the random fatigue test level. The excitation level in all coupon tests was increased in increments up to the test excitation level for calibration purposes in case of premature strain gage failure.²

aileron design, based on the random fatigue allowables in Fig. 5 and approaching 9 dB, if the margin of safety built into the proof test noise level is considered. Improved fabrication procedures which eliminate the syntactic core compression problem could increase the existing margin by 2 dB.

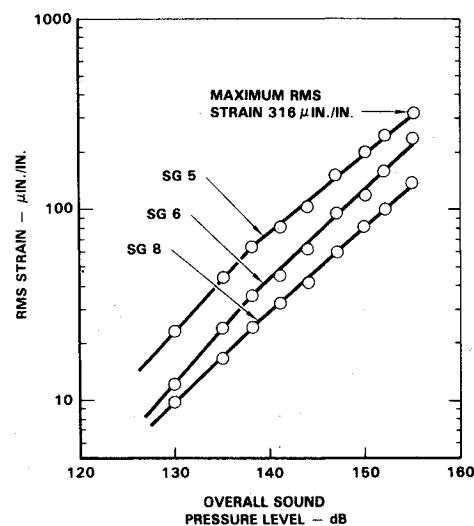
Fig. 19 Variation of rms strain with overall sound pressure level.

above tests and the levels measured with a rms meter having a 30-seconds averaging time. A typical plot of the rms strain data, as a function of the overall noise level at the aileron location in the PWT is illustrated in Fig. 19. The knee in the strain data in Fig. 19 indicates the presence of large-amplitude nonlinear panel response. Linear theory breaks down when the panel vibration amplitude approaches the panel thickness. An rms vibration amplitude of 0.048 in. was measured during the proof test which is close to the panel thickness of 0.0825 in. The increase in the frequencies and the broadening of the spectral peaks, observed in the proof test panel strain response spectrum in Fig. 20, is typical of nonlinear panel response. The linear strain response spectrum is included in Fig. 20 for comparison. Consequently, damping measurements obtained with the 3-dB point method, at high excitation levels, could overestimate the actual panel damping by a significant amount. For this reason the damping should be measured at low excitation levels.
