# Damage Tolerance and Failure Analysis of a Composite Geodesically Stiffened Compression Panel

A geodesically stiffened continuous-filament composite structural concept has been designed for a transport aircraft fuselage application and fabricated using an automated manufacturing process. Both large panels and element specimens derived from these panels have been experimentally and analytically investigated when subjected to axial compression to understand their buckling, postbuckling, and failure responses. The primary failure mode for this structural concept is skin-stiffener separation in the skin postbuckling load range. The large panels are subjected to low-speed impact damage and tested to failure in axial compression to evaluate the damage tolerance of this structural concept. These results suggest that damage to the stiffener and a stiffener intersection point from the skin side do not influence the failure load or failure mode of this structural concept. Nonlinear finite element analysis using a detailed element specimen model indicates that failure of this specimen may have initiated at the skin-stiffener flange region close to the stiffener intersection. When the skin

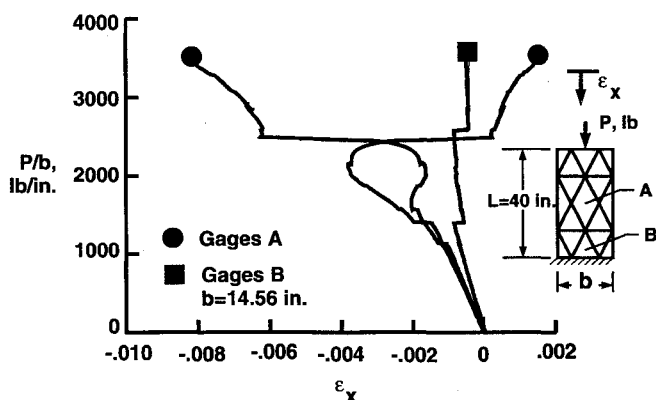
Fig. 5 Typical surface strain results for a 14.56-in.-wide panel.

A comparison of typical surface strain results for a 14.56-in.-wide panel tested without impact damage is presented in Fig. 5 as a function of normalized load. The surface strain  $\epsilon_x$  results were recorded from back-to-back strain gauges oriented parallel to the direction of applied loading at two locations on the skin. Surface strain results from back-to-back strain gauges at location A, which is at the center of the specimen on the skin, are indicated by the filled circles. Surface strain results

from back-to-back strain gauges at location B, which is away from the center of the specimen on the skin, are indicated by the filled square. The panel had a maximum compressive strain of approximately 0.008 in./in., and a maximum tensile value of approximately 0.002 in./in. at the center of the specimen at failure. The divergence of the back-to-back strain gauge results at the center of the panel suggests that bending strain at the center of the specimen is because of local buckling of the skin as the panel was loaded to failure. The discontinuities in the surface strain results measured at the center of the panel suggest that a redistribution of load occurred at approximate values for normalized load of 1500 and 2500 lb/in. The redistribution of load was because of a combination of changes in the skin local buckling mode and local failures at the skin-stiffener interface and fiber crossover region. The panel had a maximum compressive strain of approximately 0.001 in./in. at location

B. The discontinuities in the load-strain curve for surface strain results measured at location B suggest that local failures caused redistributions of the load in the panel as it was loaded to failure.

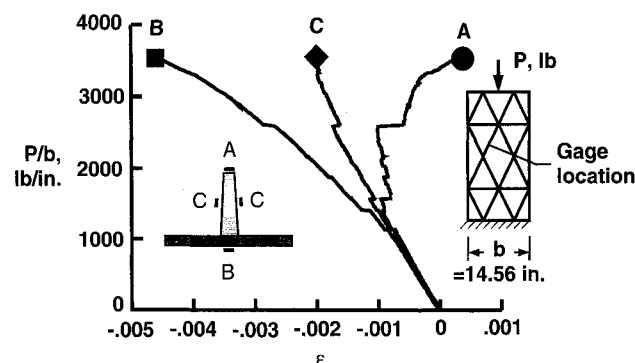
Fig. 6 Typical stiffener axial strain results for a 14.56-in.-wide panel.

Typical stiffener axial strain results for a 14.56-in.-wide panel tested without impact damage is presented in Fig. 6 as a function of the normalized applied load. The axial strain  $\epsilon$  results were recorded from strain gauges oriented parallel to the direction of the stiffener at locations midway between stiffener intersections. Axial strain data at location A on the crown of the stiffener are indicated by the filled circle. Surface strain data on the skin below the stiffener are indicated by the filled square. Axial strain data at locations C on the sides of the stiffener are indicated by the filled diamond. A maximum tensile strain at failure of approximately 0.005 in./in. was measured at location A. The panel had a maximum compressive strain at location B of approximately 0.0047 in./in. at failure. Divergence of the axial strain data at locations A and B suggests that bending strains occurred about a plane parallel to the midplane of the skin as the panel was loaded into the postbuckling range. The panel had a maximum compressive strain value at locations C of approximately 0.002 in./in. at failure. The results at locations C also suggest that no lateral

bending of the stiffener occurred. Also, the discontinuities in the load-strain curves shown in Fig. 6 suggest that a redistribution of load occurred in the panel because of local failures prior to the failure of the panel.

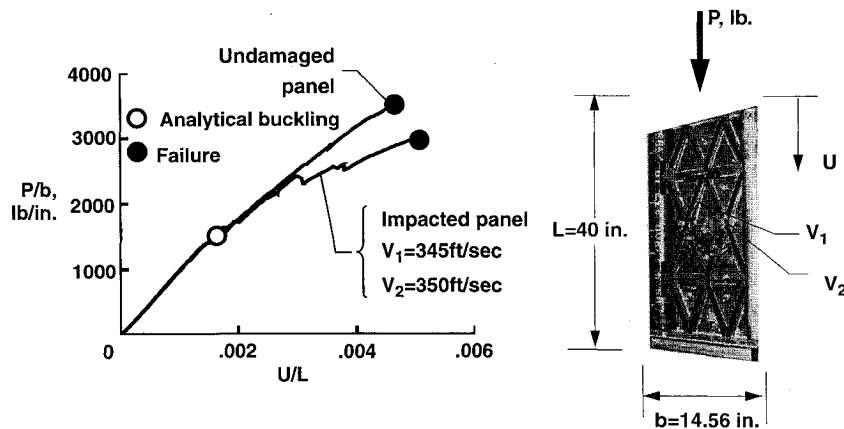
Fig. 10 Summary of end-shortening results for specimens with low-speed impact damage at two stiffener locations.

Experimental results for a geodesic compression panel subjected to low-speed impact damage are presented in Fig. 10. A 14.56-in.-wide panel was subjected to low-speed impact damage normal to the skin surface at two locations near the skin-stiffener interface prior to testing. Aluminum spheres 0.5 in. in diameter were used as the impact projectile in this investigation. The panel was impacted at a point midway between intersecting stiffeners with a speed  $V_1$  of 345 ft/s and at the intersection of two stiffeners with a speed  $V_2$  of 350 ft/s. These impact locations are shown in Fig. 10. There was observable damage in the panel corresponding to the impact energy levels used. No additional nondestructive evaluations were performed to quantify the impact damage. The plot on the left of the figure shows normalized end-shortening deflection as a function of normalized applied load. Failure of the undamaged and impact-damaged panels is represented by the filled circles. The theoretical buckling load of an undamaged panel is represented by the open circle. The results show that the impact-damaged panel failed at a normalized load of approximately 2900 lb/in., which is slightly lower than the failure load of the panel tested without low-speed impact damage. The

photograph on the right of the figure shows the failed impact-damaged panel. The photograph shows that the panel failed in a mode similar to that for the undamaged panel that was shown in Fig. 7. The results presented in Fig. 10 suggest that the presence of low-speed impact damage did not significantly influence the stiffness or strength of this geodesically stiffened panel.

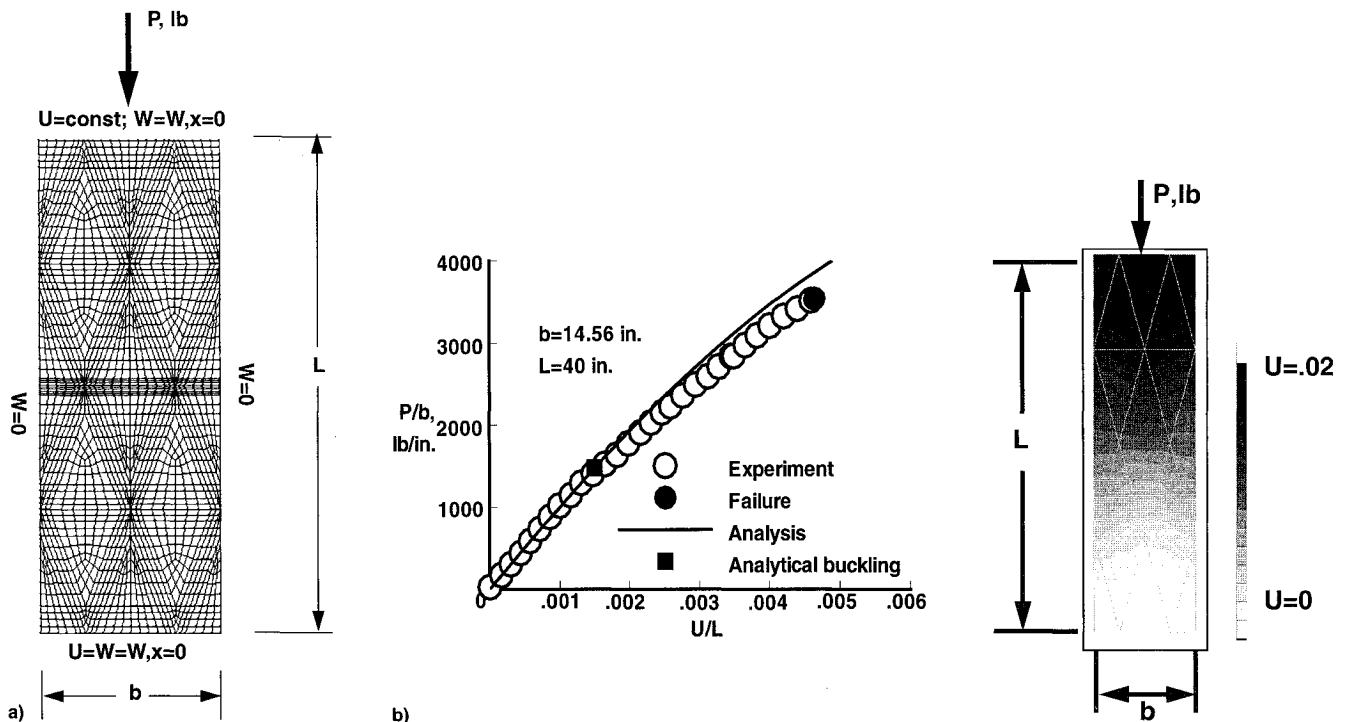
Fig. 11 Comparison of experimental and analytical results for panel specimen: a) finite element model and b) end-shortening results.

A finite element model for the panel specimen is shown in Fig. 11a. The material properties used in the analysis are shown in Table 1. The skin, stiffeners, and frame clips were modeled with quadrilateral plate elements that allow transverse shear deformations. The finite element model of the 14.56-in.-wide panel had 2900 quadrilateral plate elements with approximately 18,000 degrees of freedom. Boundary conditions shown in Fig. 11a were assumed along the edges of the panel. The loading condition used for the analyses was a uniform end-shortening applied to one end of the specimen. The  $U$  displacement degree of freedom was constrained at the opposite edge. The out-of-plane deflections  $W$  were constrained along all the edges of the panel. A comparison between test results and analytical results obtained using the structural analysis of general shells (STAGS) computer code (Ref. 9) is presented in Fig. 11b. A finite element analysis was used to perform linear and geometrically nonlinear analyses of panel global response. Normalized end-shortening results as a function of normalized load are shown on the left of the figure. The open circles represent experimental results and the line represents analytical results. The filled circle denotes failure of the panel and the filled square denotes the analytical buckling load obtained from linear buckling calculations using the STAGS finite element code. End-shortening displacement contours calculated from a geometrically nonlinear finite element analysis are shown on the right of the figure. The contour results indicate that applied end-shortening was uniform across

the width at the loaded edges of the panel. However, the end-shortening displacement contours were not uniform across the width of the panel away from the loaded edges. The results suggest that the end-shortening displacement contours were influenced by the stiffeners and stiffener intersection points. The results presented in Fig. 11 indicate that the analysis accurately predicts the panel end-shortening response up to buckling. The difference between analytical and experimental post-buckling responses of the panel may be attributed to local failures at buckling that result in reduced panel stiffness.
