Damage Tolerance Implications of Corrosion Pillowing on Fuselage Lap Joints

N. C. Bellinger,* J. P. Komorowski,† and R. W. Gould‡
National Research Council, Ottawa, Ontario K1A 0R6, Canada

A previous study showed that pillowing, caused by the presence of corrosion products, can significantly increase the stress in fuselage lap joints, which raises concerns about the effect on aircraft safety. In the present study finite element techniques were used to determine the effect that pillowing has on the stress-intensity factor for cracks located at rivet holes in lap joints. The stress caused by the internal pressure and riveting process was taken into account while the fuselage curvature was ignored. The results indicate that corrosion pillowing increases the stress-intensity factor for the crack edge along the skin-faying surface with a concurrent decrease on the opposite side. This difference suggests that a crack will grow more rapidly along the faying surface than in the through-the-thickness direction, thus forming a semi-elliptical crack front with a very high aspect ratio. This type of crack is more difficult to detect.

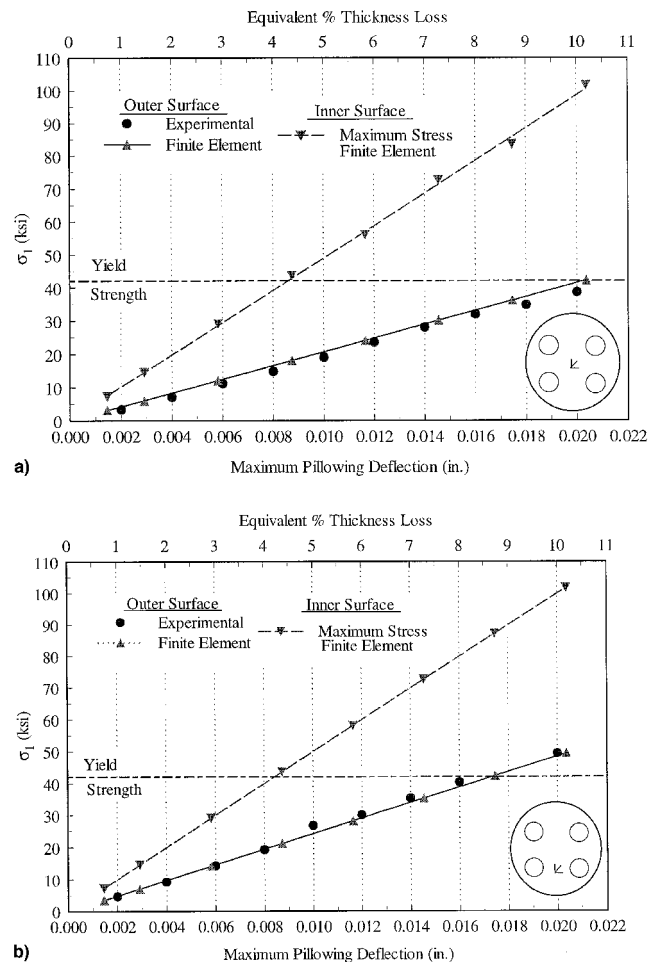
Fig. 6 Comparison between experimental and finite element results: a) center strain gauge location and b) strain gauge location between two rivets.

In a subsequent test the pressure was slowly increased to a maximum deflection of 0.508 mm (0.02 in.) corresponding to a total thickness loss of 10%. A plot of the principal stress calculated from the strain gauge readings vs the maximum pilling deflection is shown in Fig. 6 along with the finite element results. Included in Fig. 6 is the corresponding maximum stress along the inner surface of the outer skin obtained from the finite element results. Good agreement is shown between the experimental stress values and the finite element results, indicating that the finite element model used in the previous study^{2,3} produces reasonable results. The maximum stress values in Fig. 6 show just how rapidly stress increases in a corroded joint. The stress in the joint increases to above yield with less than 5% thickness loss. It should be emphasized

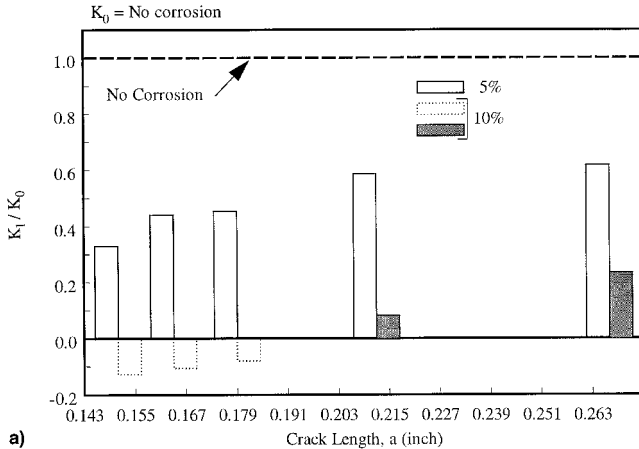
Fig. 7 Stress-intensity factor ratios for various crack lengths present in joints containing two levels of corrosion, 5 and 10%. Stress-intensity ratio for crack edge along a) outer surface and b) inner faying surface.

To calculate the mode I stress-intensity factor the nodal displacements from the three loading cases were added together and substituted into Eq. (1). A number of crack lengths were examined for joints containing two levels of corrosion thickness loss, 5 and 10%. The results were nondimensionalized with respect to the noncorroded stress-intensity factor and plotted against crack length (Fig. 7). It should be pointed out that the crack length was measured from the center of the rivet hole to the crack tip. The stress-intensity factors for the crack edge along the outer surface (Fig. 7a) are consistently lower than the noncorroded value ($K_I/K_0 = 1.0$), but steadily increase as the crack length increases. At higher corrosion levels, i.e., 10% thickness loss, the stress-intensity factors have negative values for cracks close to the hole edge. It is recognized that negative values are unrealistic, which strongly suggests that the assumed crack shape used in the model is incorrect. This is explored further in the next paragraph.

The stress-intensity factors for the crack edge along the inner (faying) surface (Fig. 7b) are significantly higher for small crack lengths, i.e., near the rivet hole, and steadily decrease as

the crack length increases. This suggests that the effect pilowing has on a joint is highest near the hole edge and slowly decreases. The divergence in the stress intensity factors for the two surfaces suggested in Fig. 7 is shown more clearly in Fig. 8. In Fig. 8 the stress-intensity factor for a single crack length of 3.84 mm (0.151 in.) was nondimensionalized and plotted against the percentage thickness loss. As can be seen from Fig. 8 the stress-intensity factor for the crack edge along the faying surface increases as the pilowing increases while the crack edge along the outer surface decreases. This is understandable because the bending in the skin caused by pilowing produces a compressive stress in the rivet area on the outer surface while a high tensile stress is present on the faying surface. The difference in the stress-intensity factor for the two surfaces suggests that the crack edge on the faying surface would grow more rapidly in the direction of the row of rivets than through the skin toward the outer surface. This should result in a semi-elliptical crack front with a high aspect ratio, as demonstrated in Fig. 9.

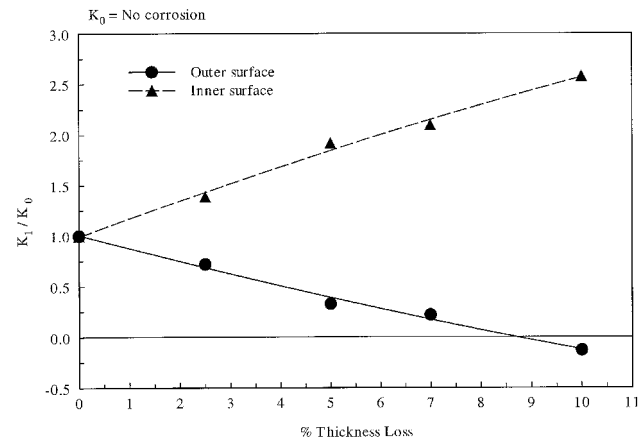
Fig. 8 Comparison of stress-intensity factor for crack edge along inner and outer surfaces.

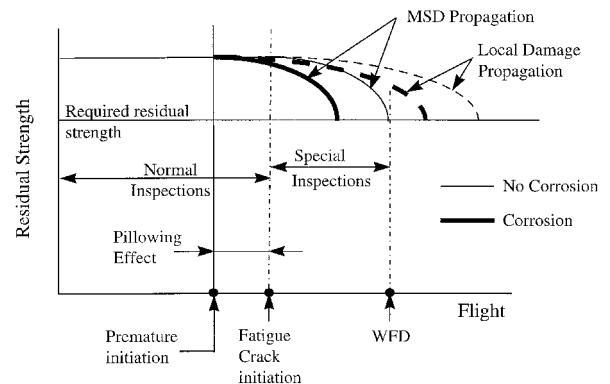
Fig. 11 Implications of corrosion pillowing on structural integrity of fuselage lap joints. Graph modified from Ref. 8.

One approach to decreasing the risk of aging aircraft failure caused by multiple site damage (MSD) is to perform special inspections of selected critical areas at predefined intervals (Fig. 11).⁸ If corrosion is present cracks could nucleate earlier than in a noncorroded joint and these cracks would be typically high aspect ratio semielliptical in shape for the reasons discussed previously. They would also be subsurface and difficult
