# Response of Damaged and Undamaged Tailored Extension-Shear-Coupled Composite Panels

Donald J. Baker\*

NASA Langley Research Center, Hampton, Virginia 23681

The results of an analytical and experimental investigation of the response of composite I-stiffener panels with extension-shear coupling are presented. This tailored concept, when used in the panel cover skins of a tiltrotor aircraft wing, has the potential for increasing the aeroelastic stability margins and improving the aircraft productivity. The extension-shear coupling is achieved by using unbalanced  $\pm 45$ -deg plies in the skin. Experimental and STAGS analysis results are compared for eight I-stiffener panel specimens. The results indicate that the tailored concept would be feasible to use in the wing skin of a tiltrotor aircraft. Evaluation of specimens impacted at an energy level of 500 in.-lb indicate a minimal loss in stiffness and less than 30% loss in strength. Evaluation of specimens with severed center stiffener and adjacent skin indicated a strength loss in excess of 60%.

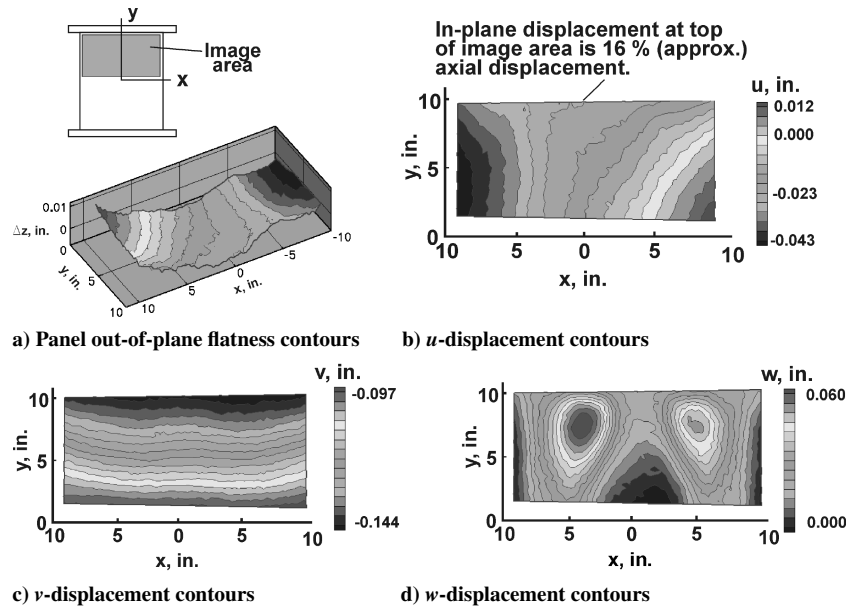
Panel TP1 - Image taken at load = 21.6 kips/in.

Fig. 12 Results obtained from the image correlation analysis on specimen TP-1.

In addition to the strain gages and displacement transducers used during the testing, a three-dimensional image correlation system, described earlier, was also used. Some of the results that have been obtained from the image correlation system on specimen TP-1 are illustrated in Fig. 12. As shown in Fig. 12, the image area covered approximately top one-half of the specimen surface area. The first image taken in any test determines the profile (or flatness) of the specimen at no load. Specimen TP-1 profile is shown in Fig. 12a and indicates the specimen surface profile varies from a theoretical plane by +0.010- to -0.005-in. Each contour line represents a constant distance from a theoretical plane. The initial imperfections are tracked to access the reproducibility of these tailored panels.  $U$ -displacement contours are presented in Fig. 12b. These contours indicate that the in-plane displacement is approximately 16% of the axial displacement. The effect of the specimen Poisson's ratio, which is nearly unity for the skin laminate, can be observed along the edges of the specimen. The  $v$ -displacement contours shown in Fig. 12c indicate a nearly uniform axial loading of the panel. The  $w$ -displacement contours are shown in Fig. 12d. The skin between the I-stiffeners and located between the quarter-point and the specimen end deflect up to 0.06-in. out of plane. This out-of-plane displacement magnitude compares well with the analysis results. The skin deflections are maximum in the bay on the left side of the figure. The analysis (see Fig. 7) also predicts the skin deflection on one side of the center stiffener will have a greater magnitude.

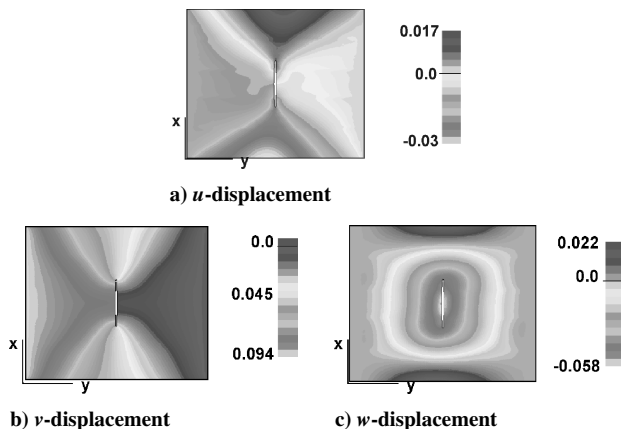
Fig. 19 Predicted displacements for specimen with horizontal slot.

quad elements and 12,494 nodes. Predicted displacement results are shown in Fig. 19 for a specimen with a horizontal slot. These contours (Fig. 19a) do not have the skewed pattern shown in Fig. 7 for the undamaged specimen. The severing of the center stiffener and adjacent skin minimizes the extension-shear coupling in the specimen. The contours shown in Fig. 19b indicate the load redistribution around the central slot. The large triangular area to the right of the slot in Fig. 19b indicates no axial displacement. Figure 19c indicates an out-of-plane bulge caused by severing the central stiffener.

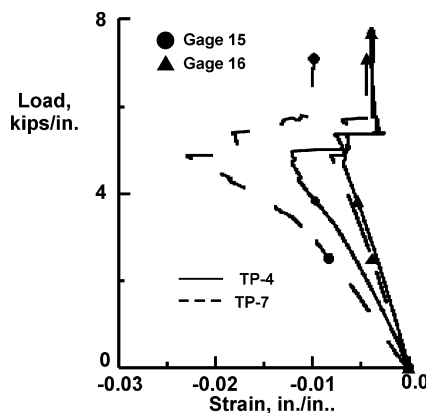
Fig. 21 Results from gages at end of slot.

Strain gage results from two strain gages adjacent to the slot are shown in Fig. 21. Strain gage 15 is at the slot end, and gage 16 is located 0.1-in. from gage 15. As shown in Fig. 21, both specimens had an initial failure at approximately 5.5 kips/in. Although the strain in gage 15 on specimen TP-7 is twice the strain in gage 15 on specimen TP-4, the strains at gage 16 are nearly equal in both specimens.

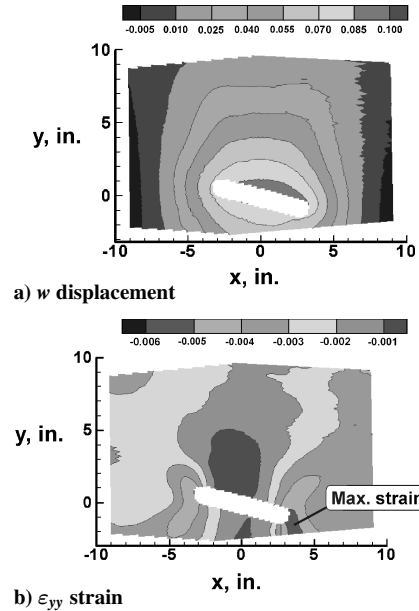
Fig. 31 Experimental displacement and strain fields for specimen TP-5 for  $N_y = 6.32$  kips/in.

The  $w$ -displacement field and  $\epsilon_{yy}$  strain field for specimen TP-5 shown in Fig. 31 are for a load of 6.32 kips/in., which are just

prior to the failure initiation. Figure 31a indicates that the out-of-plane displacement is in the same direction on both sides of the centerline. This displacement field does not match the analysis result, which predicts the skin to deflect in opposite directions on each side of the centerline. The darker area at the right end of the slot in Fig. 31b indicates the maximum strain in the image area, and the strain is higher than on the left side of the slot. The displacement field shown in Fig. 32 is at a load of 6.33 kips/in. and indicates starting of delamination at the right side of the slot, where the highest strain was indicated in Fig. 31b. The displacement field at a load of 7.45 kips/in., which is near failure, is shown in Fig. 33. The failure can be seen emanating from both ends of the slot and going upward on the left side and downward on the right side.
