Damage of Carbon/Epoxy Composite Plates Subjected to Mechanical Impact and Simulated Lightning

Paolo Feraboli* and Hirohide Kawakami†

University of Washington, Seattle, Washington 98195-2400

Damage is inflicted on carbon-fiber/epoxy composite plates using both simulated lightning strike and mechanical impact in the effort to understand the relative effect of the two damage mechanisms. A methodology is proposed to characterize the damage resistance and tolerance of unconfigured composite plates subjected to lightning strike in a fashion that is consistent with the extensive work previously done on low-velocity impact. Using current and voltage diagnostics, it is possible to extrapolate the amount of electromechanical energy absorbed by the plate during the strike and compare it to that absorbed during a mechanical impact. Damage resistance is characterized by means of ultrasonic C-scans and microscopy, whereas residual strength is measured by means of compression after impact testing. Results show that the energy dissipated in a specimen during the lightning strike is much greater than the strain energy introduced by mechanical impact, and hence a comparison based on energy is no

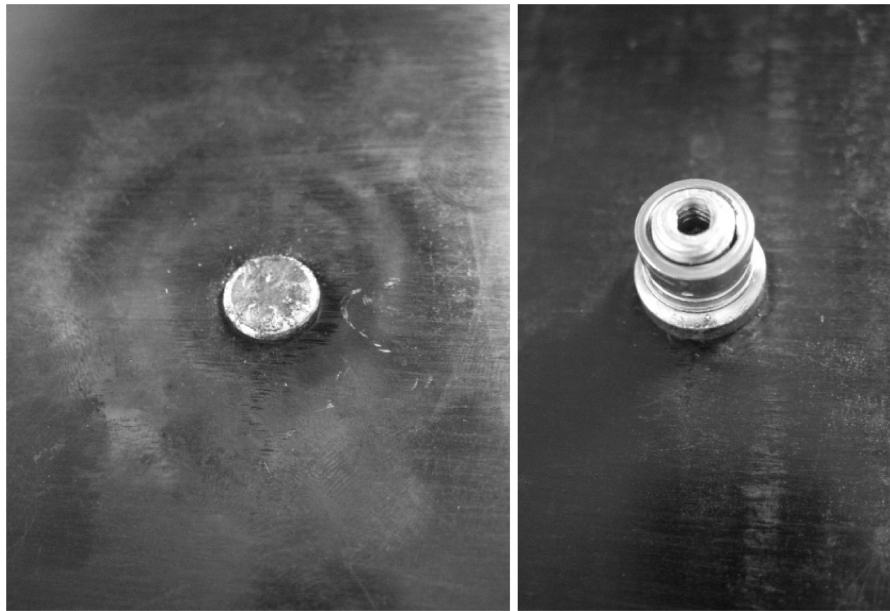
Fig. 6 Close-up of top and bottom surfaces of a filled-hole specimen subjected to a 50 kA strike.

strike takes place (see Figs. 5 and 6). For this material system and stacking sequence, even at 70 kA, only minor bulging of the plies toward the surface is visible in the proximity of the fastener, and modest fiber breakage is observable on both top and backfaces. For mechanical impact, all specimens show a small dent on the side of the impactor, but even at the highest energy values, the dent does not become particularly deep nor leads to visible surface breakage (see Fig. 7).

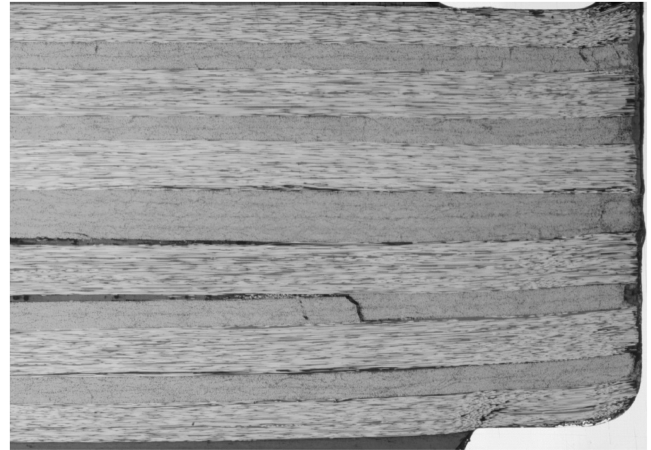
Fig. 21 Detail of the specimen struck with 50 kA, polished parallel to the 0 deg fibers in the proximity of the fastener head.

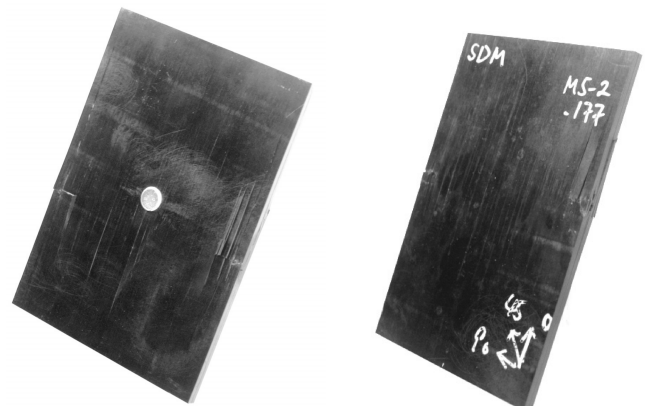
Fig. 25 70 kA lightning strike specimen (left) and 25 ft-lb (33.89 J) impact specimen (right) following residual strength CAI testing.

Fig. 24). For both pristine and filled-hole specimens, strength is calculated based on the gross section area, consistently with aerospace practice [12]. All specimens reported failed in the net section by an acceptable accepted compression failure mode as indicated by ASTM [17] (see Fig. 25).

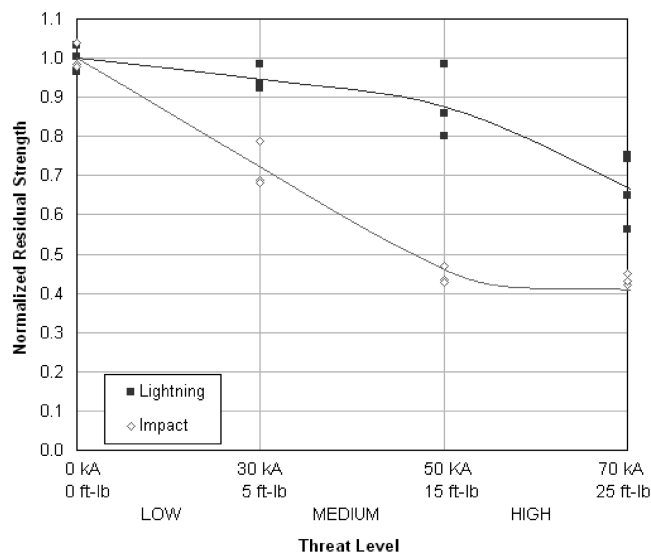
Fig. 26 Normalized CAI strength as a function of threat level for impact and lightning strike specimens.

Results for residual strength are reported in Table 5 and plotted in Fig. 26 against the severity of the threat and, in Fig. 27, against the projected damage area. This plot uses normalized strength values, which are obtained as the ratio of the damaged strength over the pristine or control strength. For impact damaged specimens, the normalized strength is calculated as

Considerations on the relative severity of impact damage and lightning strike damage are based on threat level rather than energy. The energy dissipated in a lightning strike event has been measured by means of current and voltage probes positioned strategically before and after the strike location. However, the amount of energy dissipated in the lightning strike event is an order of magnitude larger than the energy associated with an impact event of similar threat level. This makes the direct comparison of damage resistance and tolerance performance of the specimens subjected to impact and lightning strike threats difficult, as shown in Figs. 28 and 29. On the other hand, comparative evaluations can be performed successfully based on the relative severity of the threat level using impact energy and current intensity, respectively, as key threat metrics (see Figs. 10 and 26).

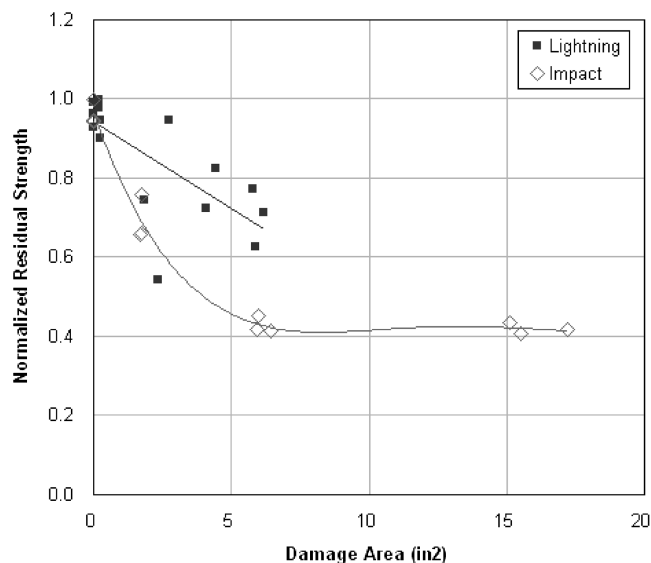
Fig. 27 Normalized CAI strength as a function of projected damage area for impact and lightning strike specimens.

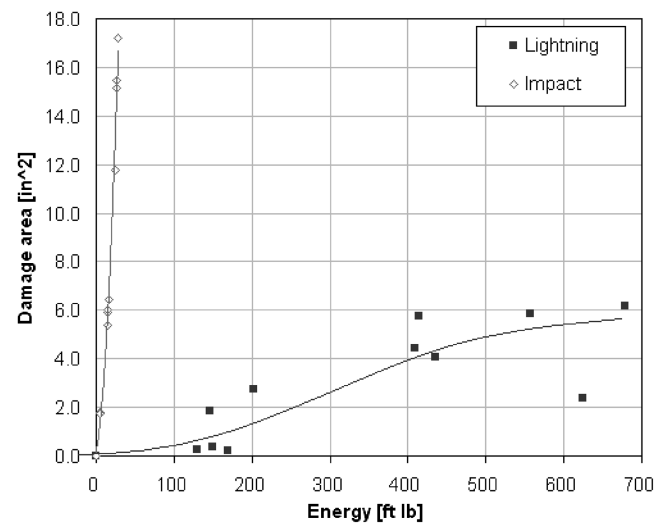
Fig. 28 Damage area for mechanical impact and lightning strike as a function of input energy.
