# Response of Spacecraft Window Materials to Hypervelocity Projectile Impact

William P. Schonberg\*

All large spacecraft are susceptible to impacts by meteoroids and pieces of orbiting space debris. These impacts occur at extremely high speeds and can damage flight critical systems, which can in turn lead to catastrophic failure of the spacecraft. In order to successfully design a spacecraft for a mission into the meteoroid and space debris environment, it is necessary to be able to characterize the response of a variety of structural materials under such high-speed impact loadings. This paper presents the results of an investigation of the response of window materials to hypervelocity projectile impact. Window impact damage is characterized according to the nature and extent of surface and internal damage. Analysis of the test data indicates that for single-pane specimens the extent of the damage to the test specimens can be written as functions of the impact parameters of the original projectile and the geometric and material properties of the projectile/window system. These functions can be used to perform parameter-sensitivity studies and to evaluate hypothetical design appli

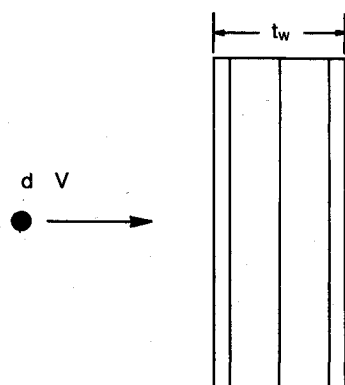
Fig. 1b Thick Lexgard window test specimen configuration.

Two different window constructions were used to evaluate the response of Lexgard windows to hypervelocity projectile impact. One consisted of a 12.7-mm layer of Lexgard sandwiched in between two 3.175-mm Lexgard layers for a total specimen thickness  $t_w = 19.05 \text{ mm}$  (Fig. 1a). The other contained an additional interior 12.7-mm layer for a total specimen thickness  $t_w = 31.75 \text{ mm}$  (Fig. 1b). In each test, a projectile of diameter  $d$  and velocity  $V$  impacted a Lexgard window specimen along a trajectory perpendicular to the plane of the window (Figs. 1a and 1b). The projectile shattered upon impact and set off a series of shock waves that created an internal area of damage. This internal damage area was typically a circular area of delamination between the Lexgard layers (Figs. 3-6). The window specimens ceased to be transparent near the

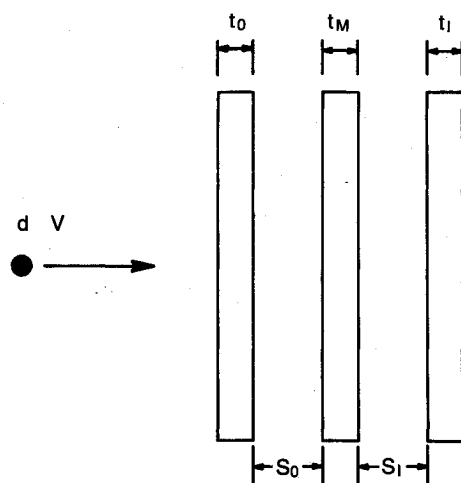
Fig. 2 Triple-pane glass window test specimen configuration.

A total of 21 single-pane Lexgard specimens and five triple-pane glass specimens were used to study and evaluate the hypervelocity impact response of window materials. The test specimens represent typical window configurations used in space structures. The Lexgard specimens were made from several 23 × 23-cm Lexgard sheets of varying thicknesses glued together (Figs. 1a and 1b). The glass specimens consisted of three 15 × 15-cm panes separated by varying standoff distances (Fig. 2). In the glass specimens, the outer and inner panes were made from annealed soda-lime and tempered Herculite II glass, respectively, while some middle panes were made from soda-lime glass and others from Herculite II glass.

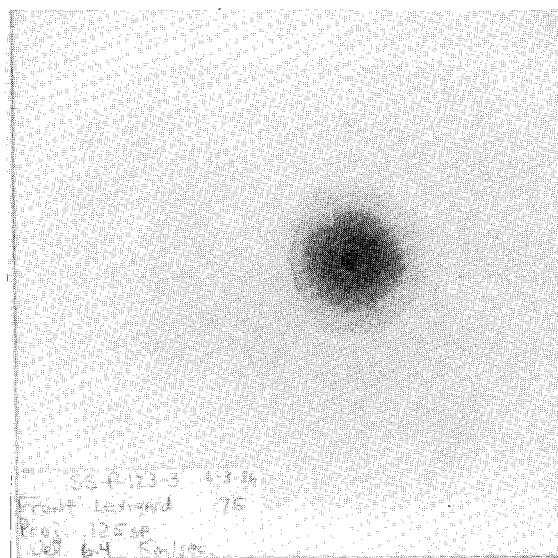
**Fig. 3a Damaged thin Lexgard window, front view, test no. 123-3 (small projectile diameter, high impact velocity).**

**Fig. 3b Damaged thin Lexgard window, side view, test no. 123-3 (small projectile diameter, high impact velocity).**

internal damage area. In some instances, rear-surface spall, as well as front and rear-surface petalling (Figs. 3b, 4b, 5b, and 6b), resulted from shock-wave interaction at the interface between a thin surface layer and a thick interior layer. Occasionally, penetration of the window specimen occurred as well (Fig. 4a). In these cases, the material surrounding the hole was melted and torn through the thickness of the specimen.

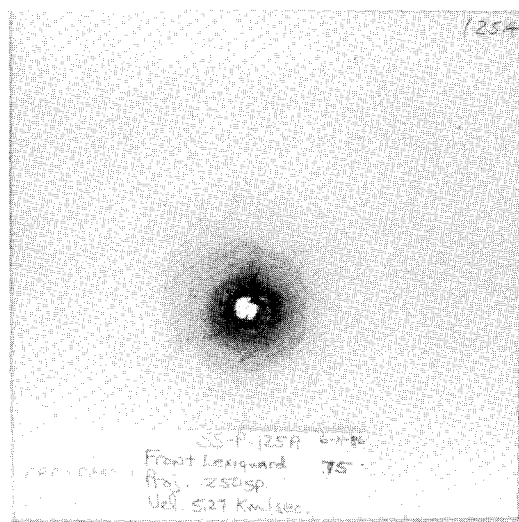
**Fig. 4a Penetrated thin Lexgard window, front view, test no. 125A (large projectile diameter, high impact velocity).**

**Fig. 4b Penetrated thin Lexgard window, side view, test no. 125A (large projectile diameter, high impact velocity).**

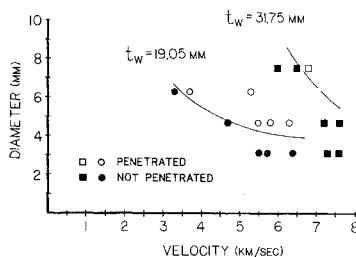
Fig. 8 Penetration functions for Lexgard windows.

A summary of the damage to each of the Lexgard specimens can be found in Table 5, where  $D$  is the diameter of the hole in the specimen if penetration occurred,  $A_d$  is the area of the internal damage region, and  $A_s$  is the area of rear-surface spall if spall occurred. Penetration functions for normal impact of both specimen types are shown in Fig. 8 based on the penetration data in Table 5; a spall function for the normal impact of the thin Lexgard panels is shown in Fig. 9. These curves can be used to determine if penetration or rear-surface spall will oc-

cur as a result of a particular high-velocity impact. It is noted that the curves in Figs. 8 and 9 are simply lines of demarcation between areas of penetration and no penetration and spall and no spall for the parameters indicated.
