Advanced Composite Materials

Impact damage detection system using small-diameter optical-fiber sensors embedded in CFRP laminate structures

Abstract—The mechanical properties of composites subjected to out-of-plane impact decrease markedly from even barely visible damage. In this study, three damage detection technologies are explained: (1) Technologies for the arrangement of embedded small-diameter optical fibers that have no serious effect on the mechanical properties of composites; (2) Technologies for the egress of the optical fibers using ‘the embedded connector for smart structures’ that can be trimmed without damaging the optical fibers; and (3) Technologies for a damage detection system that has data acquisition and analysis functions, evaluates the initiation and the position of damage, and visualizes damage information. We conducted an impact test using the composite airframe demonstrator. FBG sensors are embedded in the upper panel of the 1.5 m diameter, 3 m long stiffened cylindrical composite structure for strain measurement, and optical fibers are embedded for optical loss measurement. Damage detection in composite structures using the developed damage detection sys

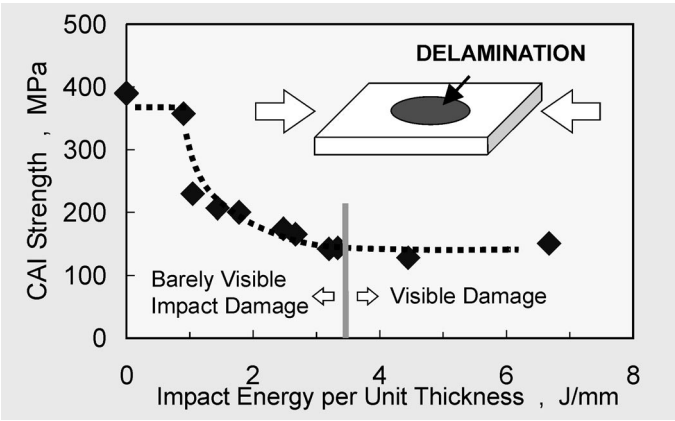
Figure 1. Relationship between CAI strength and impact energy.

Carbon fiber reinforced plastic (CFRP) composites have been used extensively for light weight airframe structures because of their high specific strength and stiffness. As shown in Fig. 1, because of the serious decrease in composites caused by damage, compression after impact (CAI) strength is regarded as an important

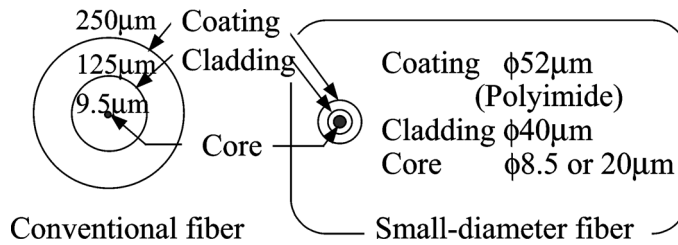
Figure 2. Comparison of small-diameter optical fiber with conventional optical fiber. (a) By measuring optical intensity. (b) By measuring strain responses.

In this study, optical-fiber sensors are used to detect damage in composite structures. ‘Small-diameter optical fibers’ (40 μm in-cladding diameter [2]) were specially used. This small diameter is very important because, as shown in Fig. 2, conventional optical fibers, such as communication fibers, normally have a 125 μm in-cladding diameter, i.e. the same as the thickness of a CFRP prepreg. Small-diameter optical fibers can be embedded within a CFRP prepreg without deteriorating the mechanical properties of composites. Here, the core diameters of small-

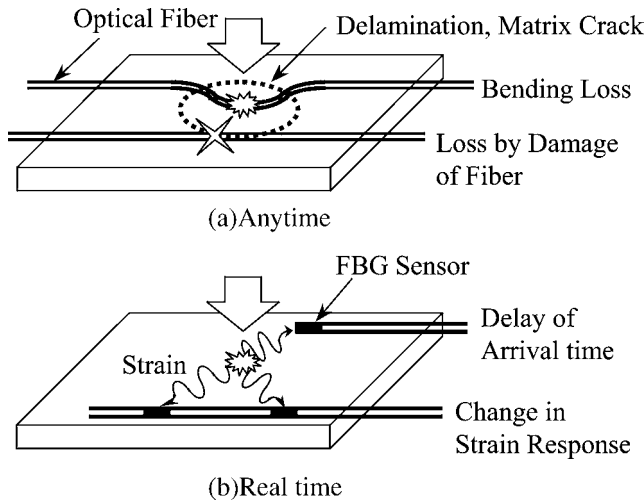
Figure 3. Damage detection method. (a) External view. (b) Internal view.

Figure 3 depicts two methods of damage detection using the small-diameter optical-fiber sensors. The first is the method of measuring the optical intensity of multi-mode type optical fibers, as shown in Fig. 3a. Incident light enters from one end of an optical fiber, passes through the damage-detection sensing area, and comes out from the other end. If the optical fiber is subjected to damage or local bending or deformation by impact damage, such as delamination or matrix cracking, the optical intensity of optical fiber decreases. Damage initiation can be judged from the degree of the optical loss. It is not necessary to measure the optical intensity in real-time in this method. The other method is to use single-mode type FBG sensors. As shown in Fig. 3b, the sensors can measure the strain induced by impact events. Damage initiation can also be judged from the change in strain responses, and the damage position can be detected using the differences of arrival times of the strain at each sensor.

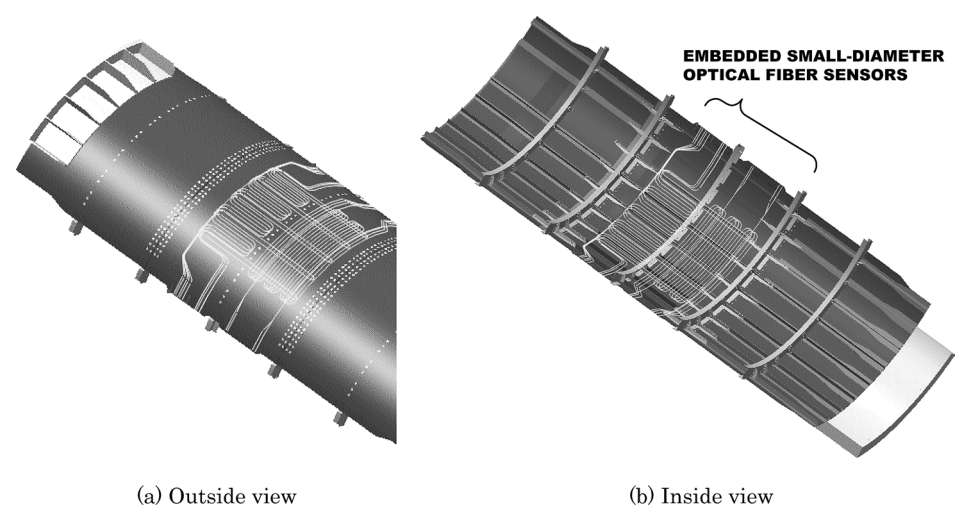
Figure 4. Designed arrangement of embedded optical-fiber sensors. (a) Edge of skin. (b) Edge of stringer. (c) Detail of (b).

The designed embedded optical-fiber sensor arrangement in a curved, stiffened panel is shown in Fig. 4. The embedded fibers are 16 small-diameter optical fibers and four small-diameter FBG sensors. This 3 m long panel consists of three small panels with nine blade-type stringers and five frames. Each small panel is joined using splice plates and splice stringers. As a part of simulating an airframe structure fuselage, this panel was assembled with other panels by single-lap (longitudinal) splicing. Fastener holes are therefore drilled at the lap splice segment without cutting the embedded optical fibers.

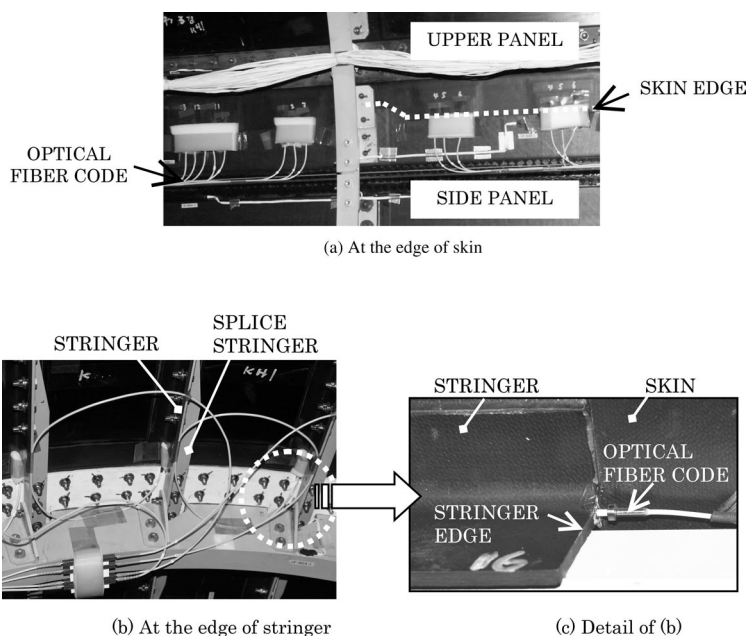
Figure 5. Connection of embedded connectors for smart structures with optical-fiber cord.

Embedded optical-fiber sensors egress the laminate/CFRP structure to connect with a measurement system. However, at the level of structural element specimens, the embedded fibers were egressed directly from the specimens. This egress method has a serious problem in that the handling from manufacturing to assembly is difficult and trimming after the curing of composite structures is impossible. Therefore, 'the embedded connector for smart structures' was developed. This connector is embeddable in composites, trimmable after curing and connectable with optical-fiber cords or cables. Figure 5 illustrates the connection with optical-fiber cords. As shown in Fig. 5a, there is a part of the lap splice between an upper panel and a side panel. Optical-fiber cords can be connected to the edges of the skin of an upper panel. Figure 5b depicts the connection of optical-fiber cords to the edges of

stringers. Figure 5c presents detail of part of the connection. In this study, optical-fiber cords could be easily attached or removed.

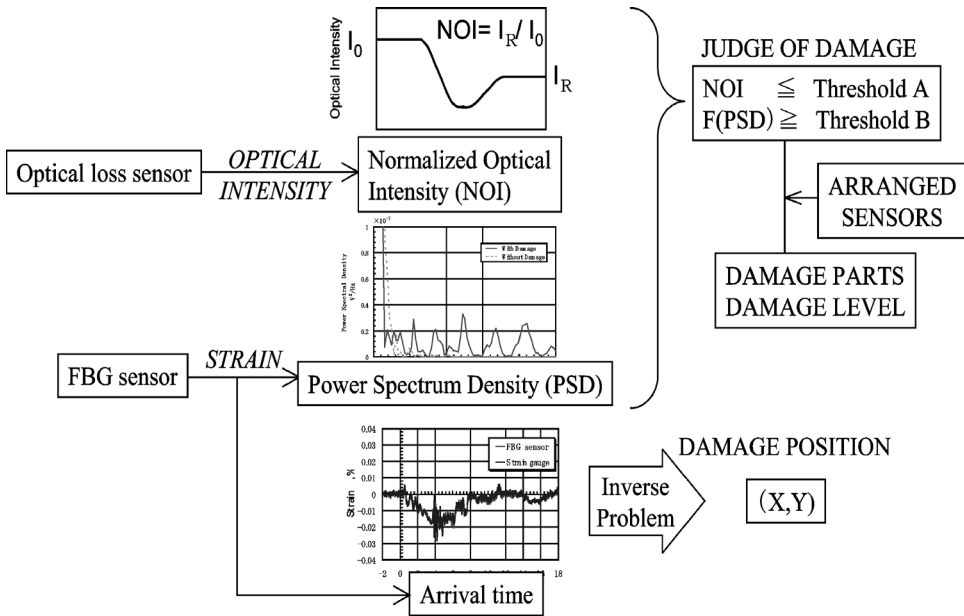
Figure 6. Damage detection analysis and evaluation.

The optical signal data (optical intensity and strain) are analyzed and evaluated to identify damage incidents, specify the position/part damaged, and estimate the damage level. The information is displayed on a graphical screen to indicate the result of damage detection. The methods of analysis and evaluation are shown in Fig. 6. For damage detection, as mentioned in Section 2.1, two optical-fiber sensor measuring methods are used. Measured optical intensity is normalized by equation (1). The value of the normalized optical intensity (NOI) is compared with threshold A. An $\text{NOI} \leq A$ indicates a ‘damage incident’. Damage is also detected from the power spectrum density (PSD) of the strain responses measured by FBG sensors when $F(\text{PSD}) \geq \text{threshold B}$. The area and level of the damage can be determined by correlating the received data to the sensor arrangement. Moreover, since the arrival time of a strain wave at each FBG sensor differs, the position (x, y) of the damage can be specified by solving the inverse problem for the time lag function of equation (2).

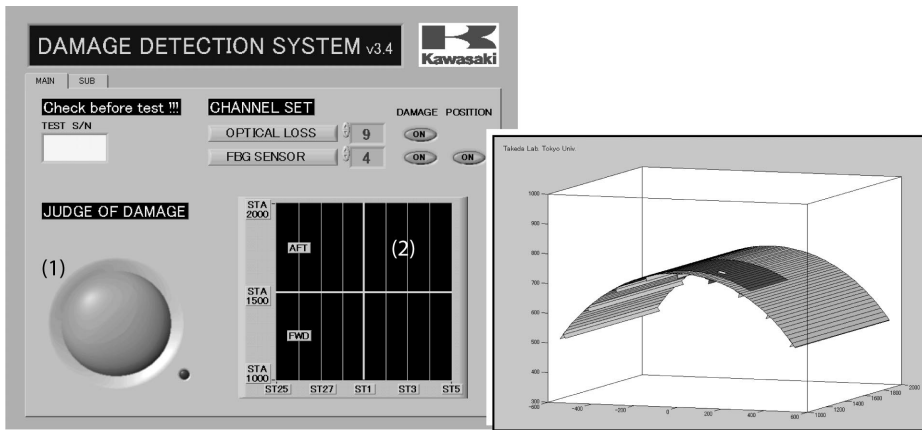
Figure 7. Damage detection system main screen. (a) Photograph of demonstrator. (b) Sketch of demonstrator.

The analysis, evaluation, and visualization system, which is included in the damage detection system, was developed using the algorithm mentioned above. As shown in Fig. 7, the system has a graphical screen/interface. The main screen (on the left) displays the data measured by the optical-fiber sensors, and the data is analyzed and evaluated. The color of indicator (1) changes to red as new damage is detected. The X – Y graph (2) can indicate the damage point. Here STAx and STy mean the position of frames and stringers, respectively. Using damage initiation and position information, correlated to the arrangement of embedded optical-fiber sensors, the position of the damage parts included in the damaged area can also be indicated on a 3D structural model. An example of the visualization of the damage in a skin and a stringer is shown in the 3D model on the right of Fig. 7. The point of view for the model can be easily changed using a mouse, and the information can be understood visually. (The 3D model was developed at the University of Tokyo.)

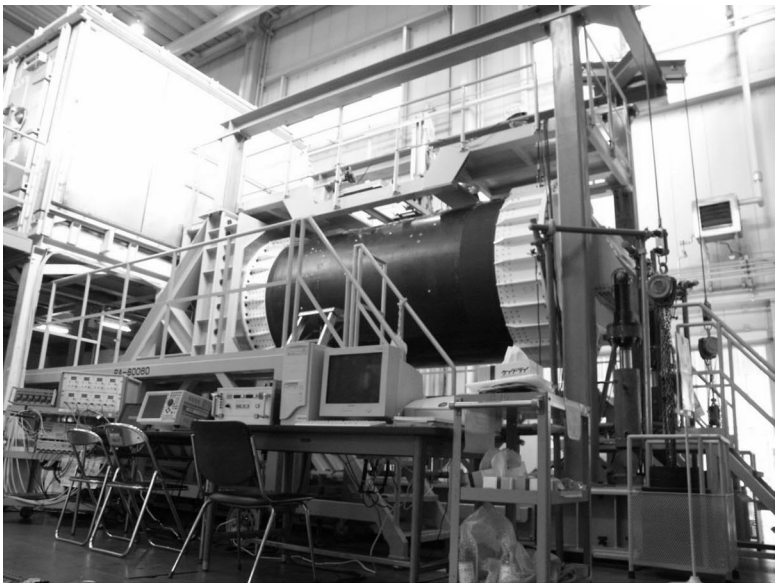
(a) Photograph of demonstrator

Figure 8. Full view of demonstrator.

As shown in Fig. 8a, the impact test for the demonstration of damage detection after bending and pressure tests was conducted using a 1.5 m diameter and 3 m long demonstrator. The composite demonstrator, assembled with a single lap splice, consists of the upper panel, left and right side panels, and lower panel. The specimen

induced by dropping a 55 N impactor from an impact test machine installed above the demonstrator (Fig. 8a). In this study, the impactor was dropped from heights of 0.19 m to 0.56 m.

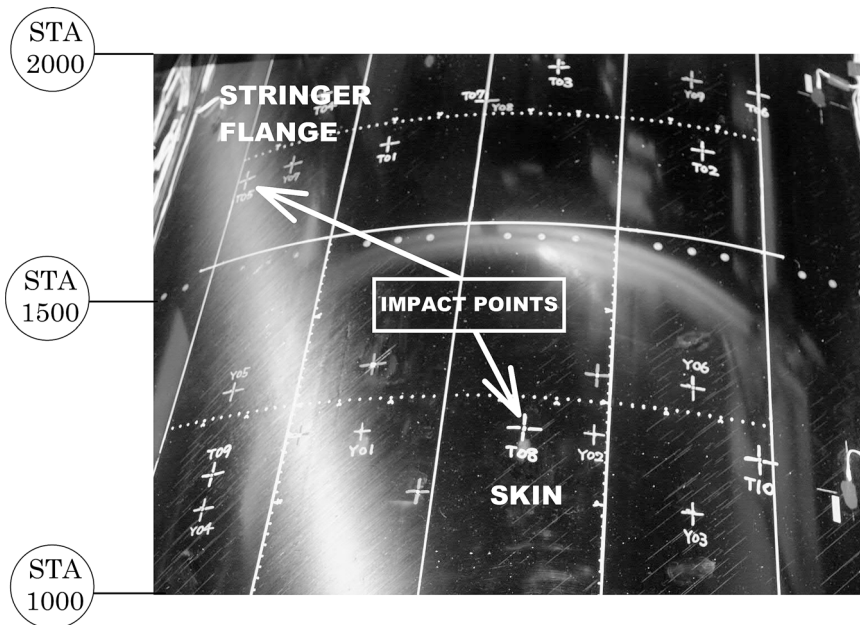
Figure 9. Impact points on the upper panel.

is supported as shown in Fig. 8b. The sensing area of the optical-fiber sensors is the mid-part of the upper panel, from STA1000 to STA2000. The area has a skin with three frames and five stringers. Ten impact positions on a mid-bay skin, the flange and the center of a stringer are shown in Fig. 9. Impact damage can be

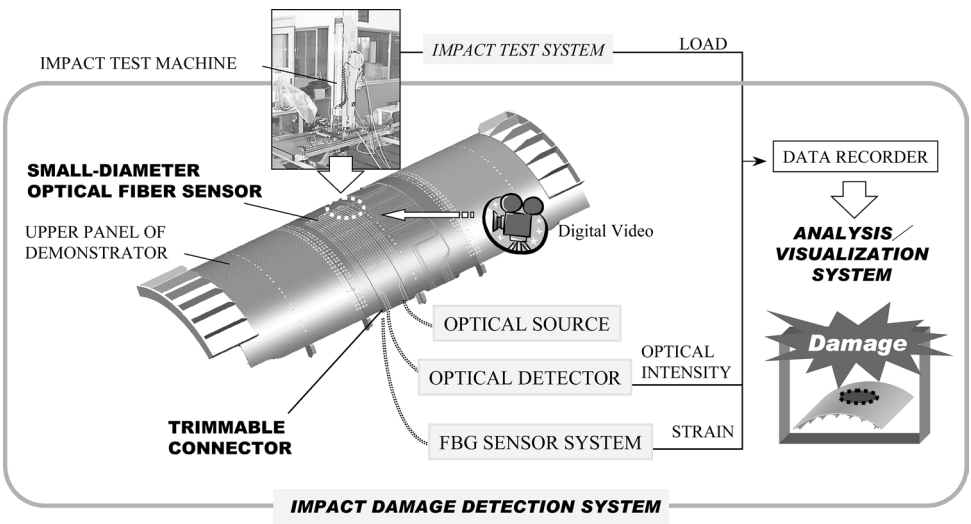
Figure 10. Impact damage detection system and impact test system.

Figure 10 depicts the impact damage detection system (DDS). The DDS consists of the measurement system and the analysis, evaluation, and visualization system. The optical intensity measured by the optical detector and the strain measured by the FBG sensor system are stored in a digital data recorder. At the same time, the impact load measured by an impact test system is acquired. The damage to the composite is detected by the analysis, evaluation, and visualization system.

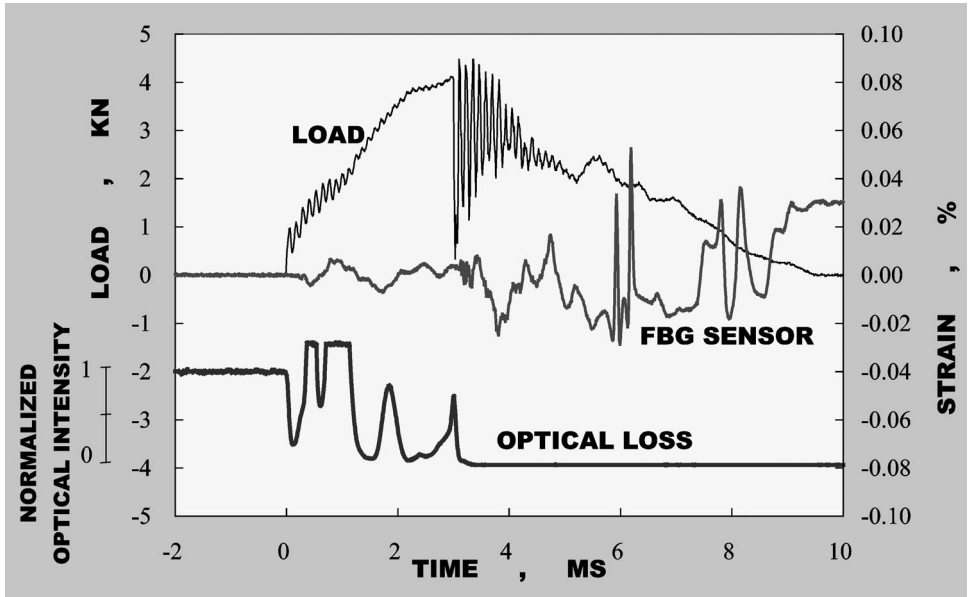
Figure 11. Typical example of the responses measured by optical-fiber sensors. (a) Result 1. (b) Accuracy of a predicted point.

Damage in all of the tests induced by barely visible damage in a composite could be detected. First, typical responses of optical intensity and strain measured by the optical-fiber sensors with an impact load are shown in Fig. 11. In this case, the BVID occurs in the composite at approximately 3 ms after impact. As the impact load is increased, the response of normalized optical intensity changes. We found that the intensity is reduced to zero by the initiation of damage. The strain response also changes after impact, and changes rapidly after the initiation of damage.

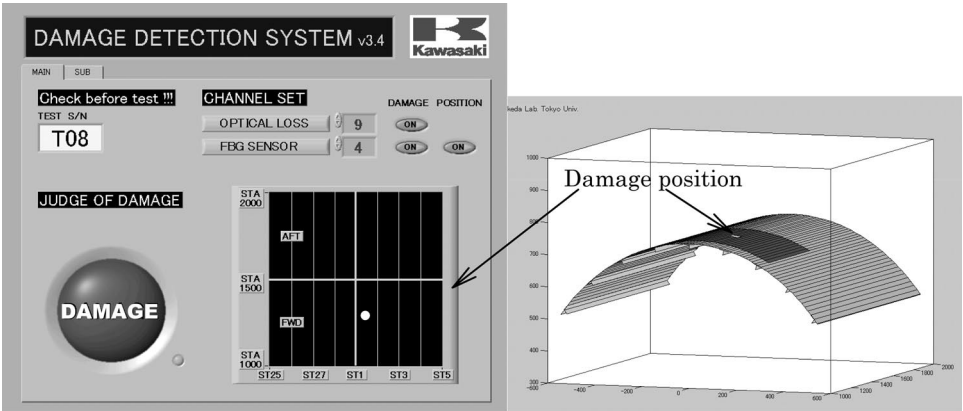
(a) Result 1

Figure 12. Result 1 — Damage detection of a mid-bay skin subjected to impact load.

Skin damage was initiated by the impact load on a mid-bay skin. The 900 mm² damage area measured by ultrasonic scan is ‘barely visible impact damage’ since the dent depth on the impact surface is 0.4 mm. The initiation and the part/position of the damage were evaluated by DDS as shown in Fig. 12a. DDS judges there

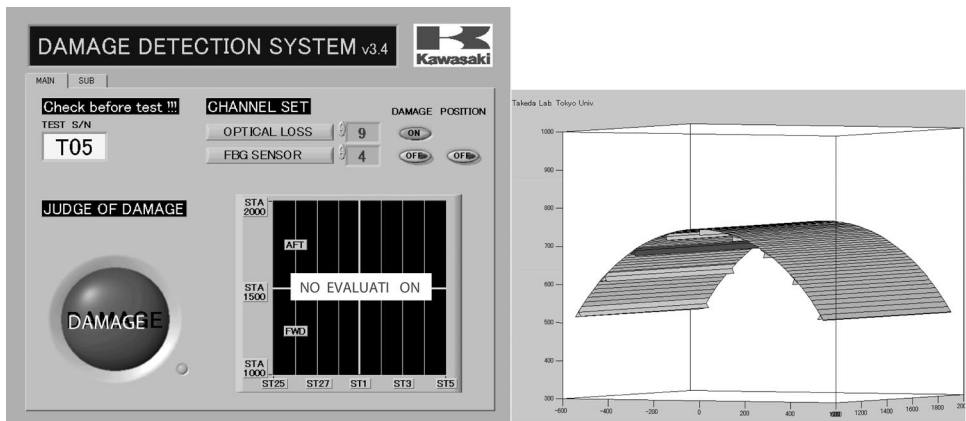
Figure 13. Result 2 — Damage detection of a stringer flange subjected to impact load.

Damage was initiated in an interlaminar region between the skin and a stringer by an impact load on a stringer flange. The 450 mm² damage area is barely visible impact damage since the dent depth on the impact surface is 0.0 mm. The initiation and the part damaged were evaluated by DDS as shown in Fig. 13. In this case, the damage position was not evaluated since the FBG sensors were not covering

the sensing area from STA1500 to STA2000. DDS judged there was damage in a stringer.
