# AFM Study of the Dielectric Breakdown in Ta<sub>2</sub>O<sub>5</sub> Films

High-resolution images, at nanometric scale, of the damage produced on anodic Ta<sub>2</sub>O<sub>5</sub> oxide films subjected to breakdown during anodic oxidation have been obtained by atomic force microscopy (AFM). The time evolution of the breakdown damage has been followed by anodizing different samples at increasing anodization times after breakdown. The AFM images reveal that the breakdown is initiated at definite spots scattered all across the surface of the oxide, producing a granular structure of about 100 nm diameter. Superimposed on this granular structure some protrusions of larger sizes also appear which, after further anodization, give rise to ridges and craters on the surface. The damaged areas are then propagated in the form of branches covering large regions of the oxide surface. The evolution of the tantalum oxide during the double-anodization experiments was also studied. Healing effects of the breakdown damage has been directly observed and related to the decrease of the electron avalanches causing the breakdown. The AFM images have been also used to quantify the variation of the surf

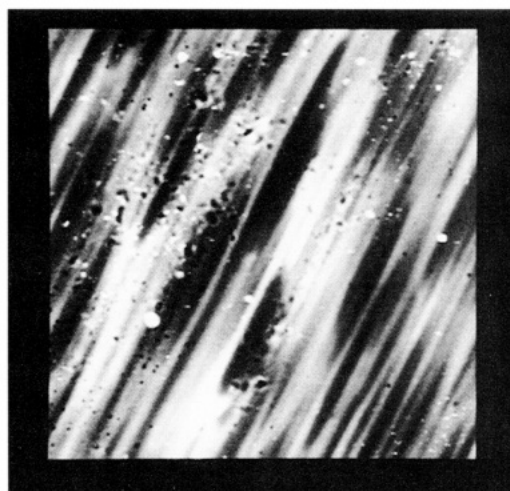
morphology. Figure 5 shows a top view of a sample after the breakdown process at two different voltages,  $V = 330$  and  $380$  V (Figure 5a,b, respectively). In Figure 5a is observed the formation of isolated pores distributed in different sizes (diameter in the 280–450 nm range). These pores are preferentially aligned along the rolling lines. For long breakdown times the pores are deeper and larger, covering almost all the surface of the sample (Figure 5b). However, in this case, the granular structure is not so apparent as in the chemically etched samples. Additionally, no crack fingers or microfissures were observed.

**Figure 5.** The  $25 \times 25 \mu\text{m}^2$  AFM images of a sample not chemically etched subjected to breakdown at  $V = 330$  V (a, top) and  $V = 380$  V (b, bottom).

The differences observed in Figures 1, 2, and 5 for the breakdown damage indicate that the breakdown processes are strongly dependent on the state of the initial tantalum surface. In samples only degreased (Figure 5), the localized breakdown spots aligned along the grooves can be associated to the impurities left behind on the surface by the rolling process, which also give low breakdown voltages. The reduction of the breakdown voltage in these samples can be related to the local electric field enhancement at the protuberances created on the receding Ta surface at the impurity sites (see sketch of Figure 8). On the other side, chemically polished samples, with a lesser defect concentration on the surface, grow to higher thicknesses before breakdown and present a lower concentration of pores and microfissures. However, the high density of grains observed on the flat areas of the surface, which have been associated to the onset of breakdown, gives an insight that this process is of an intrinsic nature, i.e., characteristic of the material.

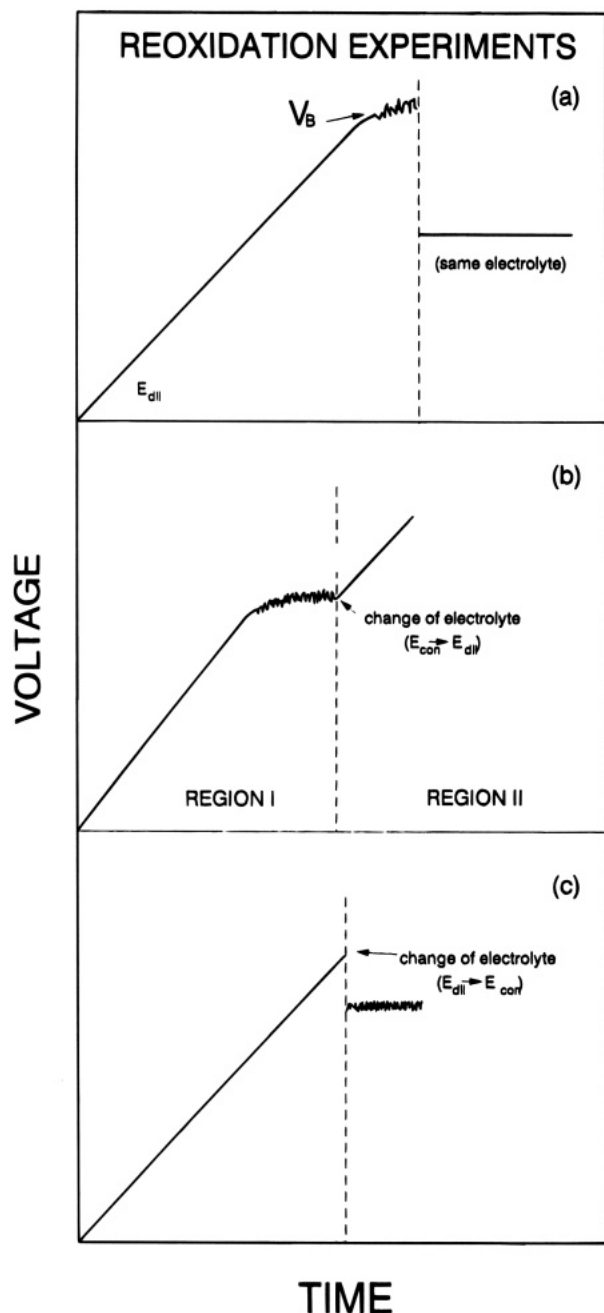
In a first set of experiments, samples previously broken down at  $380$  V in the dilute electrolyte were reanodized under the same conditions up to a constant voltage,  $V = 300$  V, lower than the breakdown voltage. The samples were then left at this constant voltage (potentiostatic conditions) for a fixed time (3 h, Figure 6a). In another series of experiments, the oxidation in a concentrated electrolyte,  $E_{\text{con}}$ , up to the breakdown was followed by another in a diluted electrolyte,  $E_{\text{dil}}$  (regions I and II, respectively). As can be observed in Figure 6b, in the region II the breakdown process is stopped and the voltage curve starts to increase at the last voltage attained in region I at a rate characteristic of the second electrolyte, until it reaches a higher breakdown voltage, typical of this last electrolyte ( $320$  V). A new change to the first electrolyte ( $E_{\text{con}}$ , Figure 6c) leads to the  $V(t)$  curve corresponding to the concen-

**Figure 6.** Voltage-time curves corresponding to “double-anodization” experiments: (a) anodization up to breakdown voltage followed by reanodization at a lower voltage in the same electrolyte. (b) Anodization in a concentrated electrolyte ( $E_{con}$ ) followed by reanodization in a dilute electrolyte ( $E_{dil}$ ). (c) Inverse process, anodizing first in the diluted and then in the concentrated electrolyte.

trated electrolyte and gives rise to a decrease of the anodization voltage toward the value corresponding to this electrolyte, with a sudden occurrence of breakdown.

comparison of the surface morphology in a “gray” sample (Figure 3) and in the same sample after reanodization under the conditions indicated in Figure 6a (Figure 7), the branched microfissures have partially disappeared in the latter, showing wide regions of flat areas. In addition, the initial roughness produced on anodic  $\text{Ta}_2\text{O}_5$  films subjected to breakdown is smoothed (Figure 4). Thus, the values of the rms roughness of  $25 \times 25 \mu\text{m}^2$  images measured before and after the reoxidation process are 327 and 297 nm, respectively. The decrease of the roughness is associated to the formation of oxide into the cracks and pores during the reoxidation process.
